## Environmentally friendly use of timber in harbour infrastructure

NIBIO REPORT | VOL. 6 | NO. 34 | 2020

Environmentally friendly use of timber in harbour infrastructure/ Miljøvennlig bruk av tre i havneinfrastruktur

Moss Havn KF

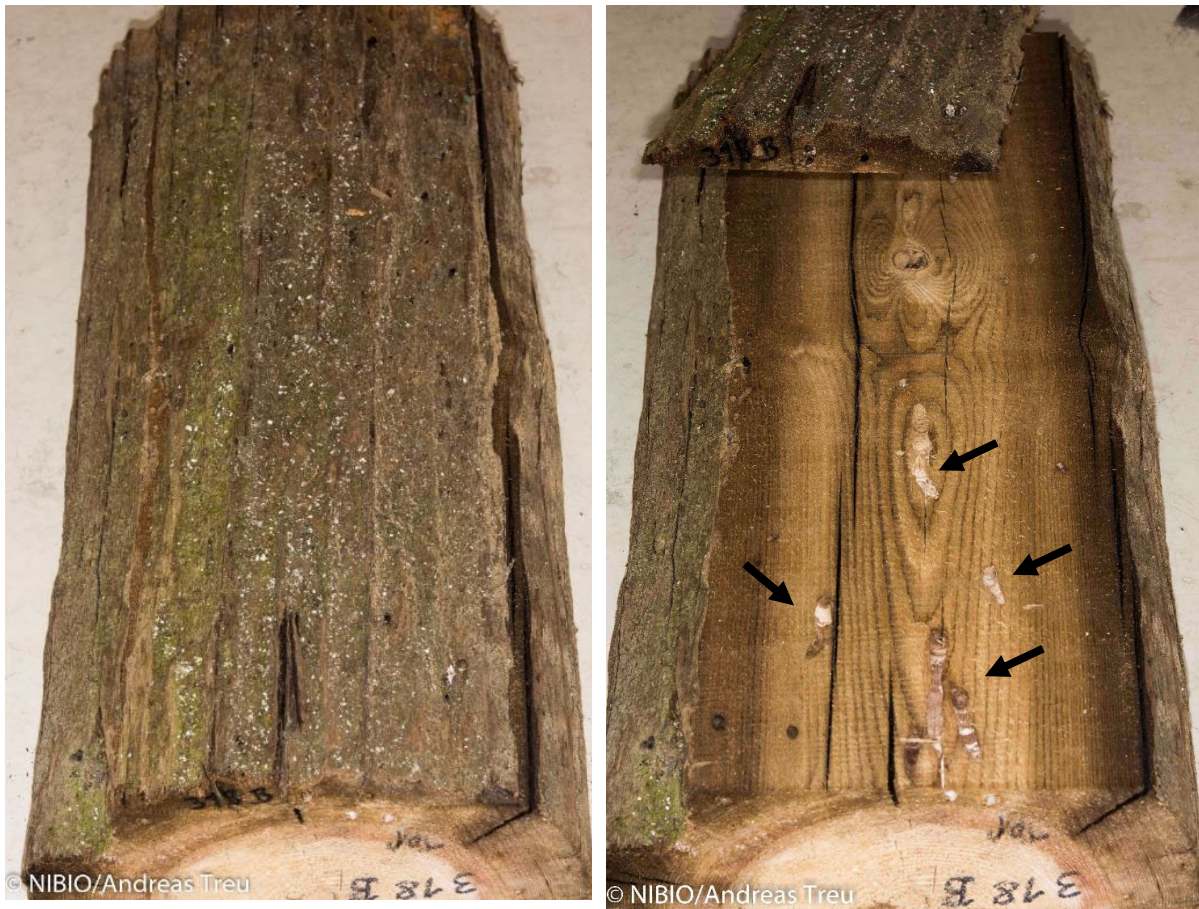
**Figure 2. Suberficial degradation of creosote treated wood pole (left) and borer attack (right). The 9 m long pole was removed from Hesselbergbrygga/Moss**

Only one pole could be removed in full length, due to practical difficulties, and an extensive analysis of the condition of the other two poles could not be performed. The pole which has been removed from Hesselbergbrygga (see Figure 1 and Figure 2) showed erosion on the surface and only slight growth of fouling organisms. Dividing the pole into four sections and cutting the sections in longitudinal direction revealed shipworm attack in all sections except for the upper section, which was partly, about 50 cm, above the water level or in the tidal zone. All boreholes appeared to be recently created because the calcareous layer of the tube walls was still present in most of the tunnels. However, no living organisms could be found in the wood. Interestingly, the boreholes are found mainly in the sapwood zone (see Figure 3), where usually most of the creosote is distributed. Although significant migration of creosote from the treated poles is not expected for short term exposure (Lebow 1987). 80 years of exposure could have changed the composition of the creosote-treated envelope. The amount and composition of creosote in the sapwood has not been analysed. An explanation, why shipworm were able to attack the sapwood zone can therefore not be given.

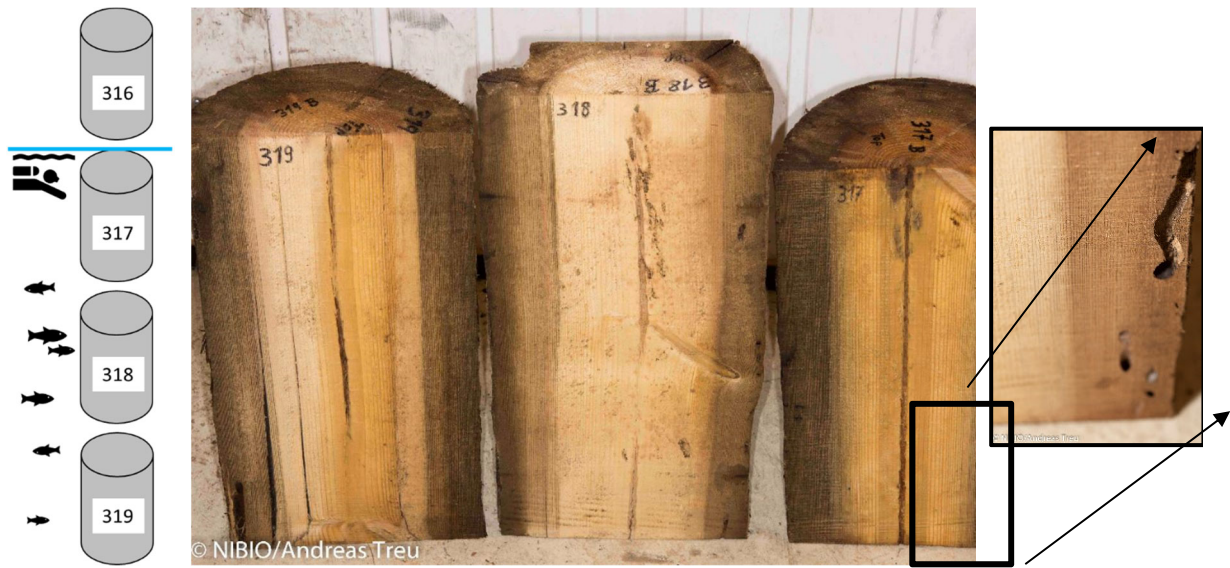
Figure 3. Borer attack of creosote treated wood pole removed from Hesselbergbrygga and close-up of borehole in creosote treated sapwood of Scots pine (right); drawing of position of pole segments in the water (left)

- One of three creosote-treated poles showed attack by shipworm
- Tunnels appear to be from recent attacks of shipworms
- The damage pattern will give great loss in strength properties in the next years
- Amount of both migrated and residual creosote content in the pole has not been analysed. The analysis of creosote in the sapwood zone could contribute to an explanation why shipworm was found in the treated sapwood area.

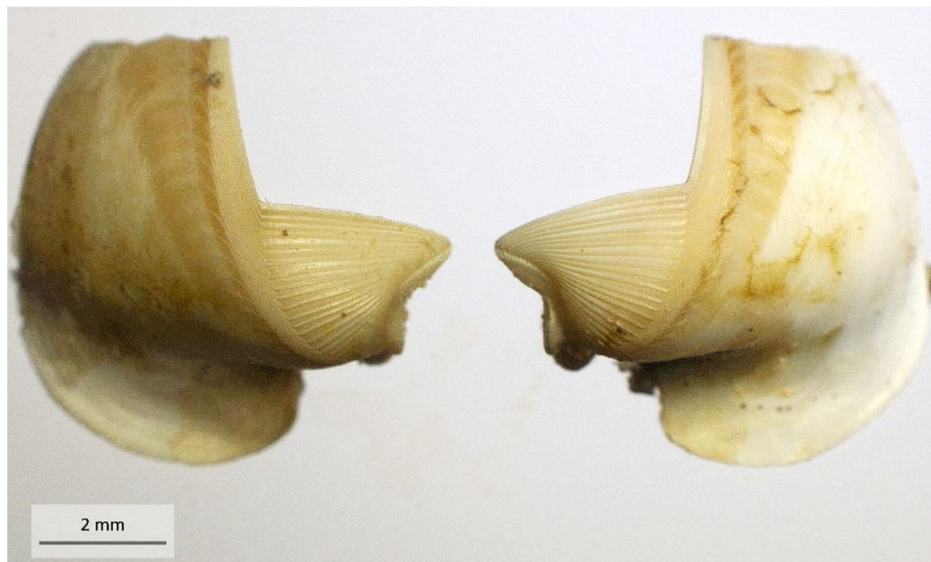
Figure 8. Shell valves from shipworm found in the heartwood zone of creosote treated Scots pine poles exposed in Moss harbour, the extending shell auricles could point to the species *Psiloteredo megotara*

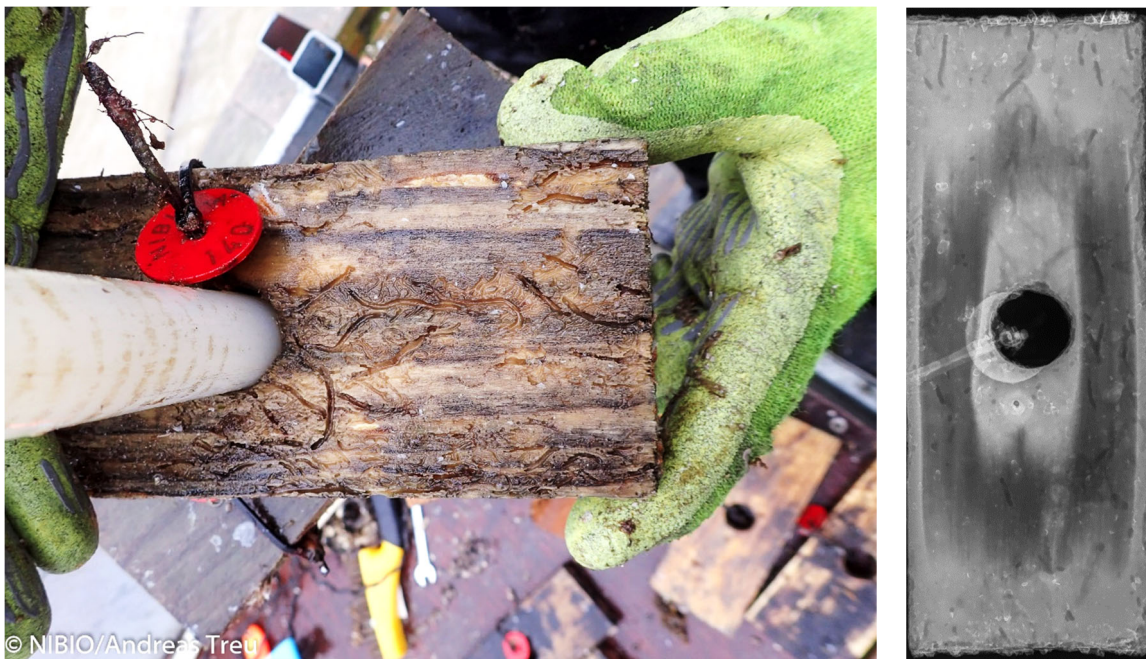
Other wood borer species such as gribble (*Limnoria* spp.) have not been found in Moss harbour. However, gribble attack was observed in the Drøbak test site 30 kilometres north of Moss (see Figure 9).

Figure 9. Gribble attack on spruce wood samples at the test site in Drøbak; tunnels are even visible in the x-ray image (right)

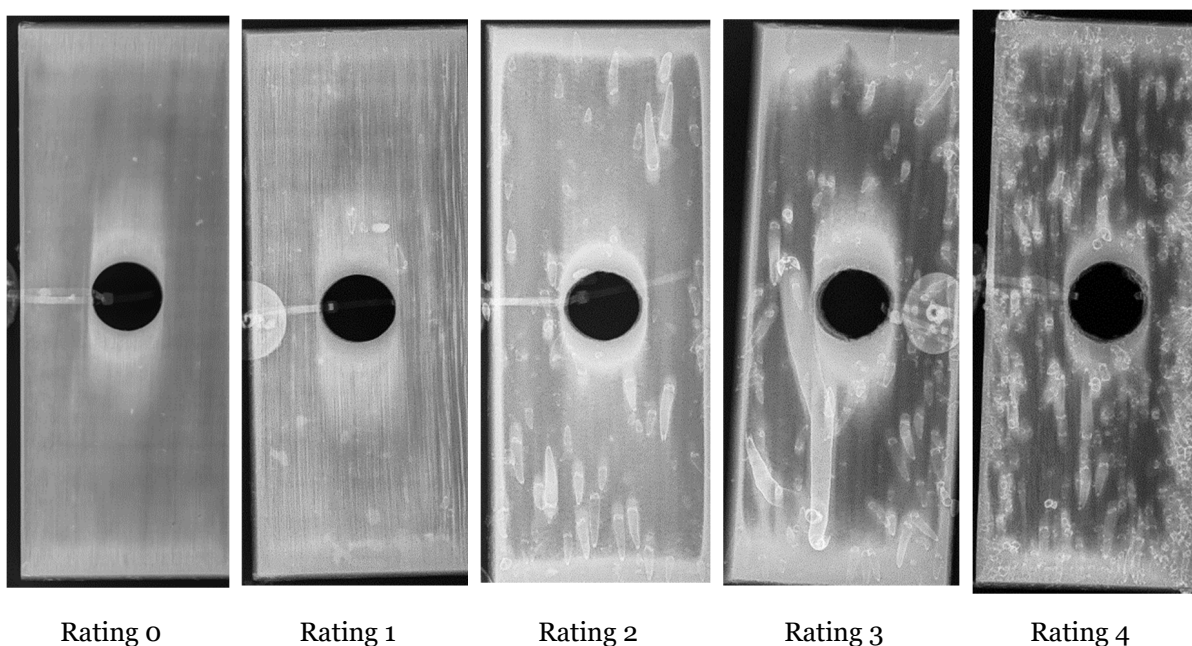
Figure 10. Attack rating, according to EN275, of wood borer attack in wood samples; all images were taken from wood samples after 4 months in Moss harbour; the attack was caused by the shipworm *Teredo navalis* and assumingly *Psiloteredo megotara* (x-ray images)

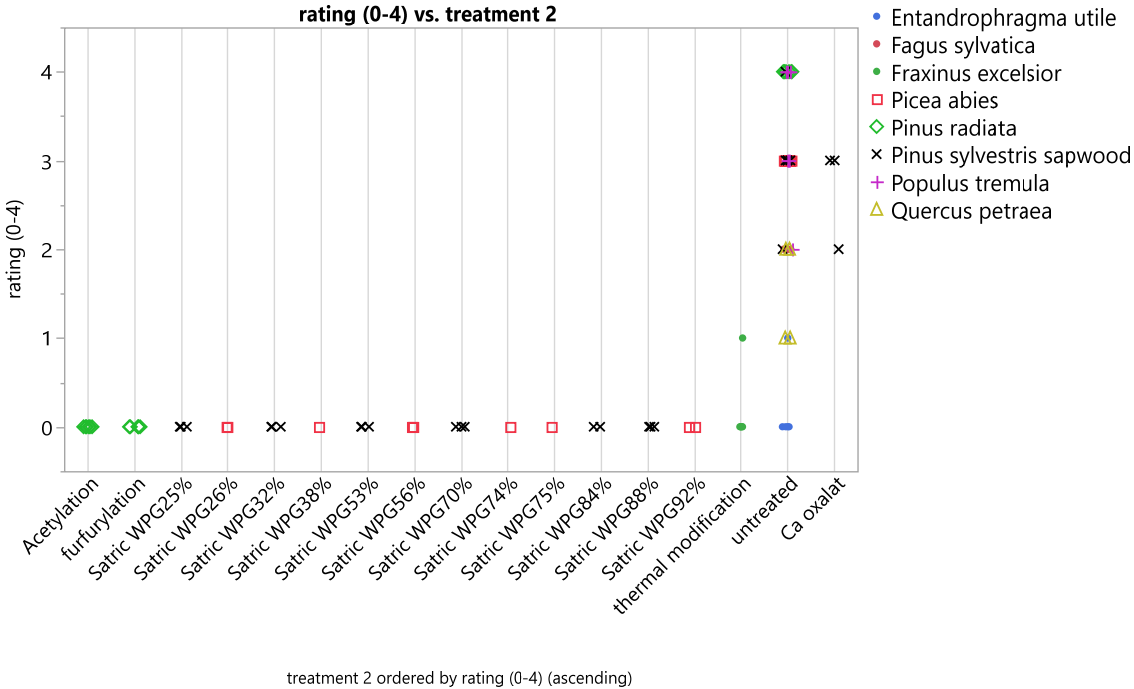
Most of the treated wood samples showed no attack by wood borers after the exposure period. Two of the treatments, thermal modification and calcium oxalate treatment of wood, showed considerable shipworm attack. Untreated control sample made from different wood species showed attack ratings from 1-4. Sipo (*Entandrophragma utile*) showed no attack. However, results from other test sites after two years, e.g. the test site near Drøbak, showed a delay in attack for Sipo wood, but no long-term resistance.

Figure 11. Attack rating, according to EN275, of different treated and untreated wood samples<sup>1</sup> after 4 months in Moss harbour

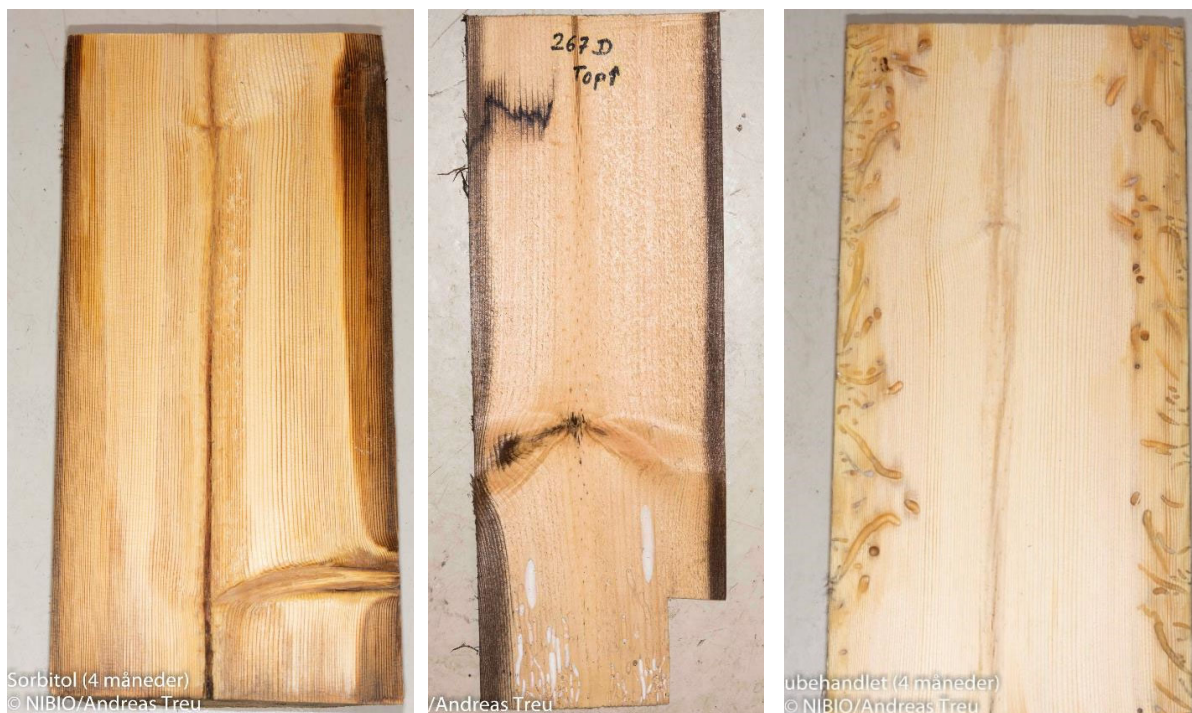
The untreated poles showed heavy attack in the sapwood zone after four months of exposure, Figure 14. The treated poles performed well and showed no attack except for samples treated with creosote, where shipworm has entered the untreated heartwood zone from the lower unprotected transverse side of the pole (Figure 14).

Figure 14. Radial section of treated wood poles; satric (left), creosote (middle) and untreated (right)

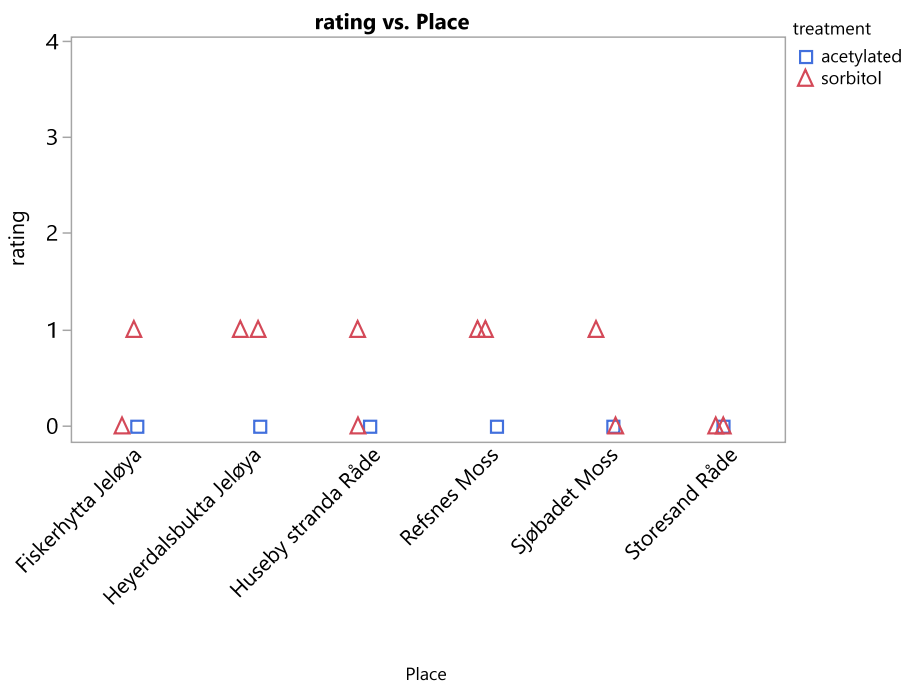
After splitting the samples in tangential longitudinal direction, the attack by wood borers was evaluated. A rating system according to EN 275 was used. Acetylated samples showed no attack after four months of exposure, while most of the satric-treated samples showed shipworm attack in the untreated heartwood zone, see Figure 17.

Figure 17. Attack rating of treated steps at floating platforms

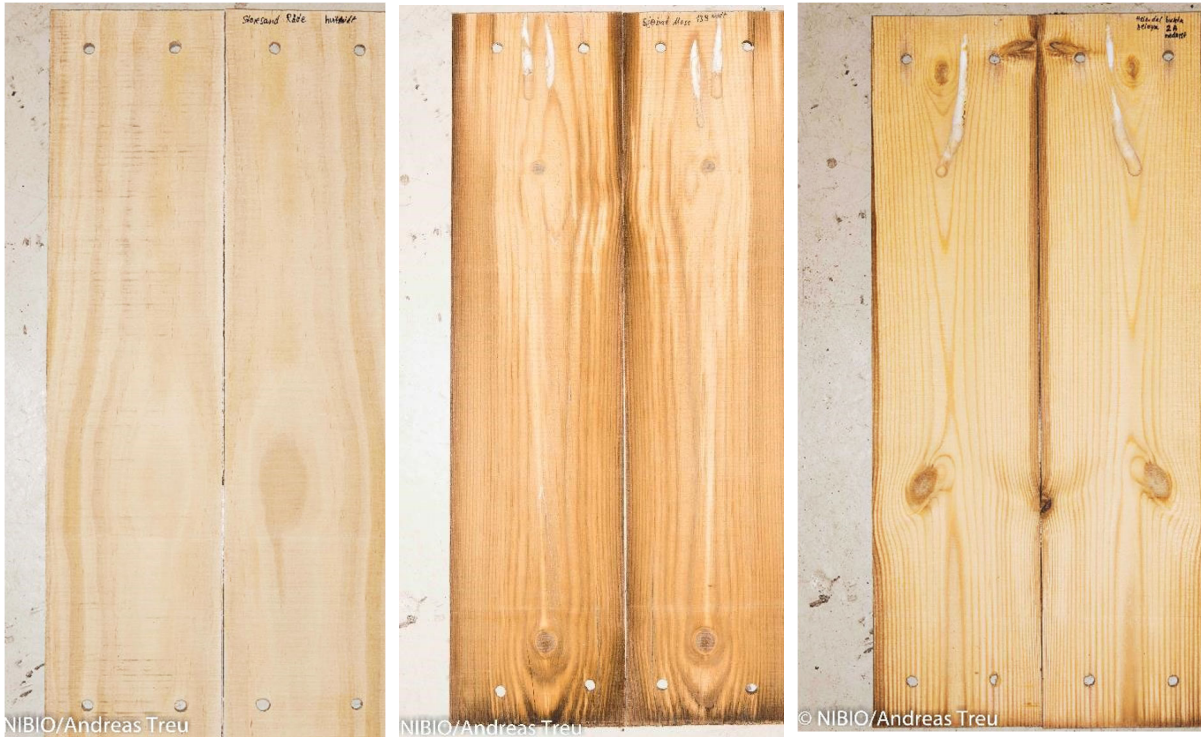
Figure 18. Steps from floating platforms, acetylated (left) and sorbitol treated (middle and right)

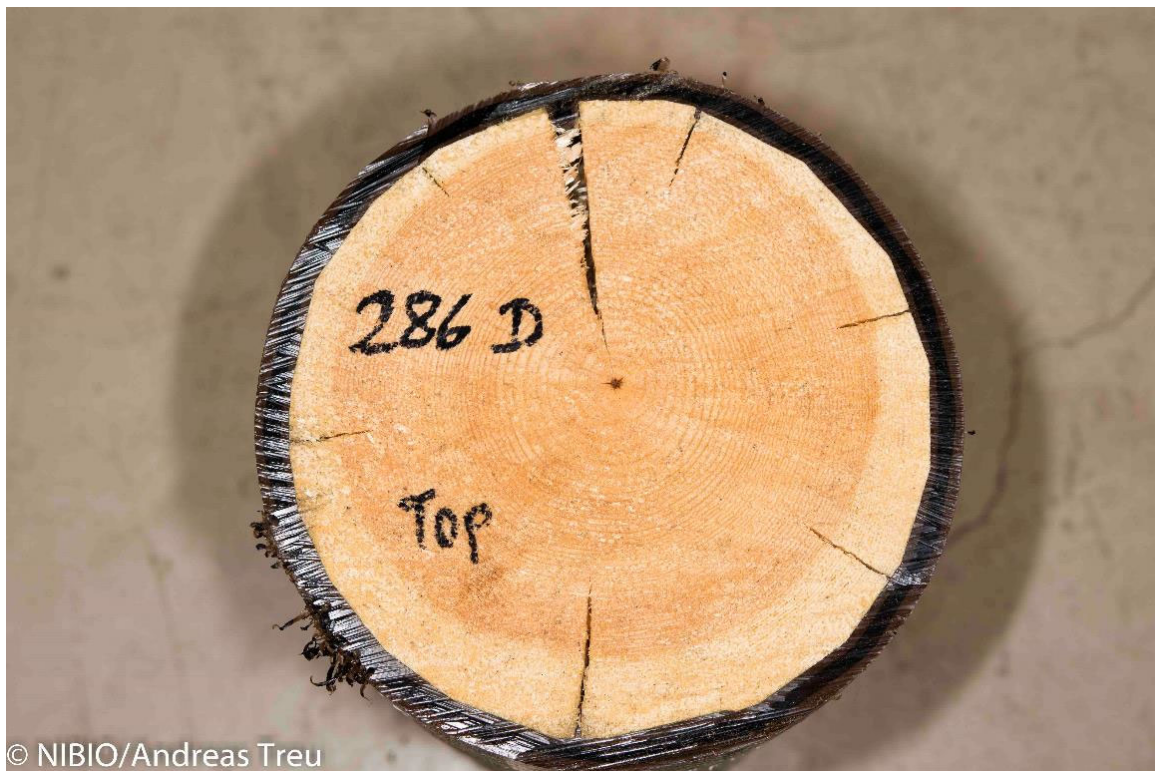
Wood poles encapsulated with plastic (polyethylene, PE 100 RC+) showed no damage after 4 months of exposure to the marine environment. No damage could be observed on the plastic coating.

Figure 20. Transverse section of WOPAS pole made from encapsulated Scots pine

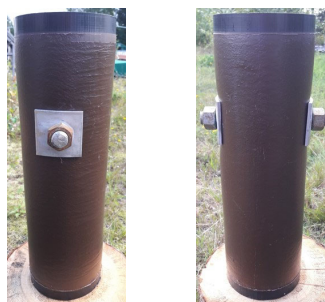
**Bolt (20 mm) with curved washer. Pre-drilled with 20 mm spiral drill. No sealant**

High water uptake

No water uptake was detected for test pieces including Mastic as sealant, test pieces with top cap and reference test pieces,. Other test pieces showed large variation in water uptake between the installation methods. Roof plate screws (without pre-drilling) and nails showed rather low water uptake, while test pieces with bolts and without sealings showed very high water uptake.

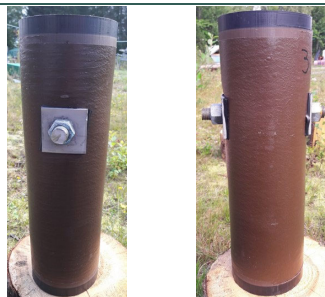
**Bolt (20 mm) with curved washer. Pre-drilled with 20 mm spiral drill. Fitted EPDM gasket, 5 mm thickness, strength 30 Sh. Gasket of the same size as washer. An 11 mm hole was punched in the center of bolt gasket.**

High water uptake of some samples

For the test pieces with EPDM-sealing, the water uptake was high in one of the test pieces. However, observations and measurements performed on the other test pieces in the same series indicated that the water uptake would have increased when prolonging the test period.
