Sampling for wood decay analyses of cable car trestles and houses at Svalbard

Field report

NIBIO REPORT | VOL. 9 | NR. 12 | 2023

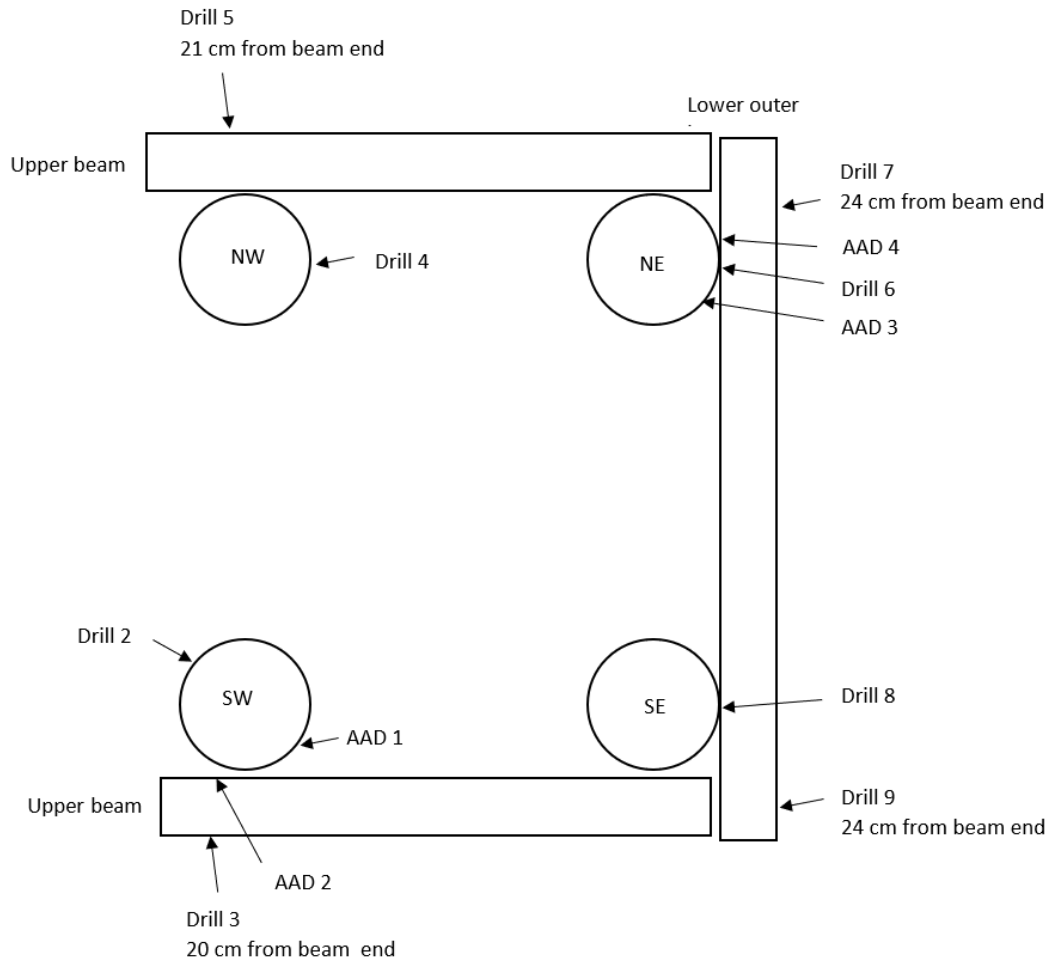
This cable car trestle has clear signs of fungal decay in all the foundation legs. It is low and stands away from traffic, so it does not pose a great danger to the surroundings. Nevertheless, reindeer often graze in the vicinity.

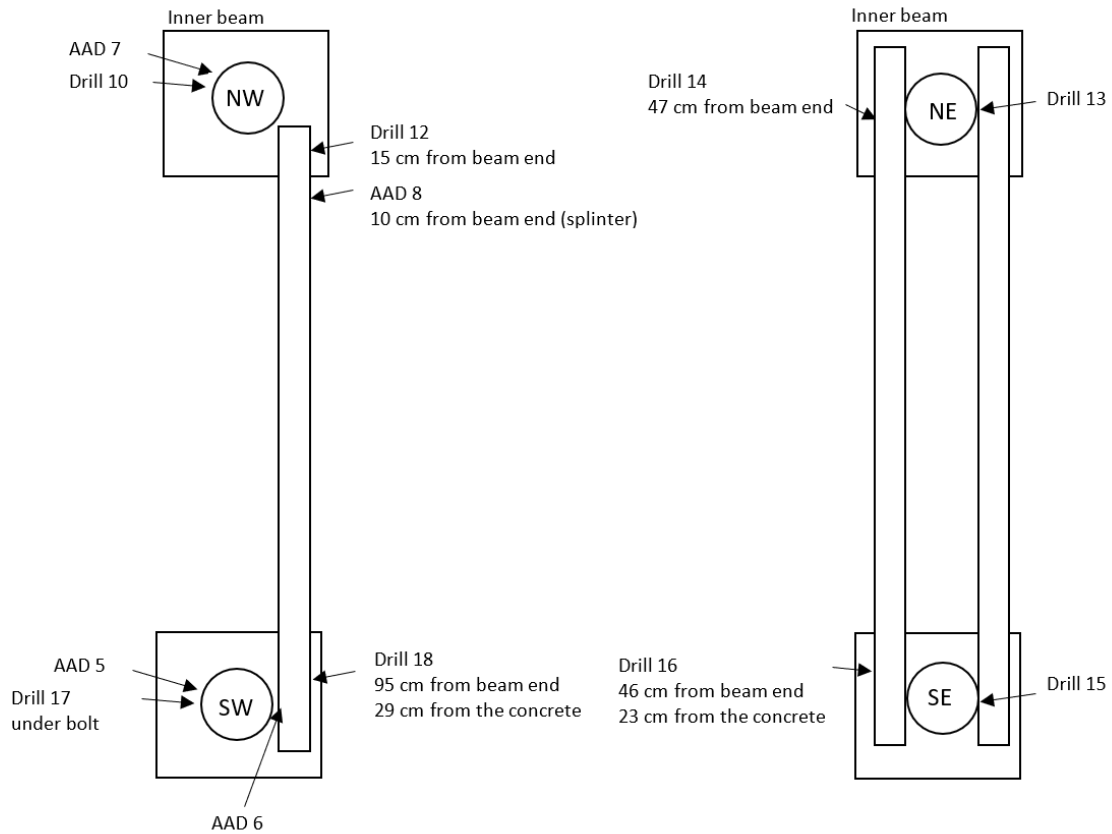
This cable car trestle is standing flat out in the riverbed of the Longyear river. It is tall but stands far from trafficked areas. This trestle is constructed differently from the others, which are grounded with round logs dug into the soil. These trestles, standing in the riverbed, are set on concrete foundations and is therefore less vulnerable to damage. The trestle appears to be in good condition, but the round timber that rests on the concrete foundations appears to have some water stress and they may be slightly deteriorated by fungal decay.

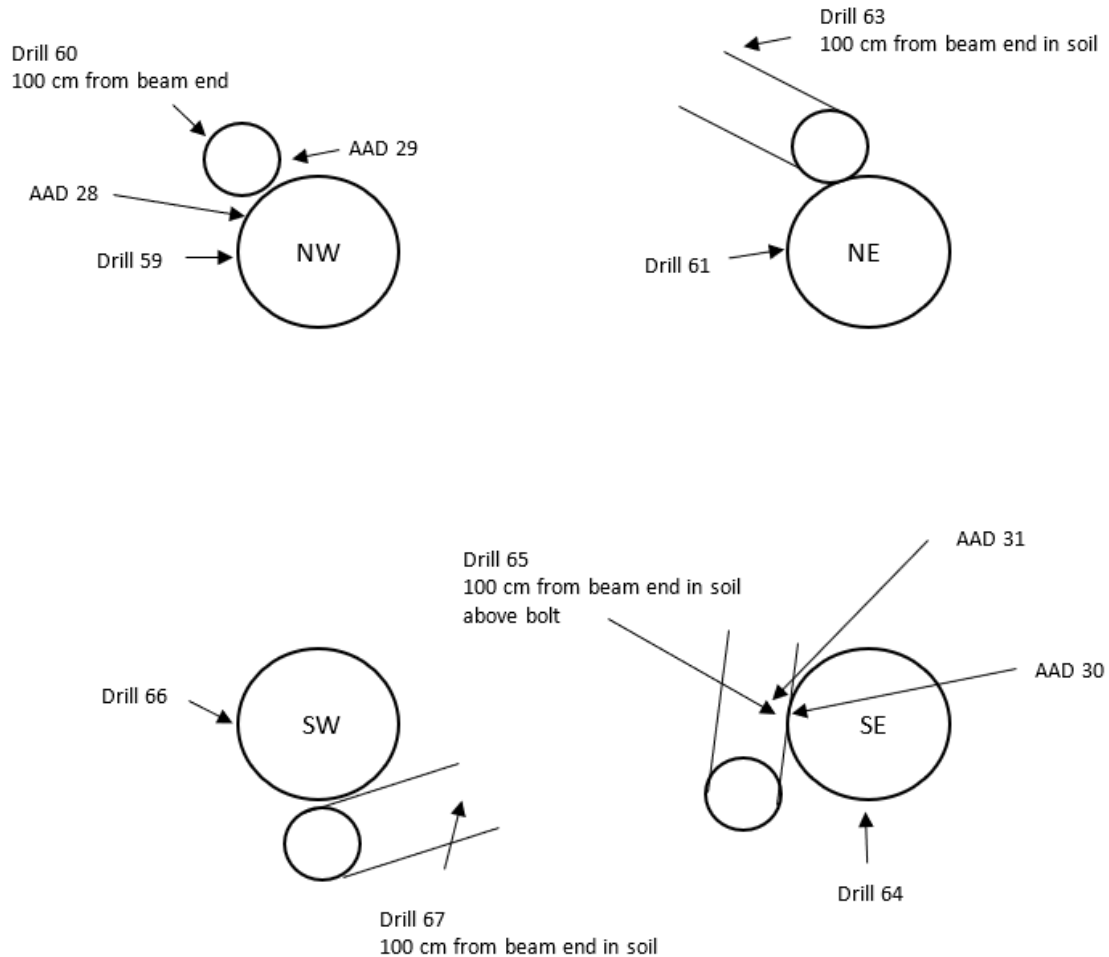
Apparently in good condition and all structural elements in place. Fungal decay in inclined braces. The cable car trestle has not been restored and stands with original materials. Two of the foundation legs may appear to be weakened by fungal decay. The trestle is of medium height, but stands close to residential buildings, and can potentially cause major damage to the buildings.

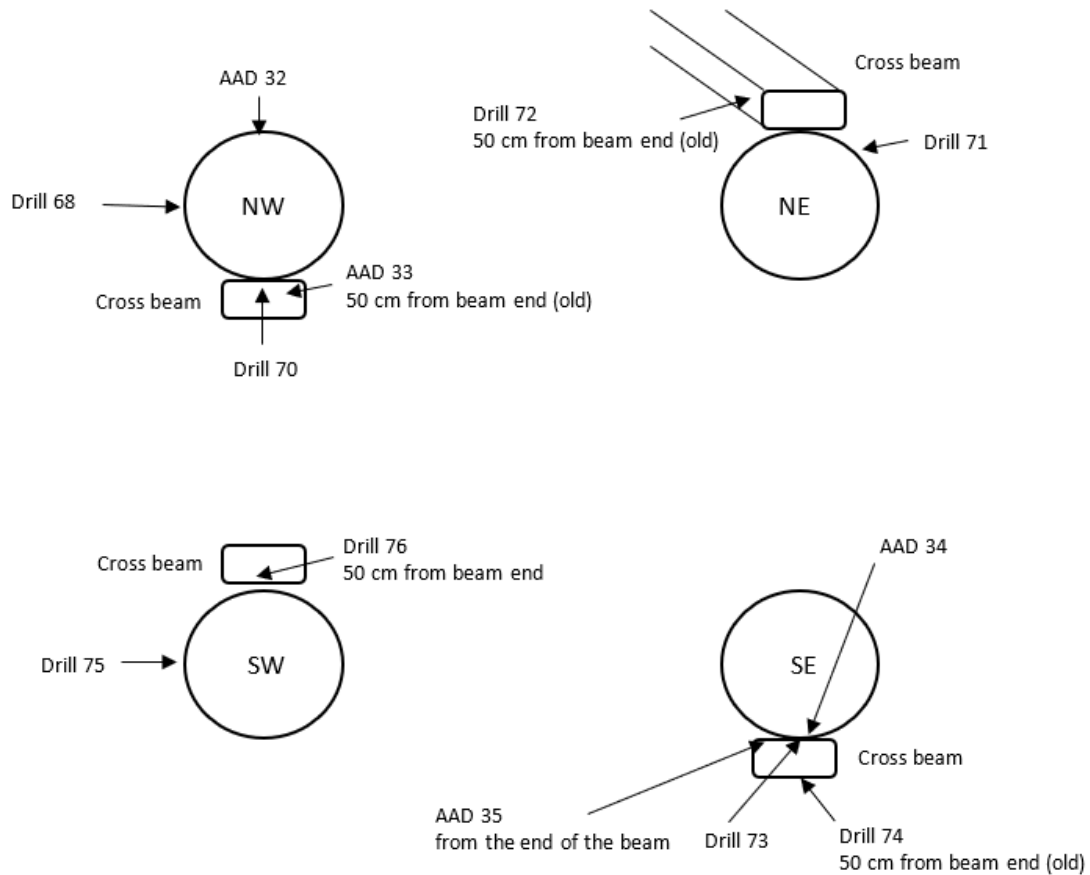
Extensive improvement/replacement in the lower part and foundations in the near future. Creosote in vertical main posts. Apparently in good condition higher up in the construction, however, extensive fungal decay on the upper side of the inclined braces to the north. Should have been replaced. The cable car trestle stands in a flat lojn, but is very tall, and are situated close to a trafficked road.

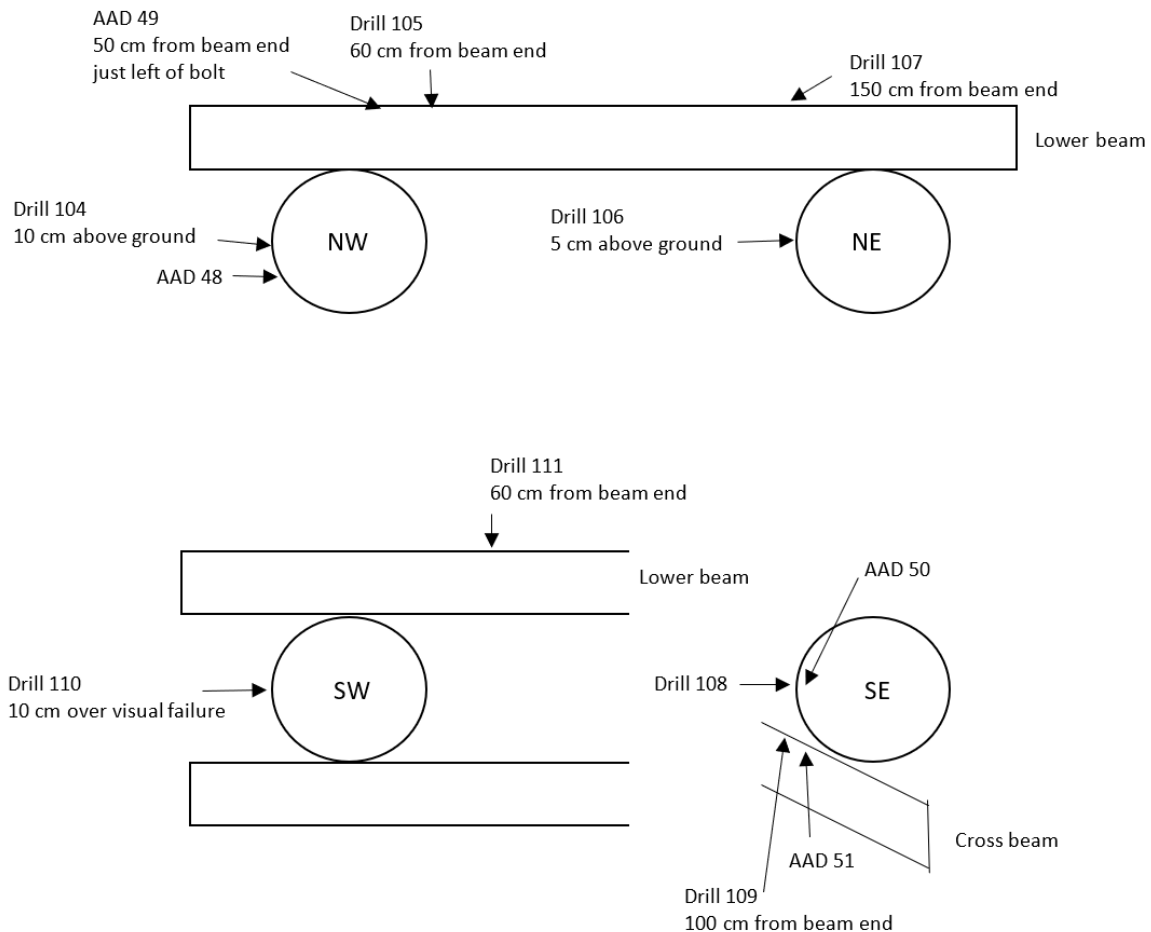
Both foundation legs to the west are completely off due to fungal decay. The rest of the construction looks relatively intact/in good condition. Due to the decayed foundation legs the hole trestle is slightly twisted. The cable car trestle is very high and stands on a steep slope, next to the path leading up to the mine, and visitors get up close. At present, however, the mining facility and the surrounding area are closed to visitors due to a very unsafe and presumably poor condition.

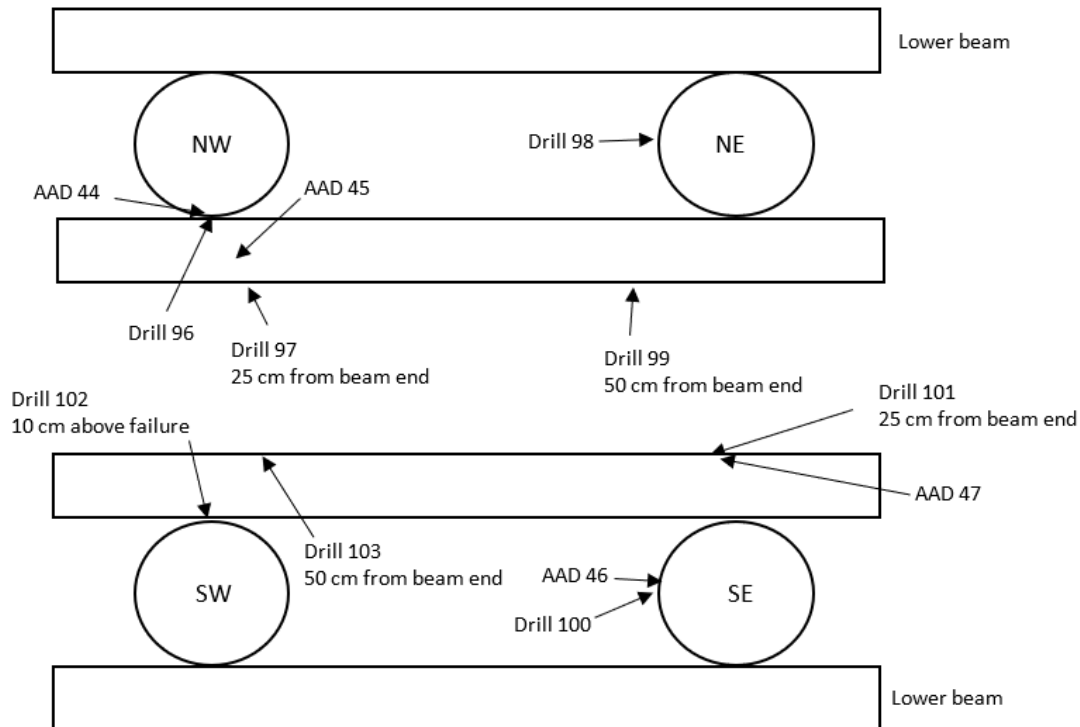
Several of the lower horizontal crossbeams to the south/southeast have broken and/or are missing. Otherwise, the rest of the construction looks relatively intact. Foundation legs to the southwest are broken and completely decomposed by fungal decay. The foundation legs show signs of rot damage. The cable car trestle is very high and stands on a steep slope, next to the path up to the mine, and visitors get up close. At present, however, the mining facility and the surrounding area are closed to visitors due to a very unsafe and presumably poor condition.

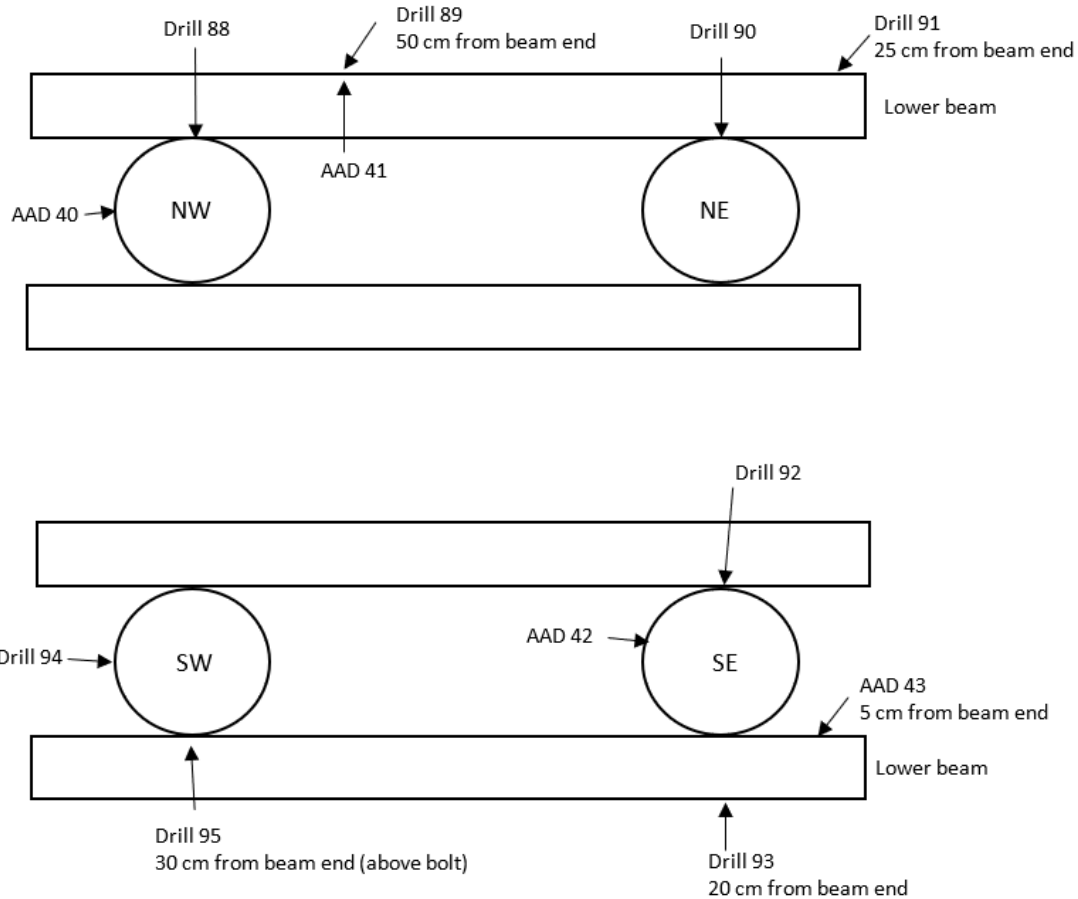
The cable car trestle stands right up next to the mine's day plant. It is partially covered by landslide material. The trestle is low but stands on a steep slope. The foundation legs show signs of rot damage. As it stands in the path up to the mine, visitors get up close. At present, however, the mining facility and the surrounding area are closed to visitors due to a very unsafe and presumably poor condition.

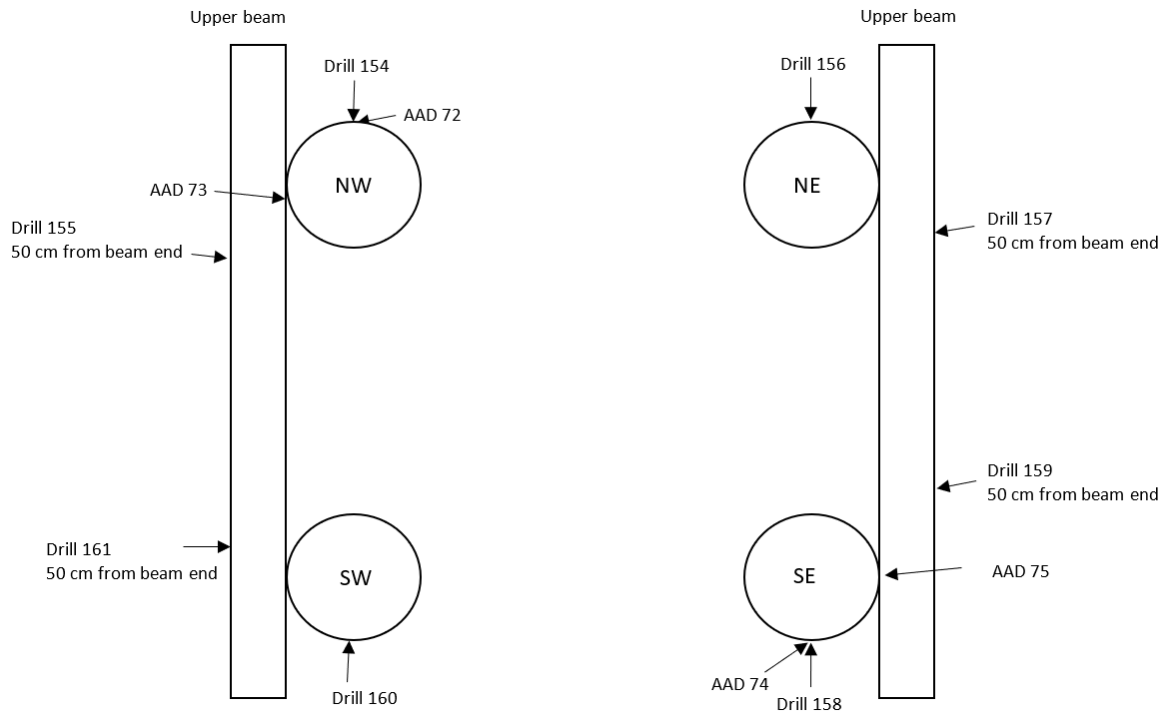
We suspect this cable car trestle is treated (creosote NW and NE, CCA/Cu SW and SE)

This cable car trestle is in surprisingly good condition. Visible salt impact from the ground on foundation legs in the south. Weathering, no rot on beams inspected above ground. This cable car trestle has not been repaired but is in original materials. All the trestles (except from two) in this line were completely replaced while the facility was still in operation. However, we have not been able to find information about when this happened.

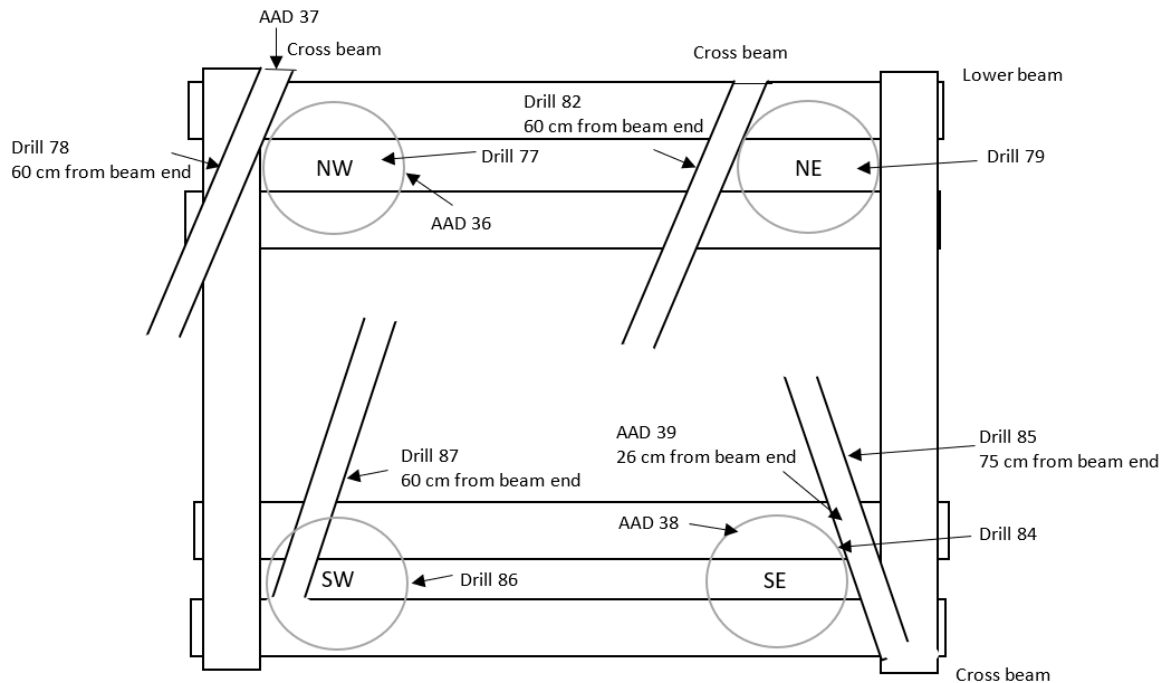
On this cable car trestle, restoration work has started, but has apparently stopped without being completed. There is no visible damage and apparently the trestle is in good condition. The trestle is very tall and stands right next to the road. It can therefore potentially pose a major danger to passers-by.

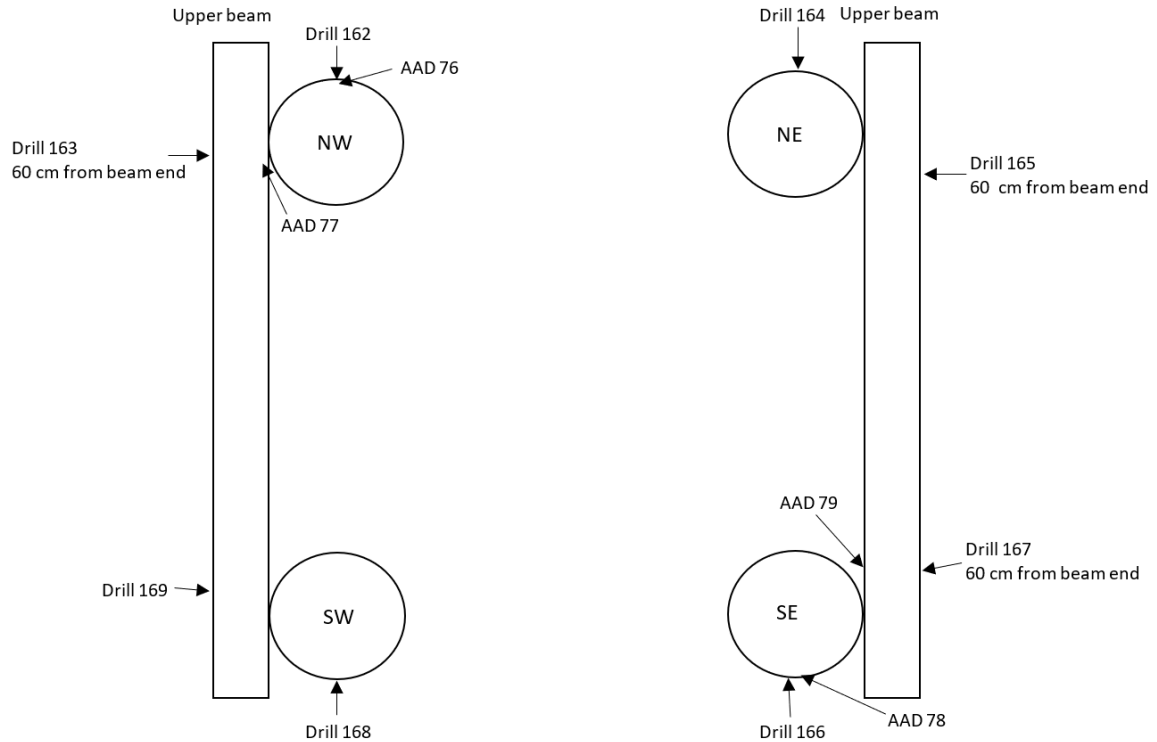
This cable car trestle has recently been restored and the lower parts have been completely replaced. The trestle is therefore in good condition. It is situated close to where people pass, with snowmobile parking and houses close by, and is very tall. It is therefore important that it is restored.

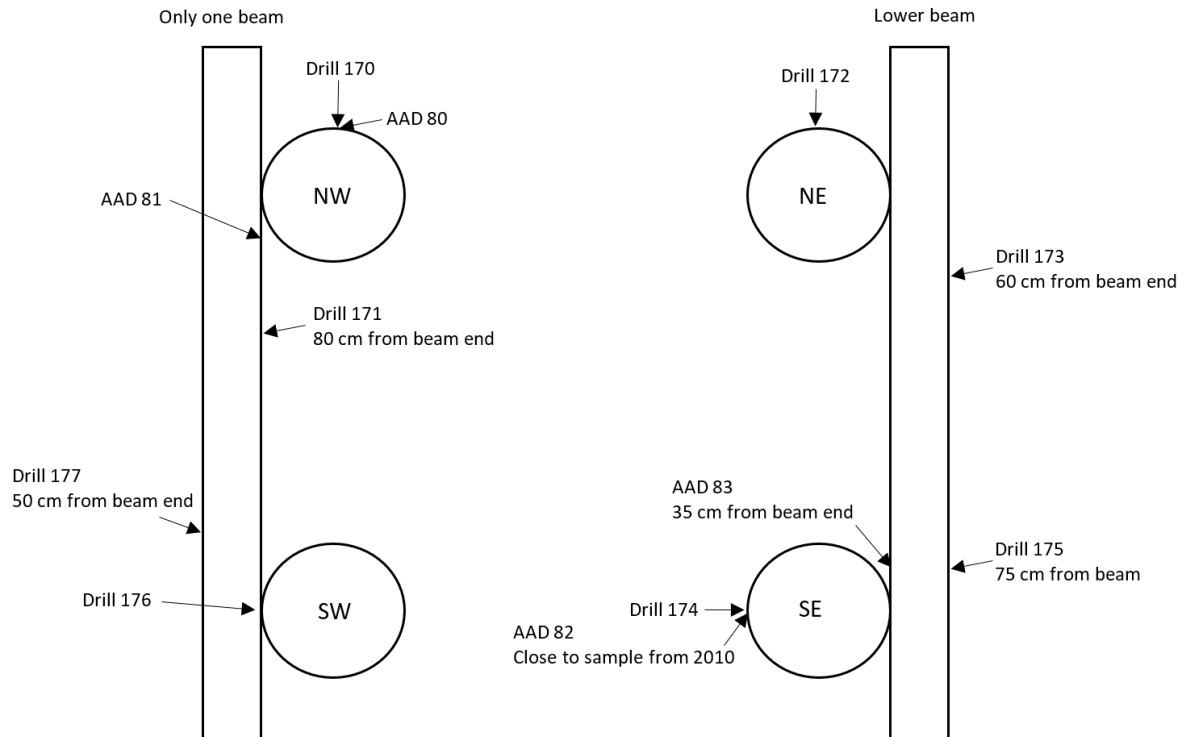
This cable car trestle has not been restored but hold original materials/timber. Several of the foundations/legs have extensive rot damage in the transition between ground and air, and the foundation has slipped partly due to solifluction, and partly due to rot. The trestle is therefore in poor condition. It is situated in a slope and will therefore continue sliding. The trestle is close to the ski lift and close to people.

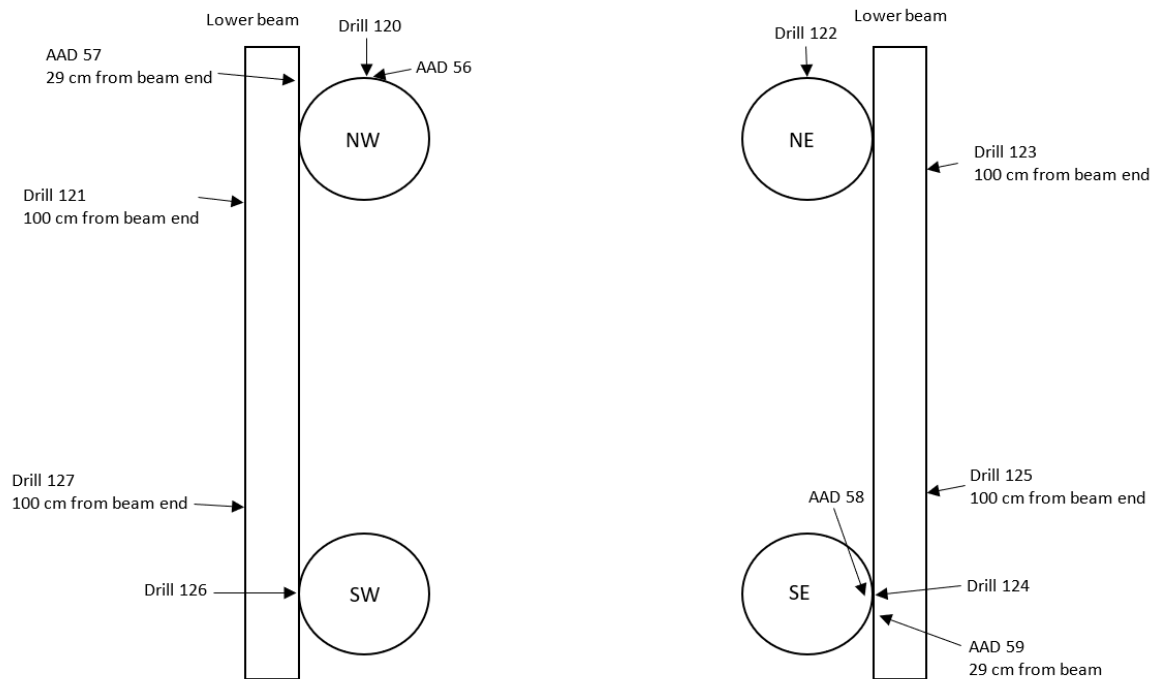
This cable car trestle is apparently in good condition in main structure/foundations and horizontal cross beams. The trestle is low and stands on flat terrain. This cable car trestle has not been restored but hold original materials/timber. There are traces that may indicate rot damage in the foundations in the transition between ground and air. The trestle stands far from human traffic and poses little risk of damage to people and property.

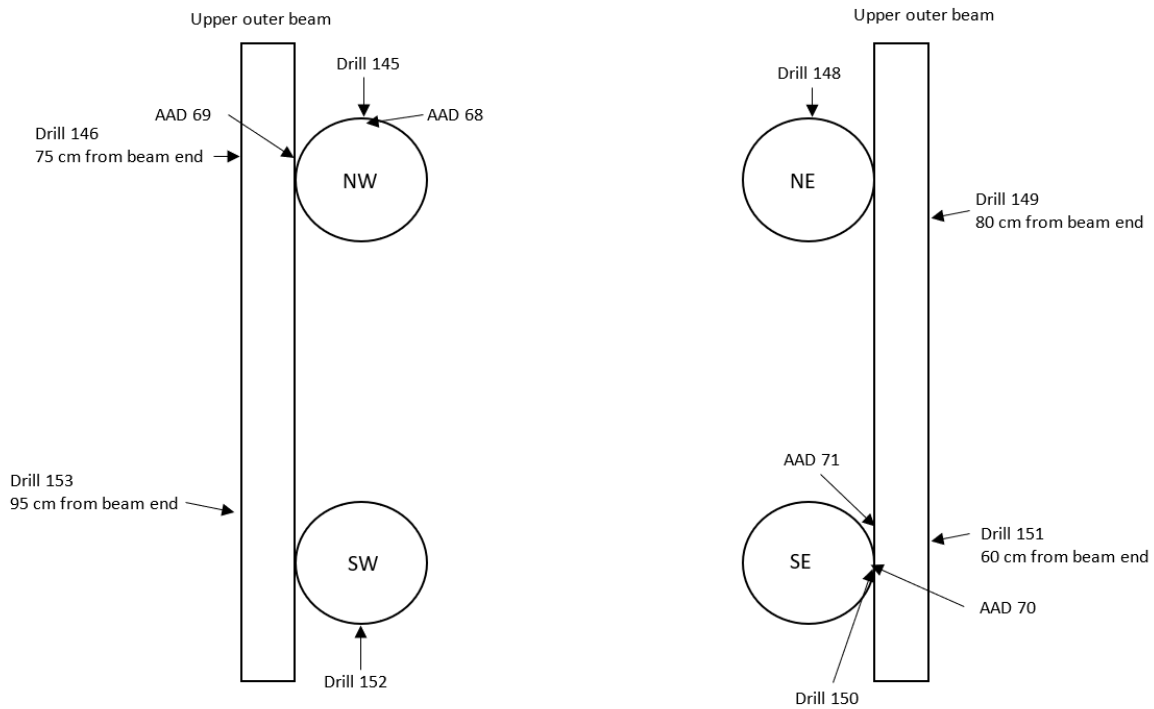
Fungal decay in all foundations/legs, but only critical condition in north-eastern leg. Horizontal beams in good condition. Good condition upwards in the construction. This cable car trestle has not been restored but hold original materials/timber. It is high, however the trestle stands far from human traffic and poses little risk of damage to people and property.

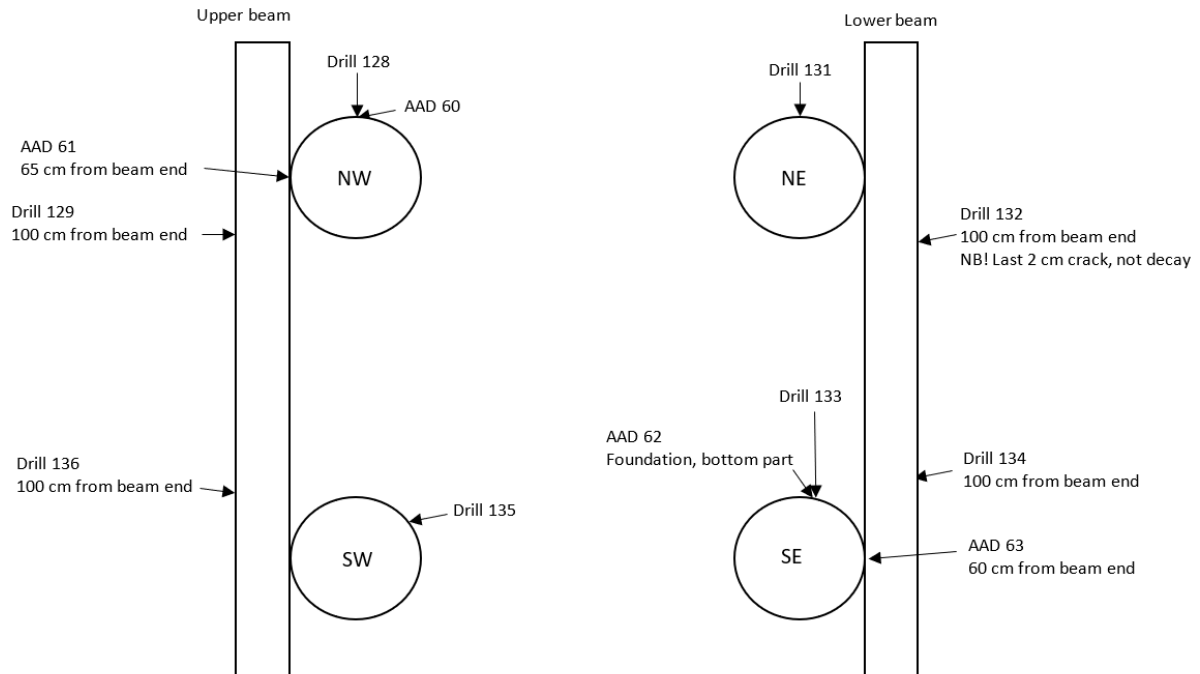
Fungal decay in all foundation logs/legs. Some fungal decay in horizontal beams in the lower arrangement. Apparently good condition higher up in the structure. This cable car trestle has not been restored but hold original materials/timber. It stands far from human traffic and poses little risk of damage to people and property.

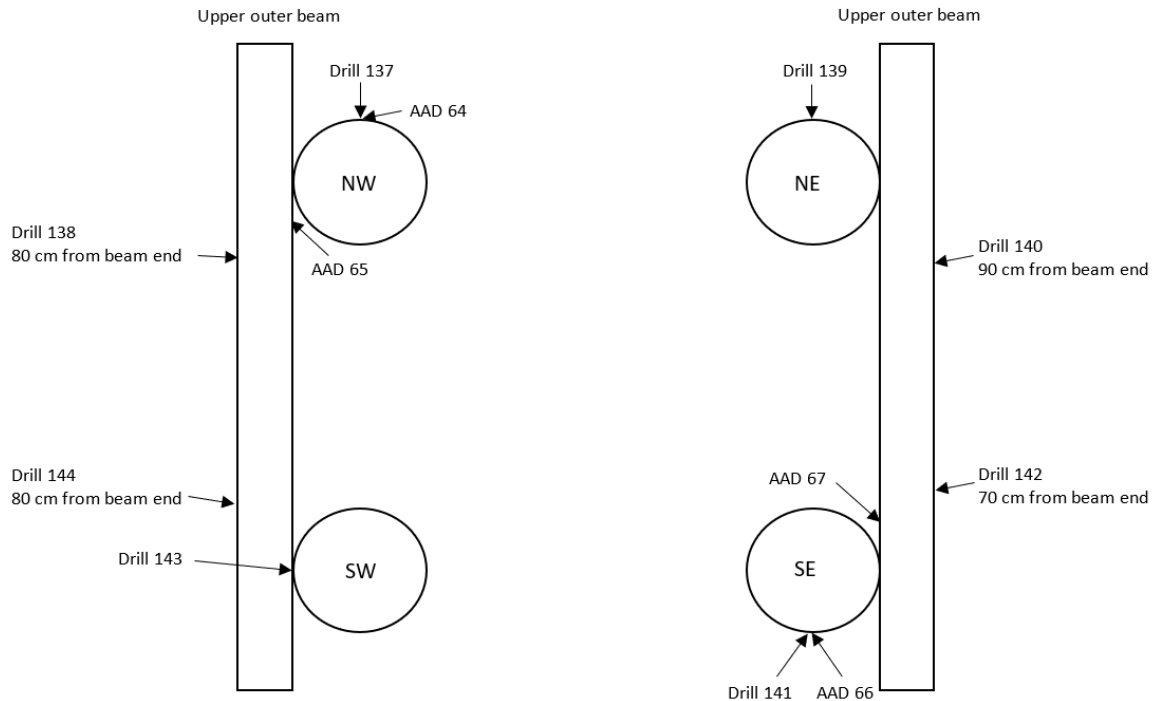
Displacement in the foundation to the east. some fungal decay in the foundations/legs. Apparently good condition higher up in the structure. This cable car trestle has not been restored but hold original materials/timber. It stands far from human traffic and poses little risk of damage to people and property.

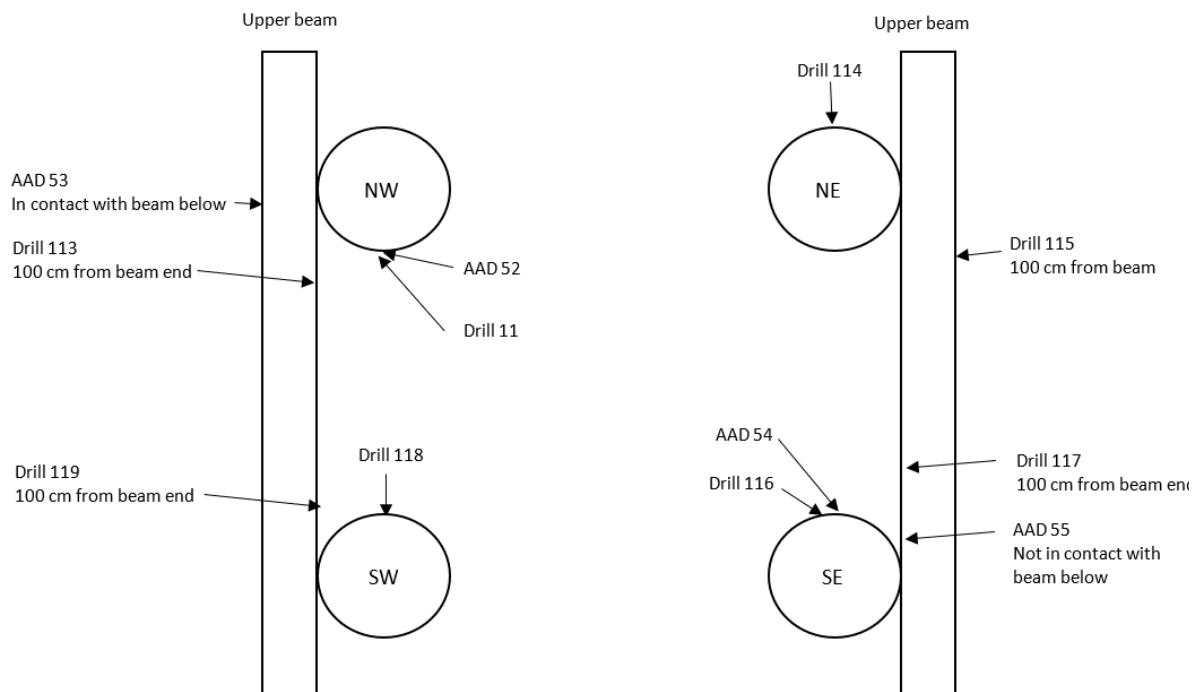
Apparently good condition higher up in the structure. Mechanical damage in the lower horizontal beams to the north-west at the foundation/legs. Fungal decay at the ends of inclined braces against the foundation in contact with the ground. The trestle is low and stands on flat terrain. This cable car trestle has not been restored but hold original materials/timber. The foundations hold signs of fungal decay in the transition between ground and air. It is situated far from human traffic and poses little risk of damage to people and property.
