Weathering of unpainted wooden façades - Experience and examples

NIBIO REPORT | VOL. 6 | NO 5 | 2020

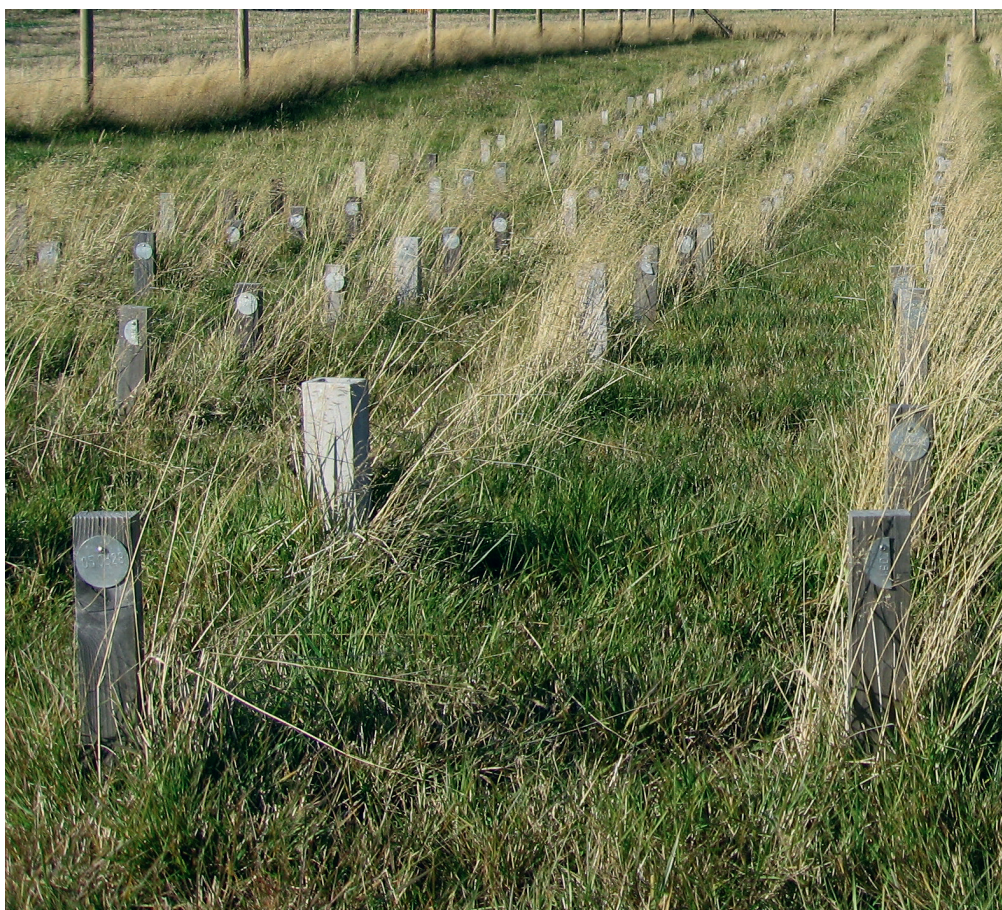
DURABILITY CLASSES AND USE CLASSES say little about future weathering and colour changes, but they provide important guidelines for deciding what wooden materials to choose in order to meet technical service life requirements.

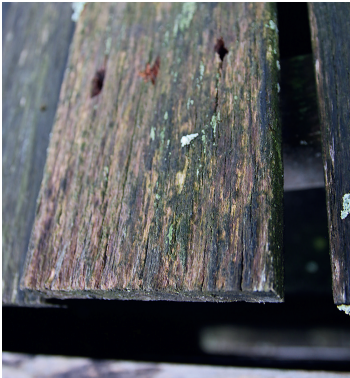
Decay in untreated aspen wood.

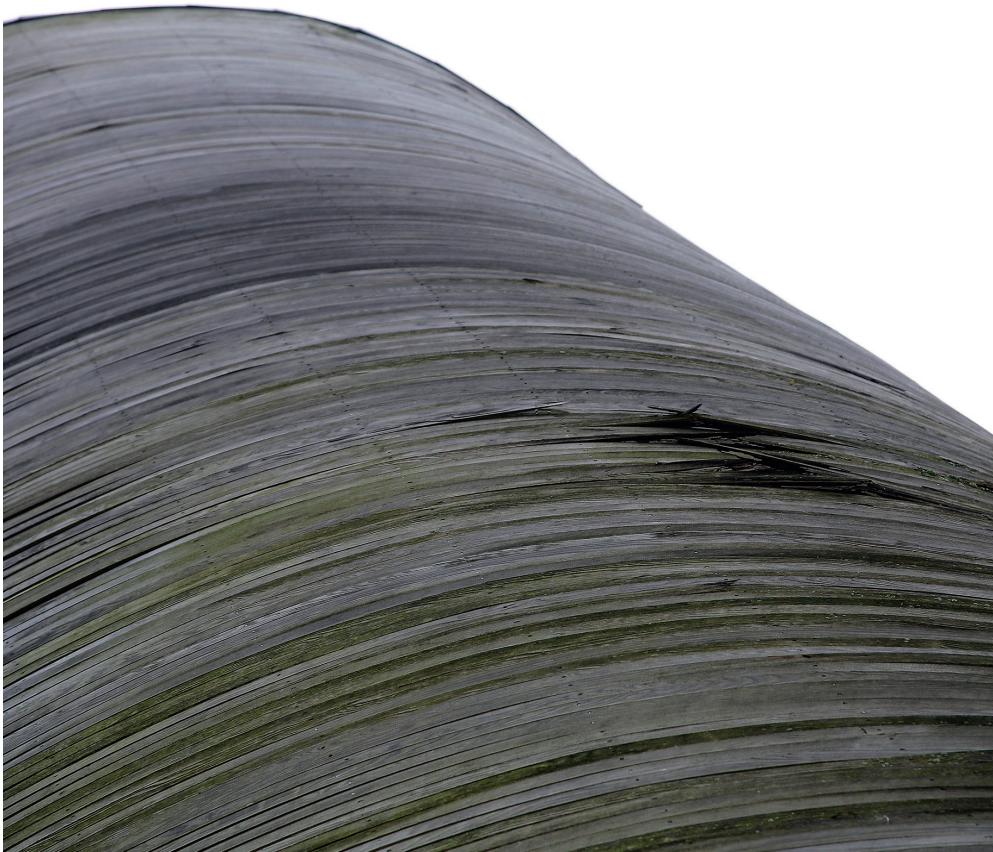
Untreated larch wood cladding with rot damage.

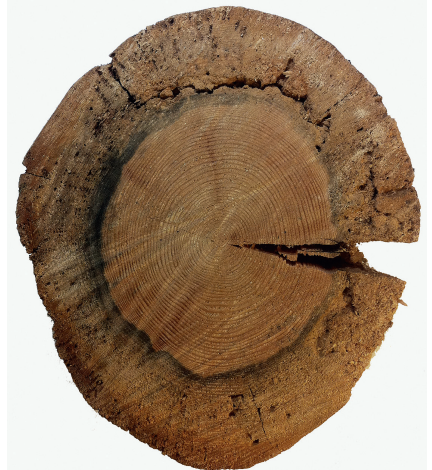
Scots pine log. Different durability of sapwood and heartwood.

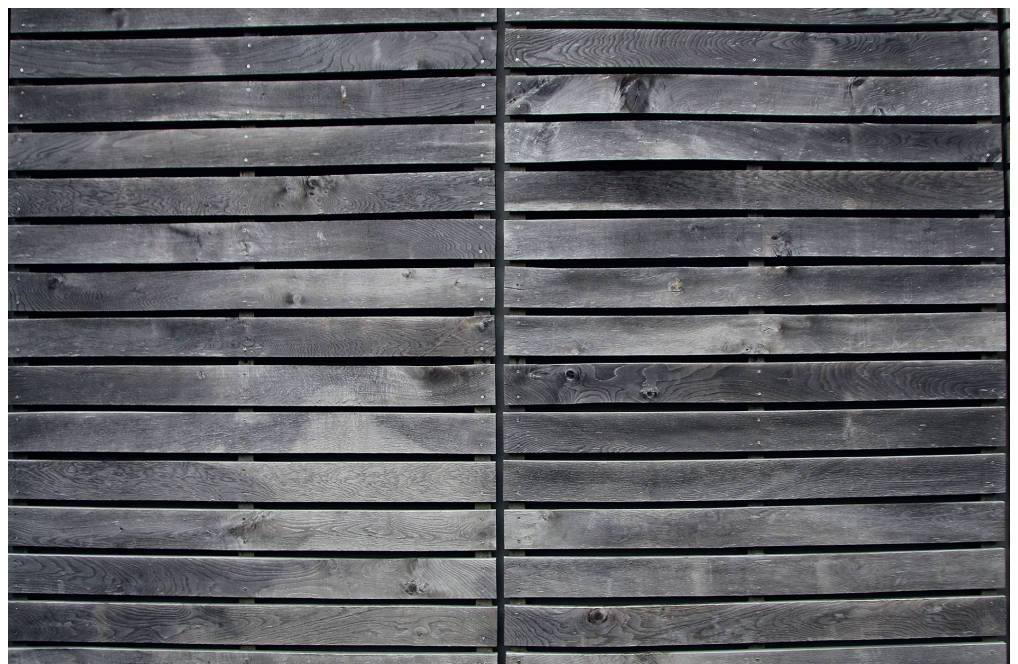
Horizontal, open aspen cladding including a great amount of warped boards.

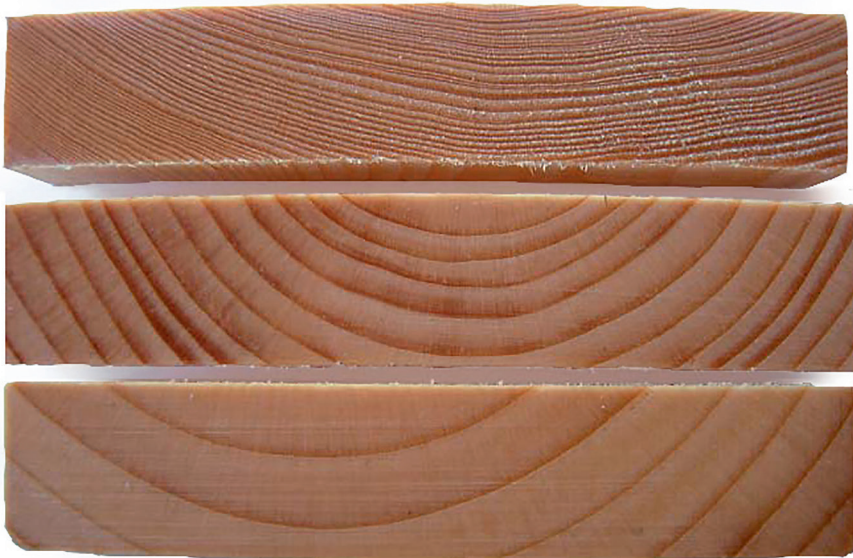
Spruce samples with different annual ring widths. Photo: Per Otto Flæte

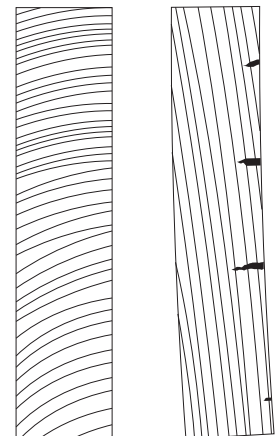
ANNUAL RING ORIENTATION: Vertical grain cladding boards will have greater dimensional stability and be less likely to develop cracks than flat-grain cladding boards.

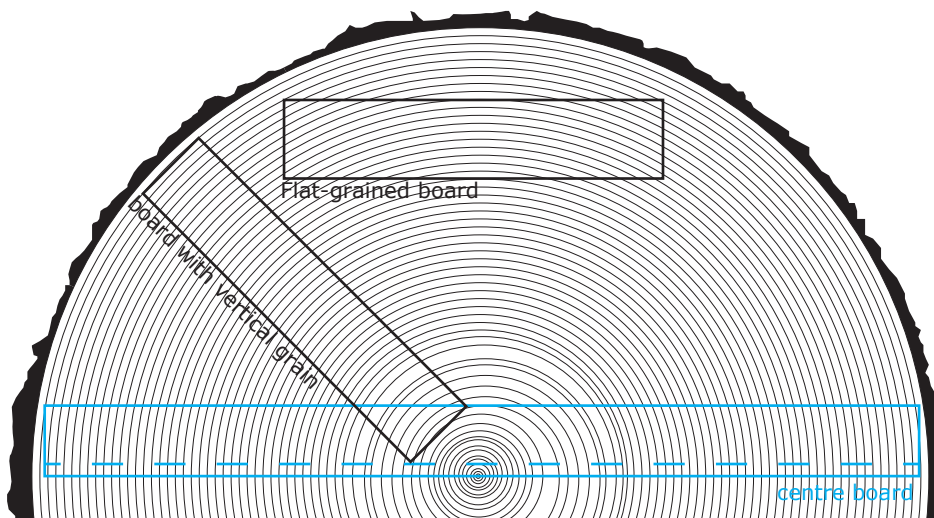
Scots pine log showing the centre board, vertical grain, and an illustration of a vertical grain and a flat grain board

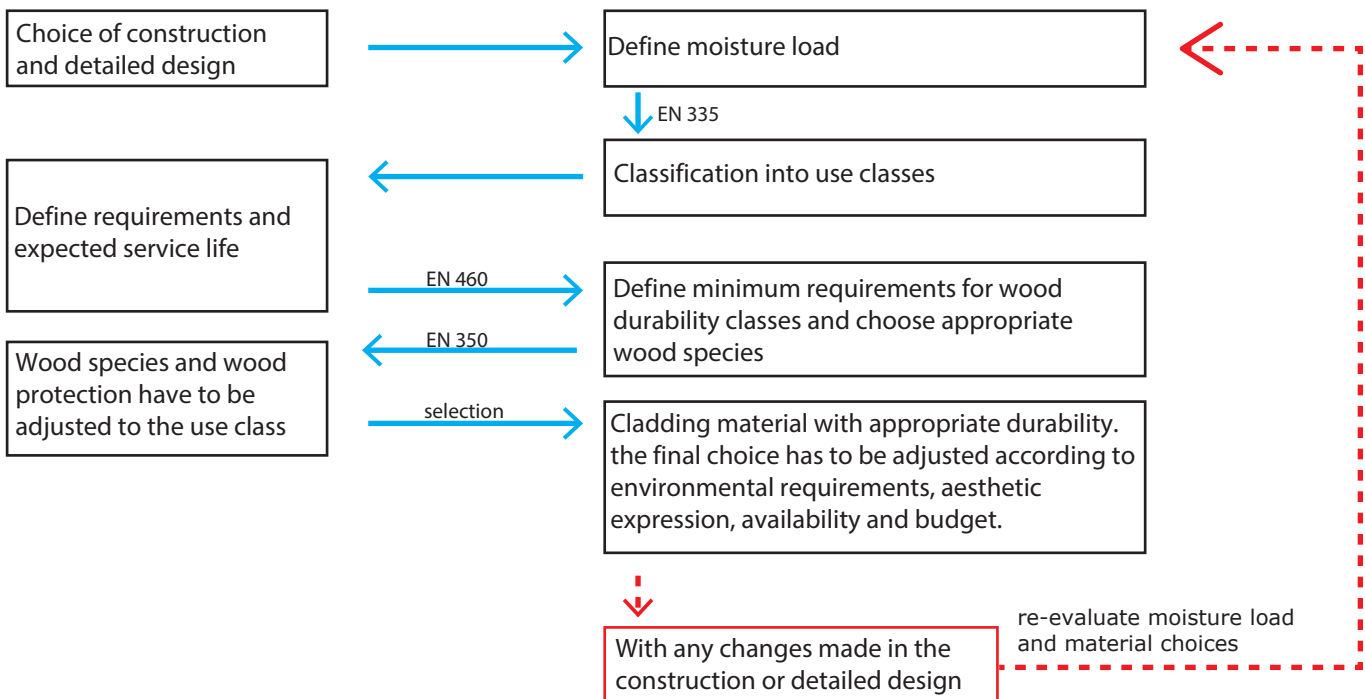
Decision diagram for the choice of the fit for purpose cladding material

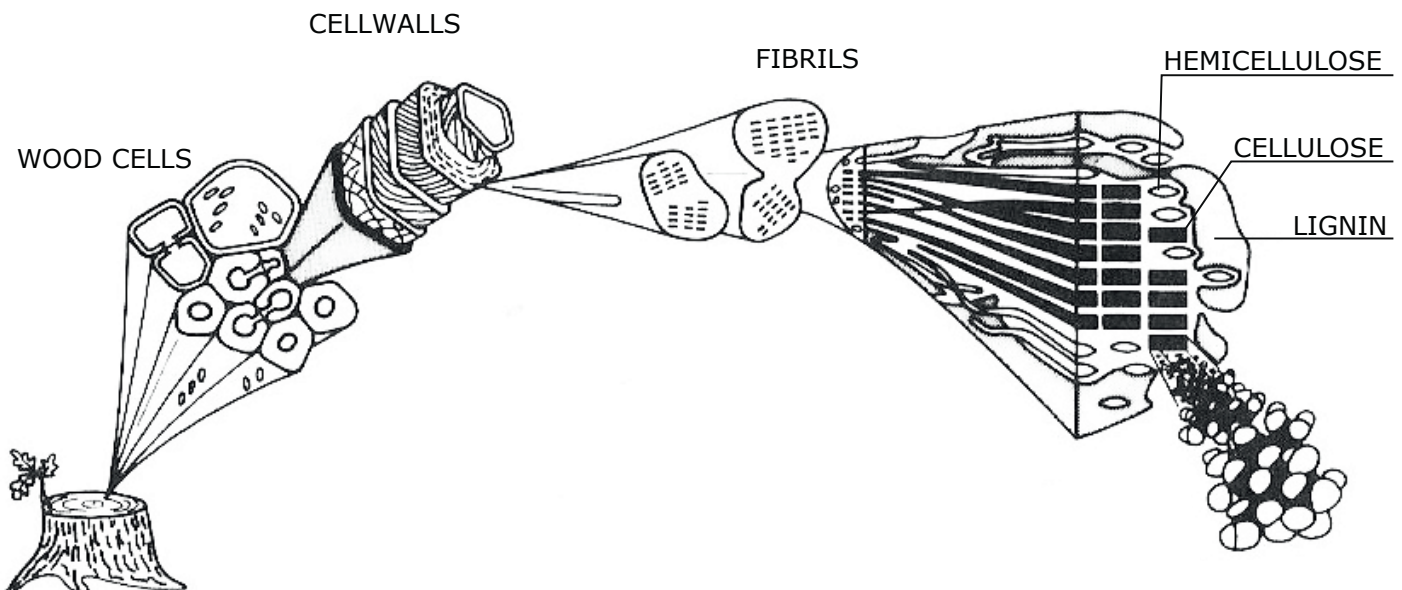
Systematic structure of wood and cell walls (Hoffmann and Jones 1989)

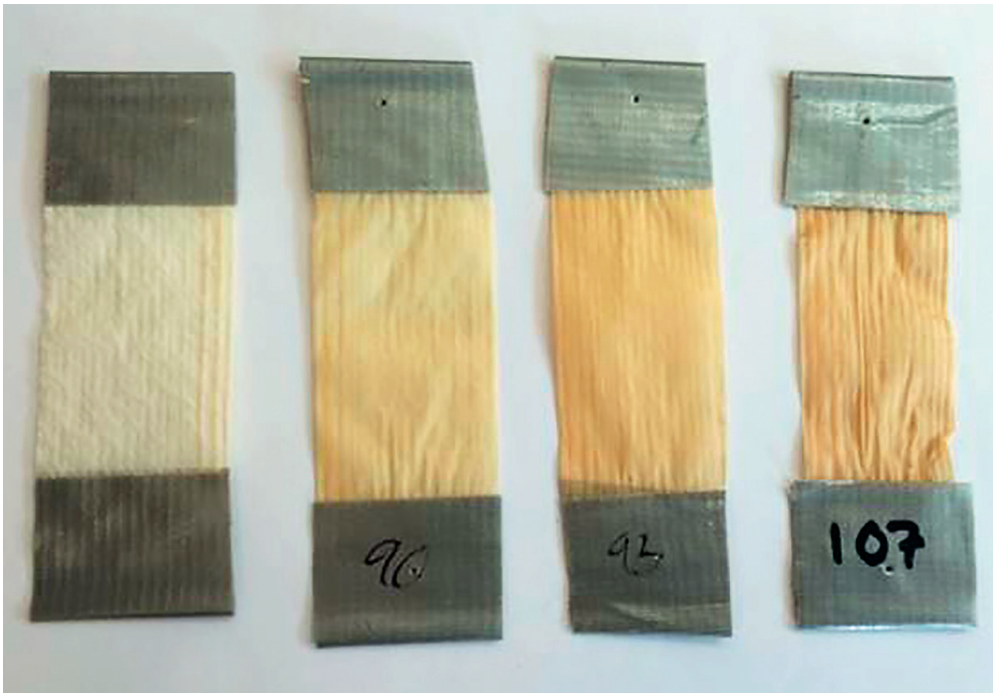
Thin spruce veneer (100 micrometres thick) exposed to sunlight for 0, 1, 5 and 20 days.
Photo: NMBU/Ingunn Burud

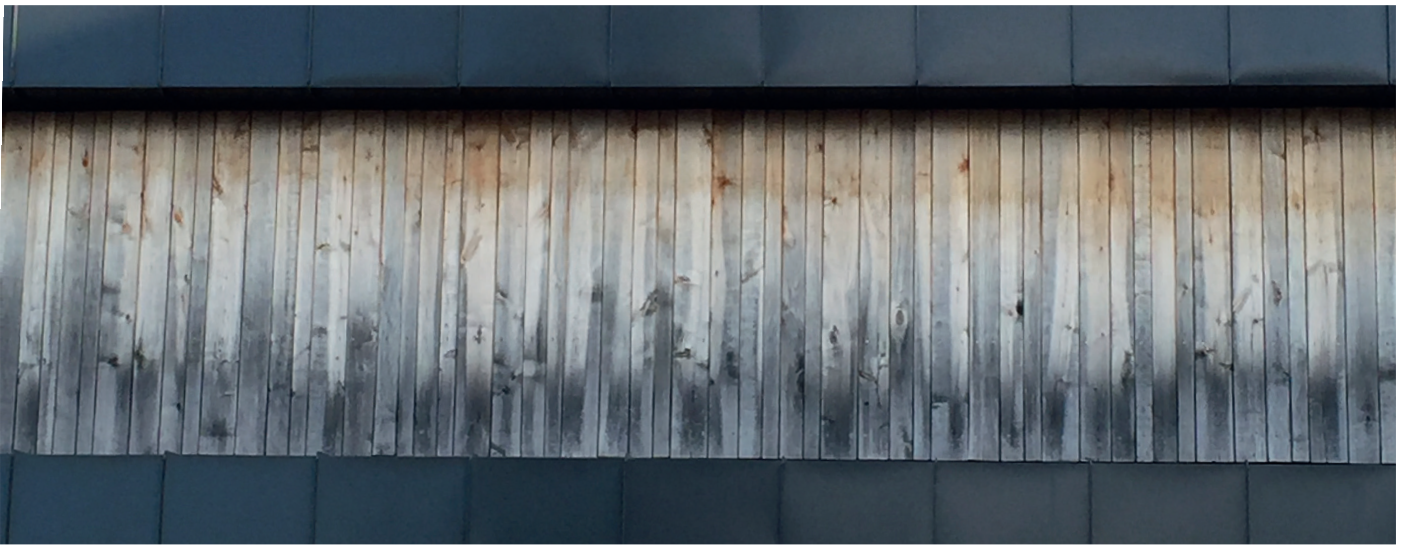
Façade section between two rows of cantilevered windows in the same section of façade. Ås High School. Photo: NIBIO/Lone Ross Gobakken

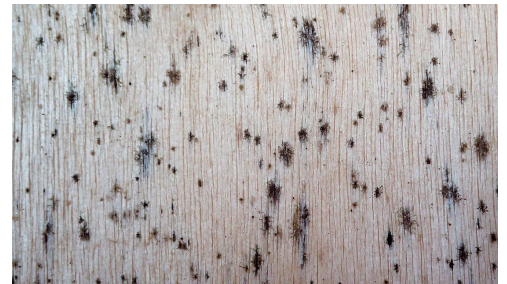
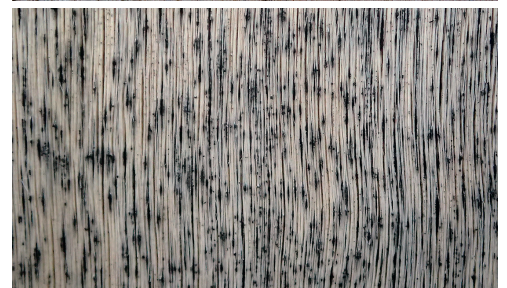
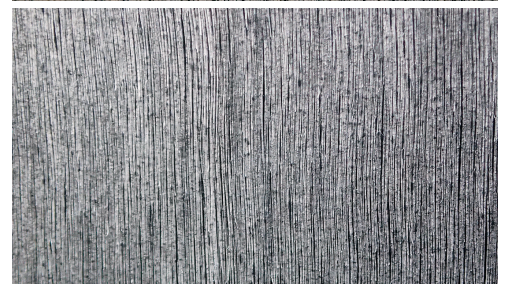
NIBIO/Lone Ross Gobakken

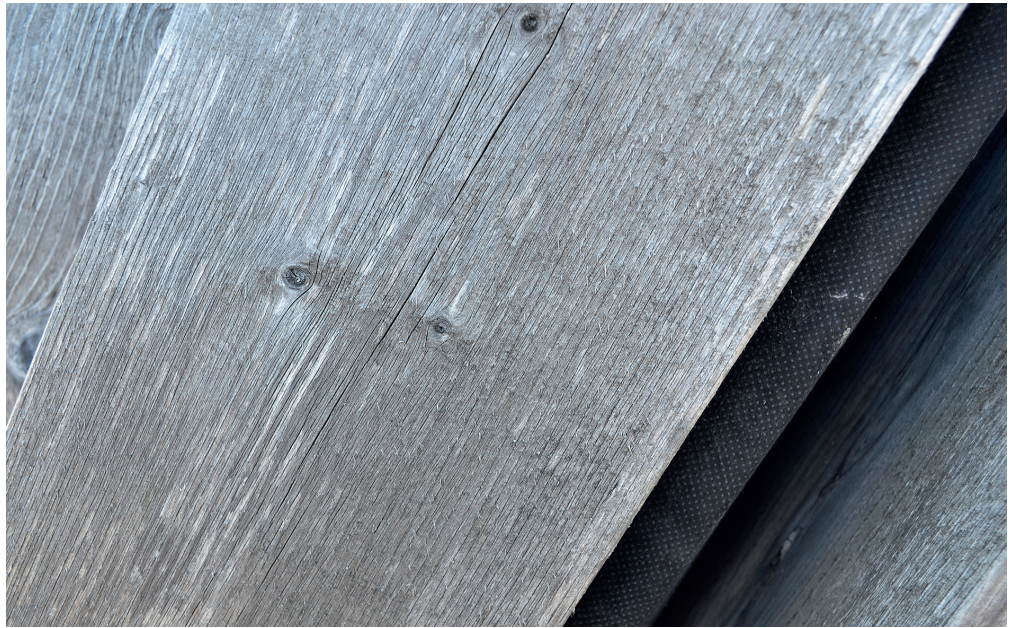
Fibrous surface of a cladding board

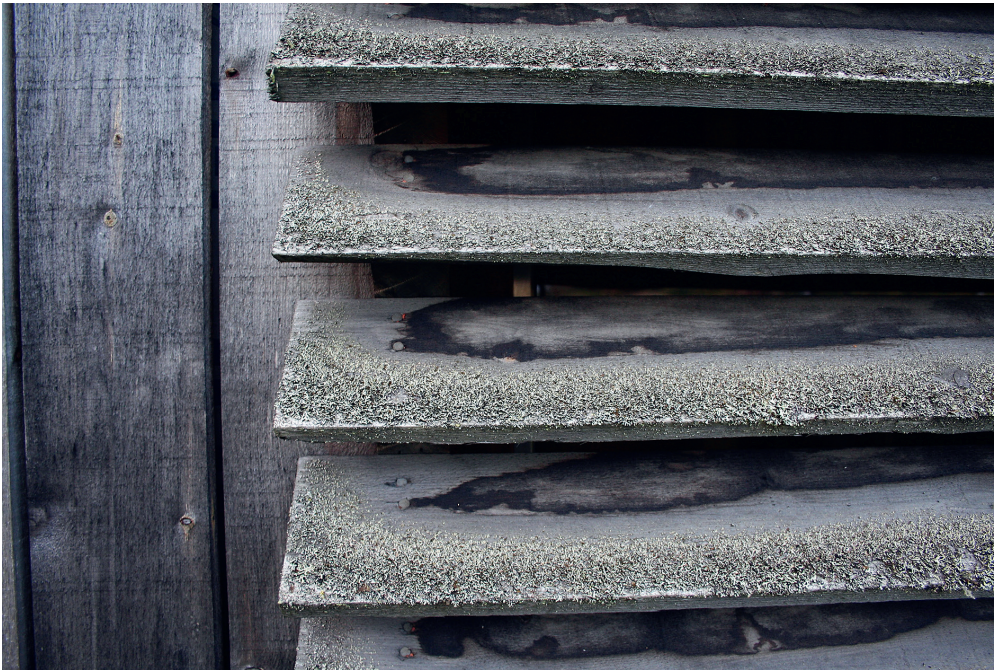
Lichens on horizontal, tilted cladding boards.

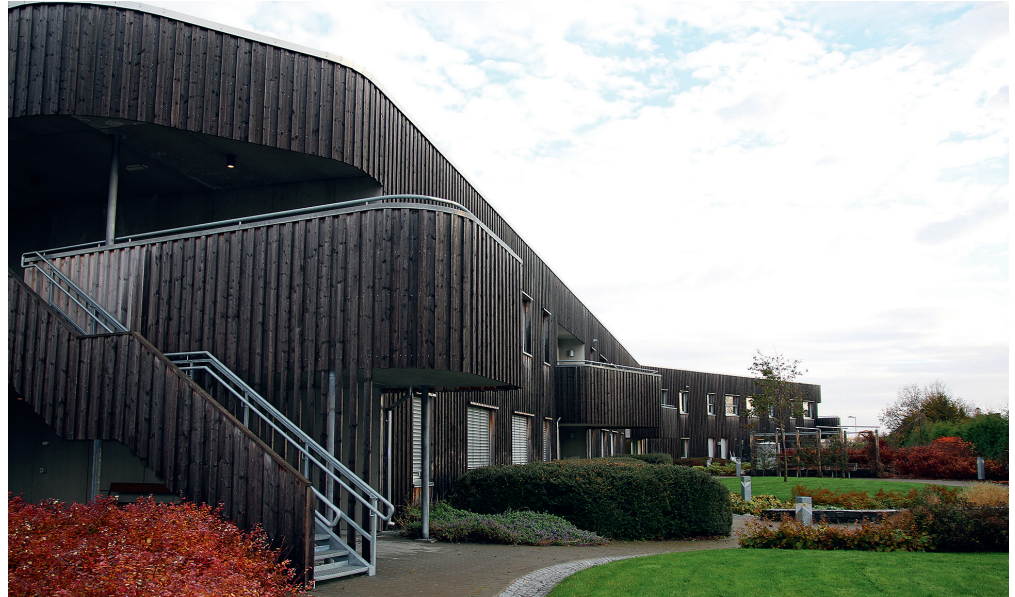
West-facing cladding of Scots pine heartwood. 4 years after installation. Stavanger.

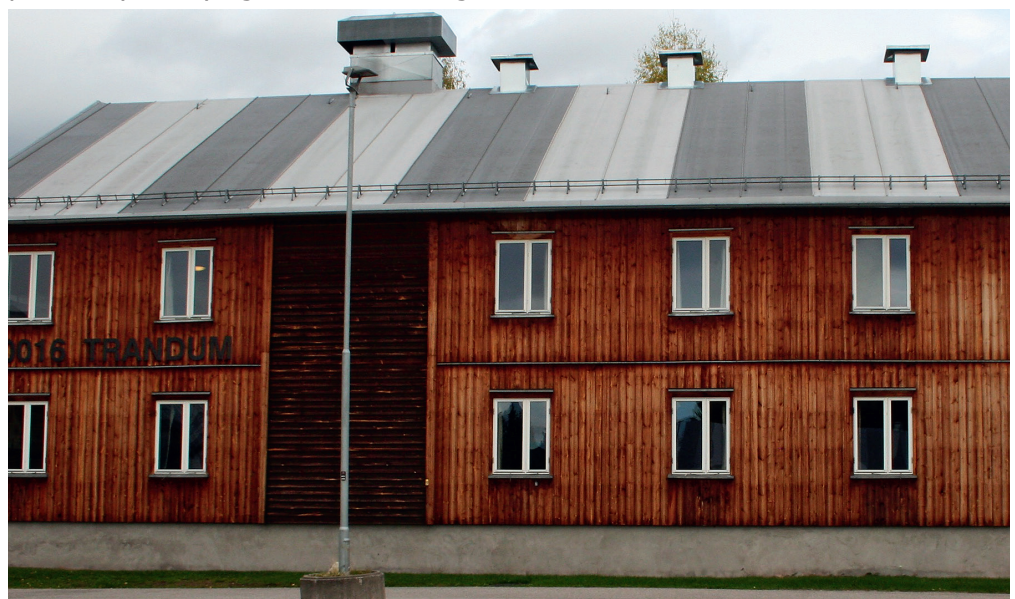
West-facing cladding of Scots pine heartwood. 19 years after installation. Rena.

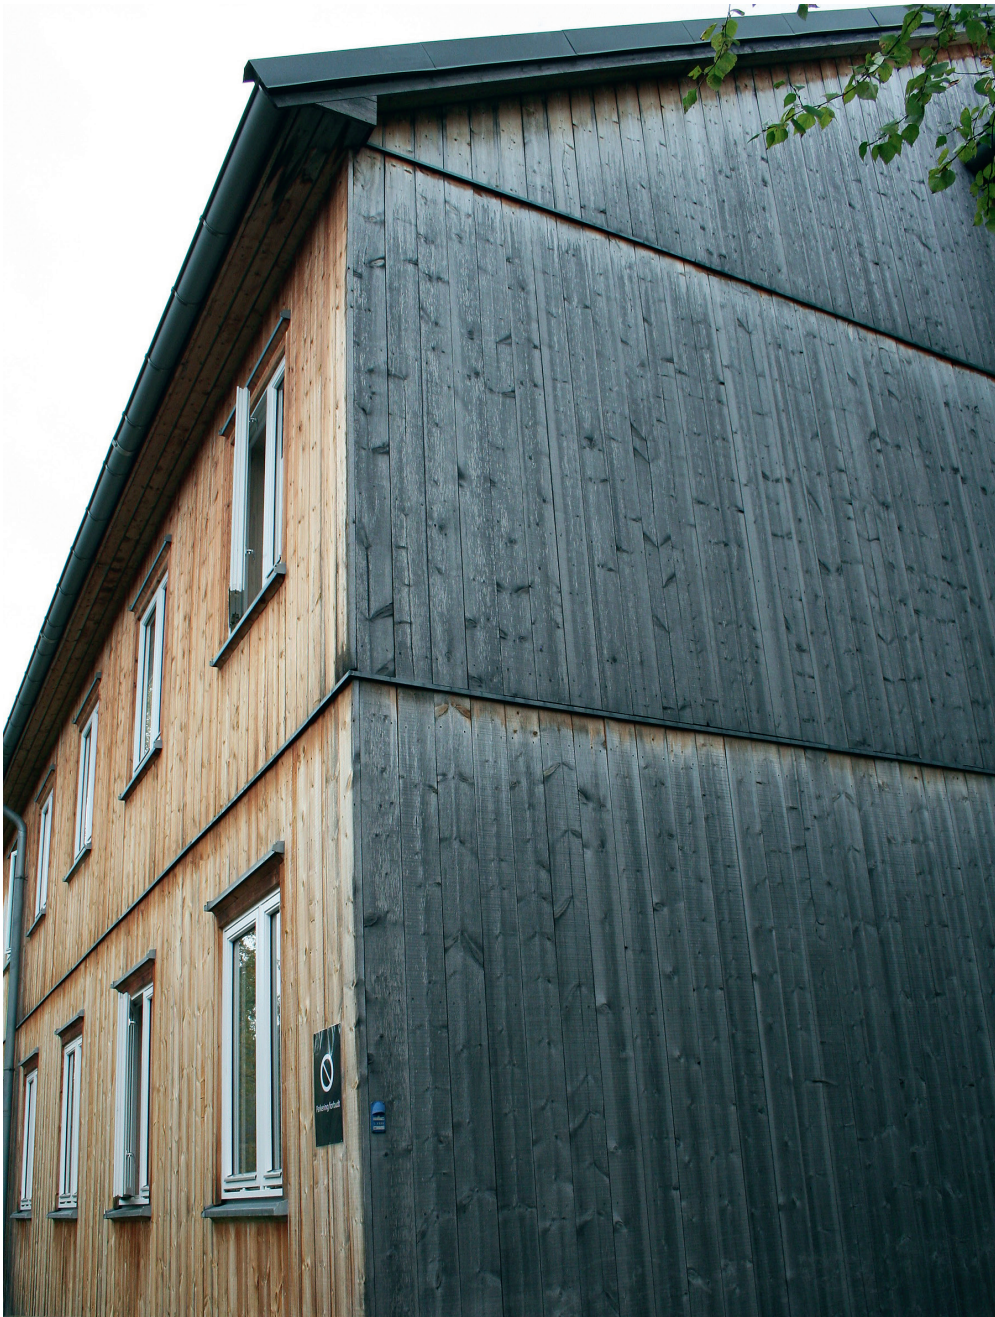
Northeast-facing building corner. The eastern-facing wall with roof-overhang. Rena.

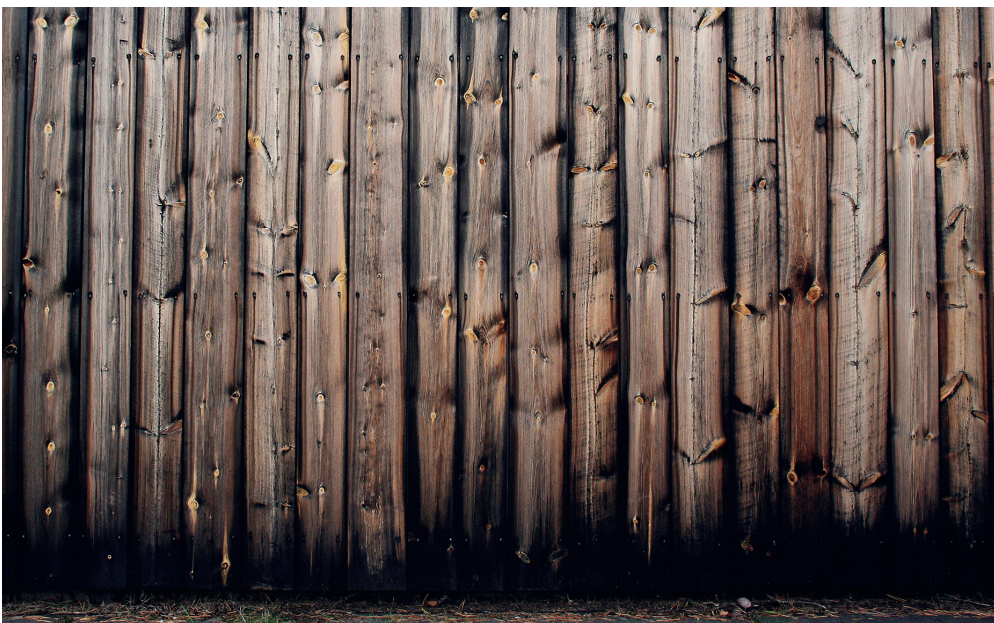
Vertical cladding where it meets the ground.

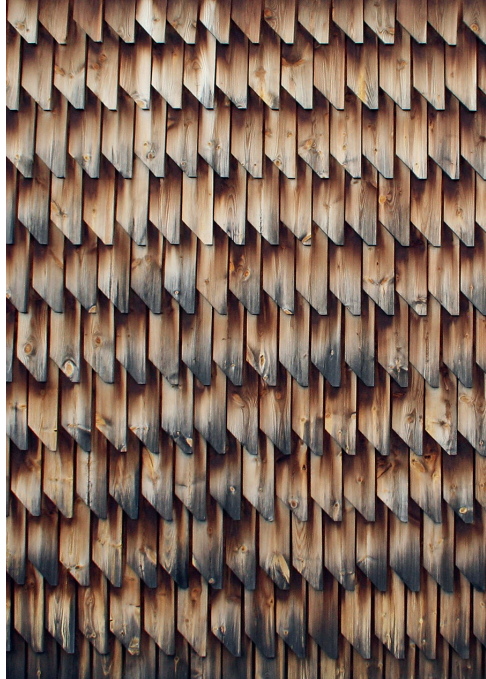
Overlapping shingles.

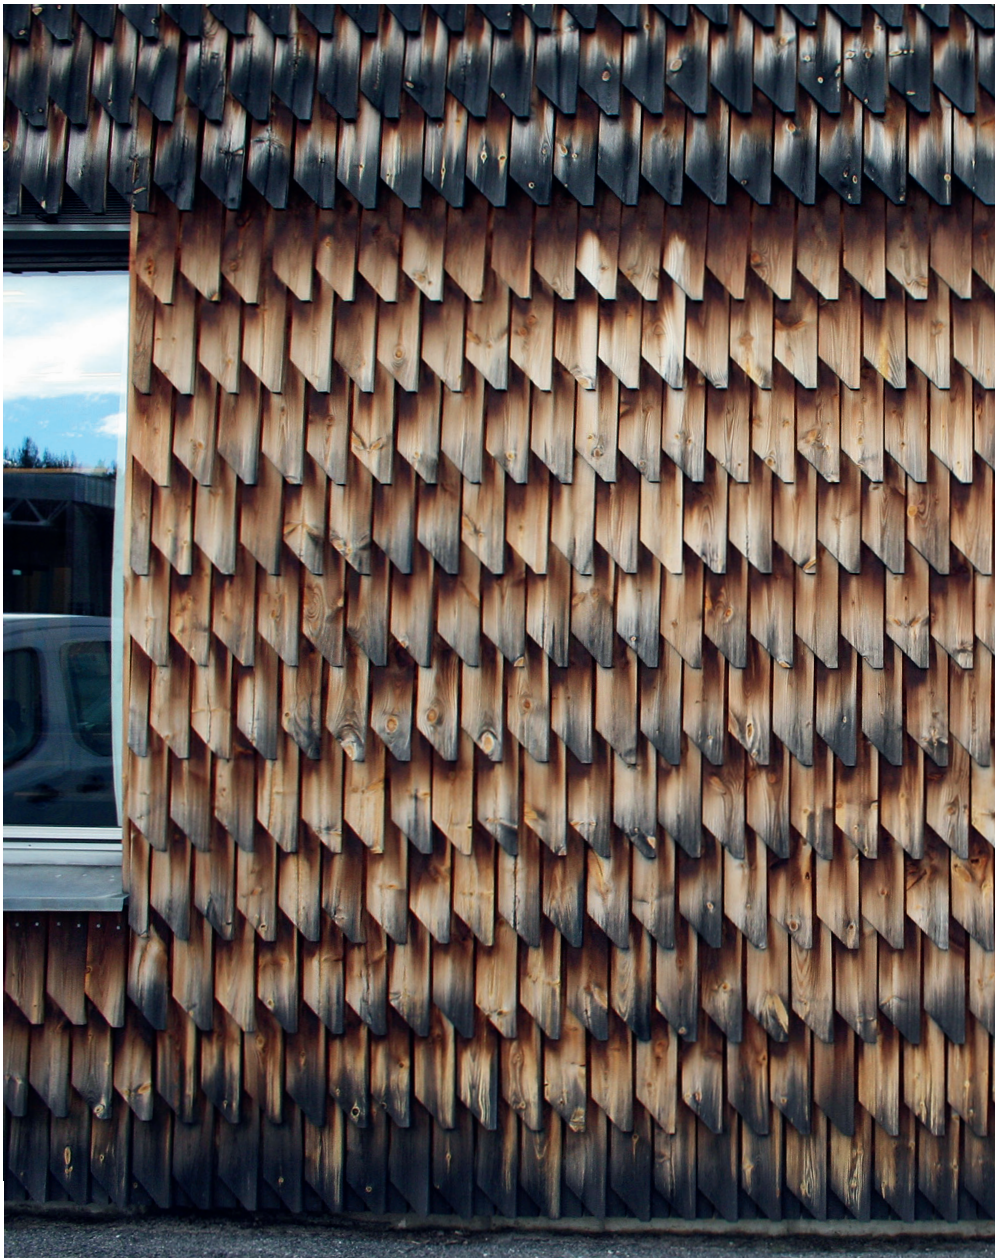
The detailed façade design entails different exposure to moisture and sunshine. This can lead to very different changes in colour within the same façade.

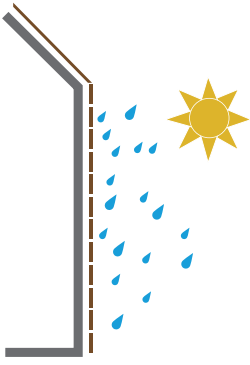
4.1 Vertical surfaces

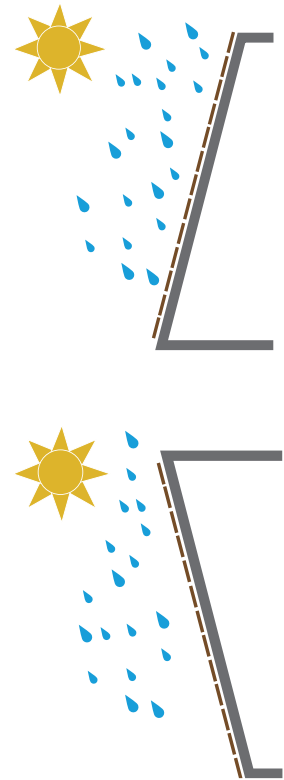
Camera Obscura, Trondheim, untreated spruce (Architecture students and lecturers from NTNU, with Knut Einar Larsen), 2006

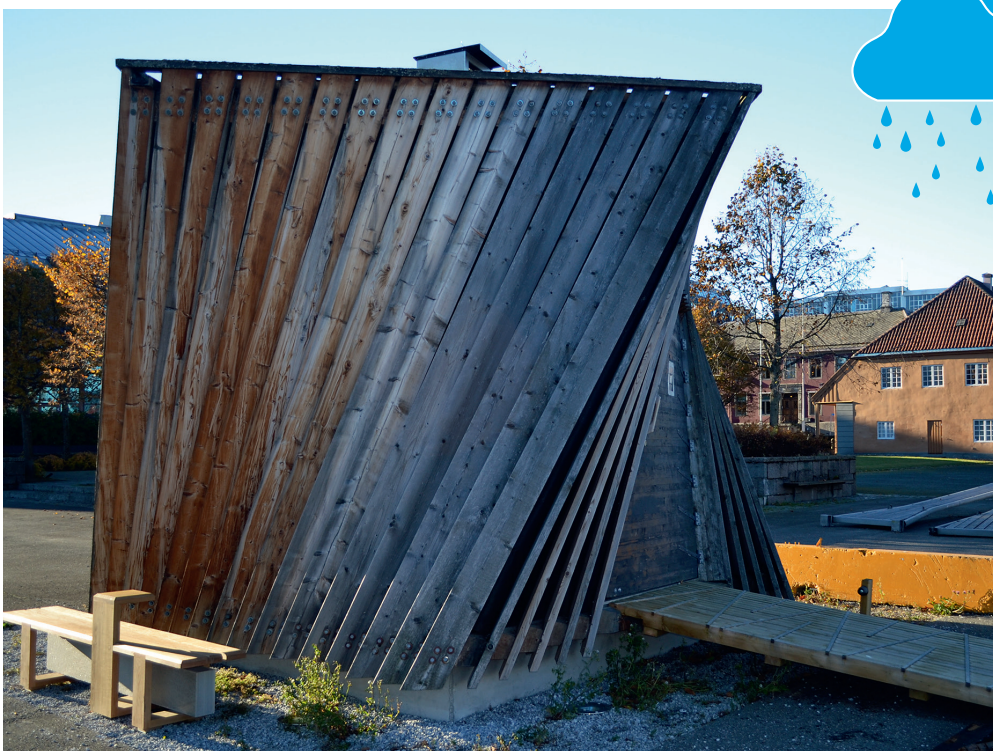
Ling Ling restaurant, Oslo, furfurylated Scots pine (Alliance Architects), 2011

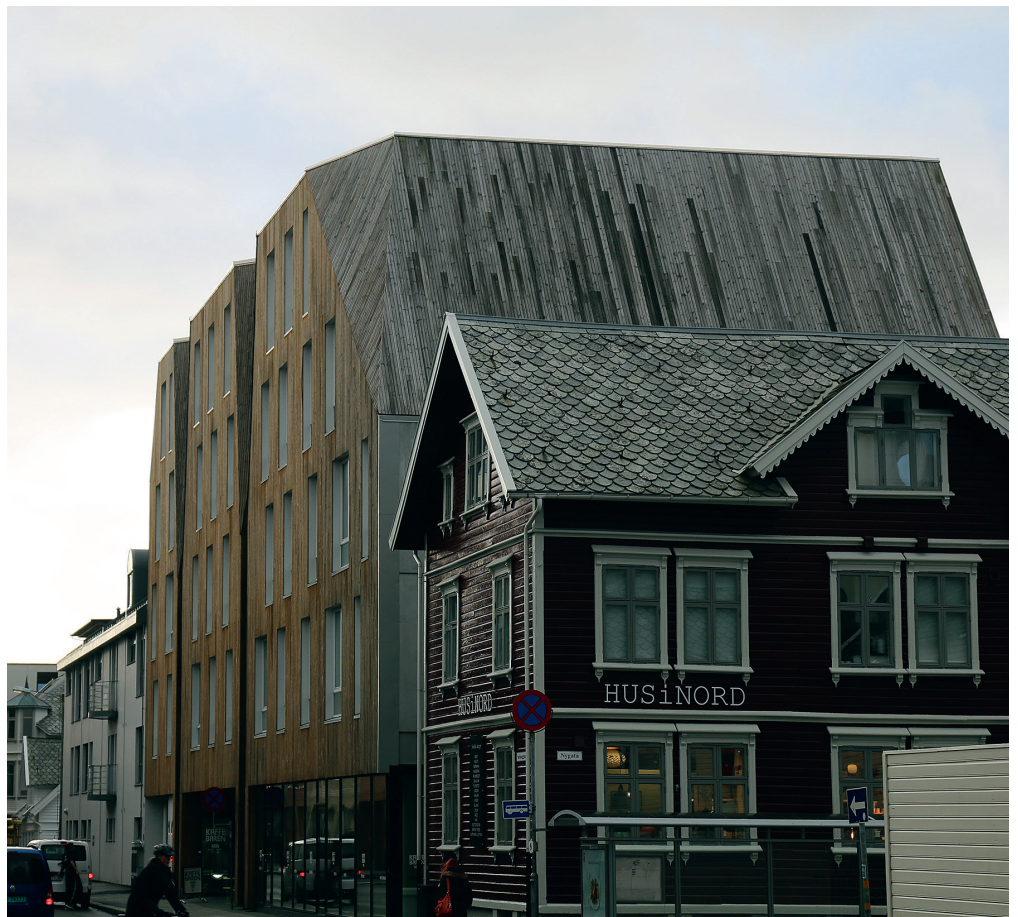
Several roof boards can also be seen to have a higher moisture content than the rest, creating a play of colours on the surface.

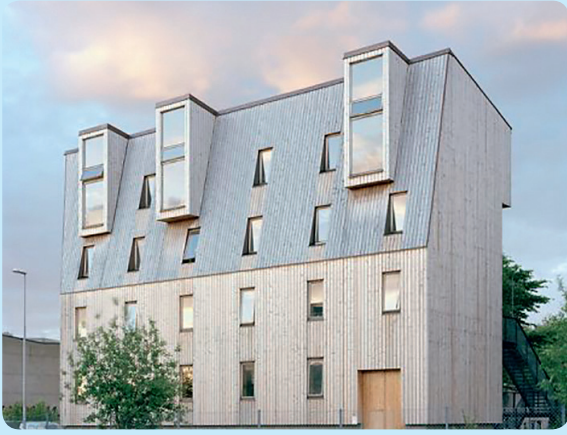
Svartlamoen sustainable apartments

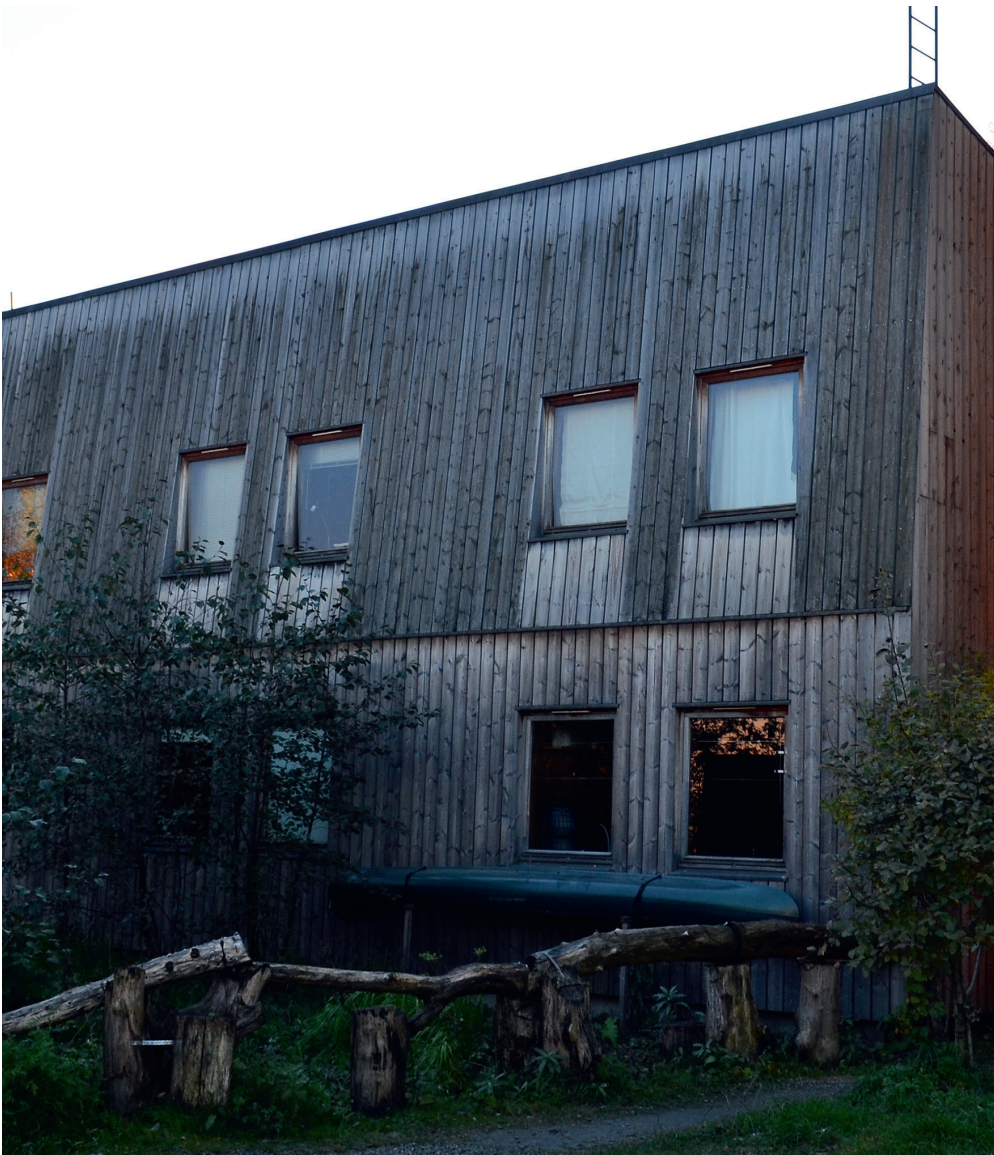
slowly and this can lead to extensive growth of blue-stain fungi, particularly in inner corners and areas that are shielded from the wind.

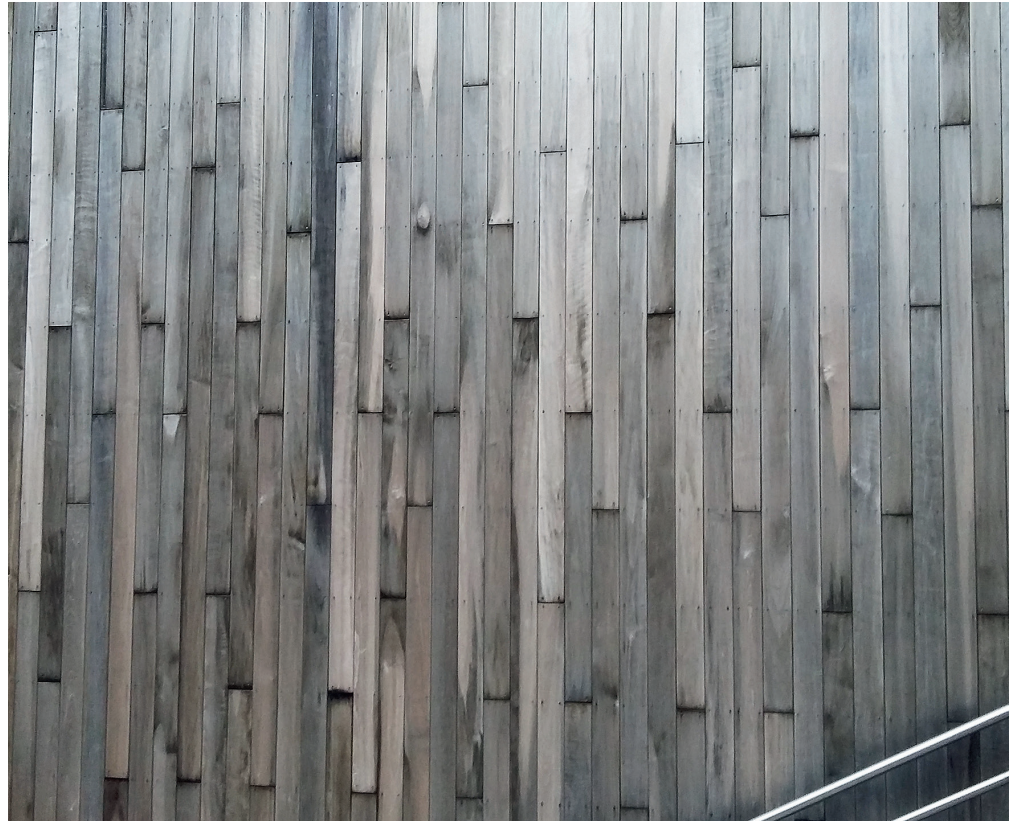
Two differently executed joints in a façade. The photo on the left shows a wide enough gap in the joint between the cladding boards, where the wood can quickly dry out. The photo on the right shows a small gap in the joint between cladding boards, resulting in a darkly

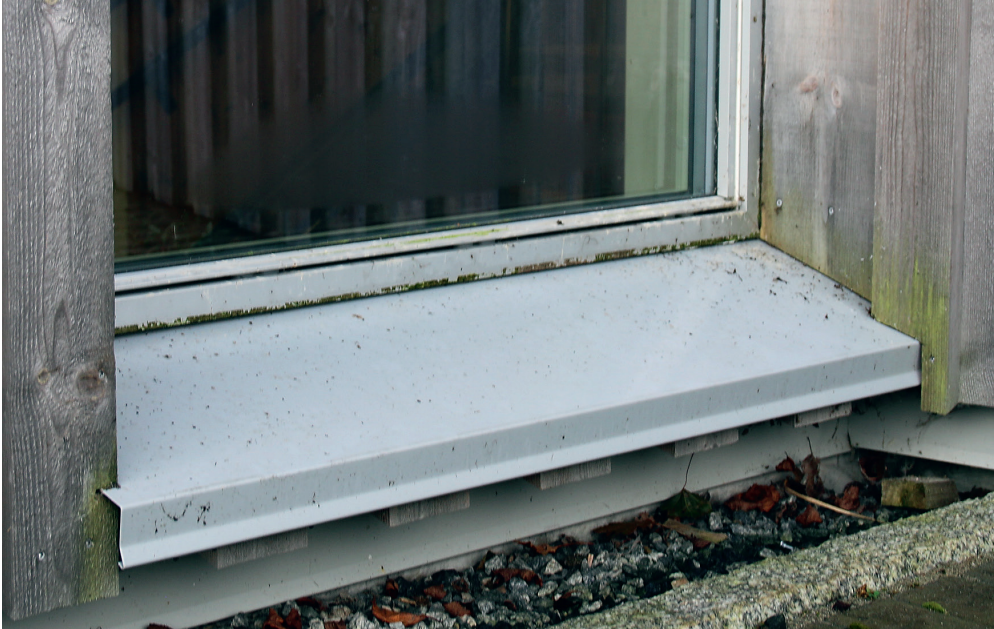
It is recommended to leave a gap of at least 6 mm in JOINTS and between cladding boards and window hardware/flashings, to prevent the water from being trapped and absorbed by the wood.

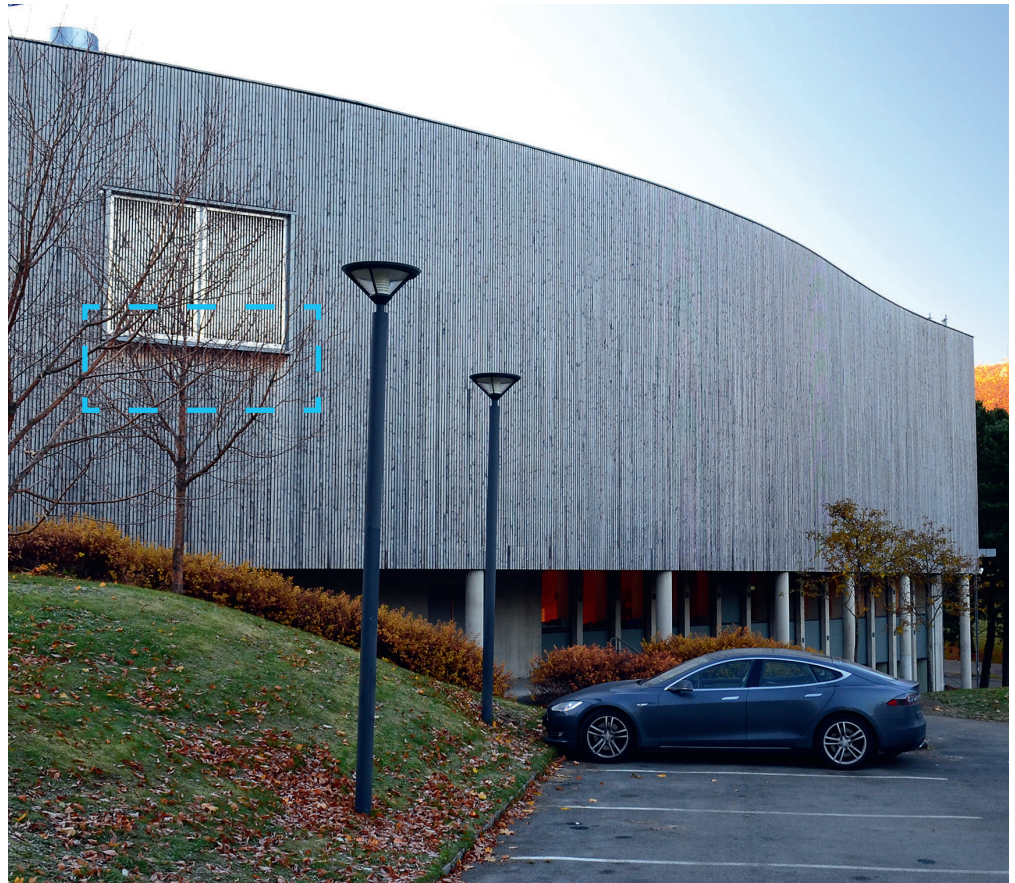
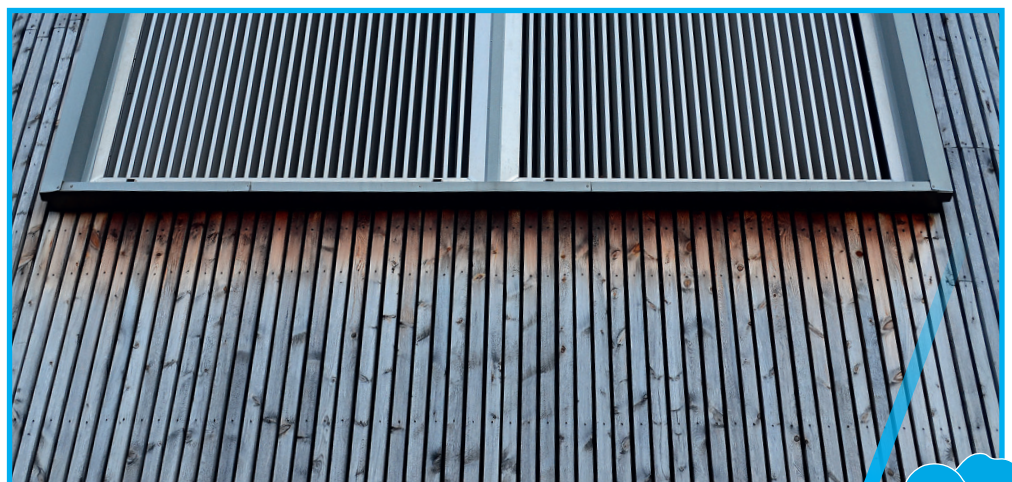
Few details and homogeneous weathering produces a homogeneous colour. The wall faces northwest. The flashing, installed in accordance with

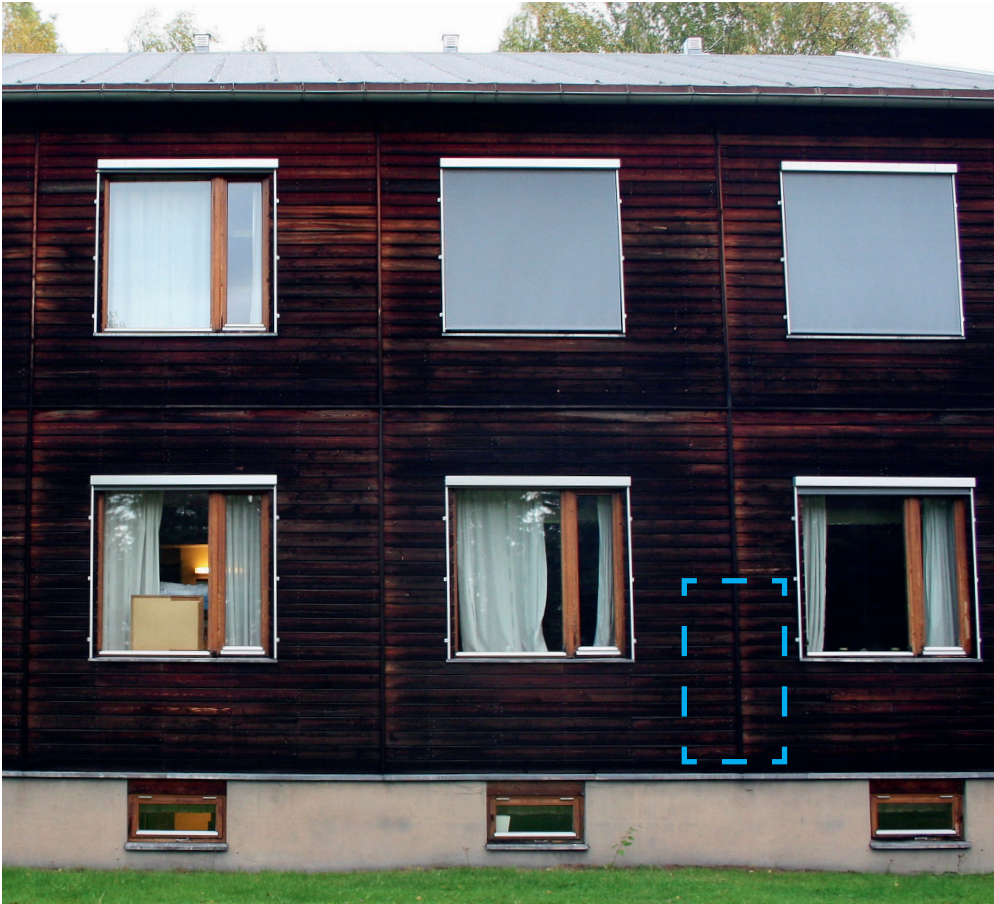
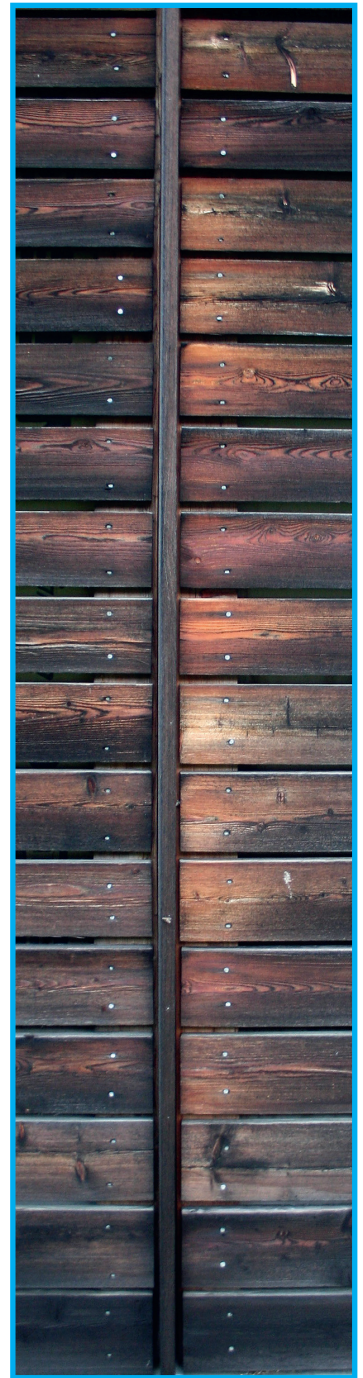
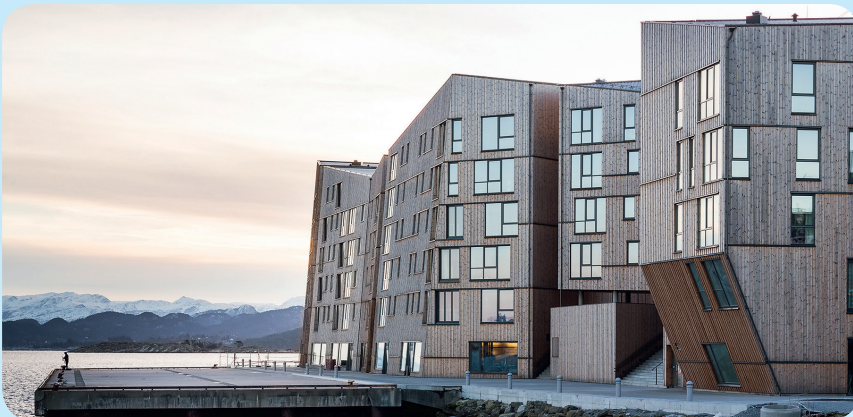
are protected against the rain and have less blue-stain fungi growth. The colour changes could be the result of locally high air humidity and drizzle on the façade, without there being enough water to cause leaching of lignin and extractives. The façade retains a brown undertone and is covered by different degrees of blue-stain fungi growth.
