Weathering of unpainted wooden façades - Experience and examples

NIBIO REPORT | VOL. 6 | NO 5 | 2020

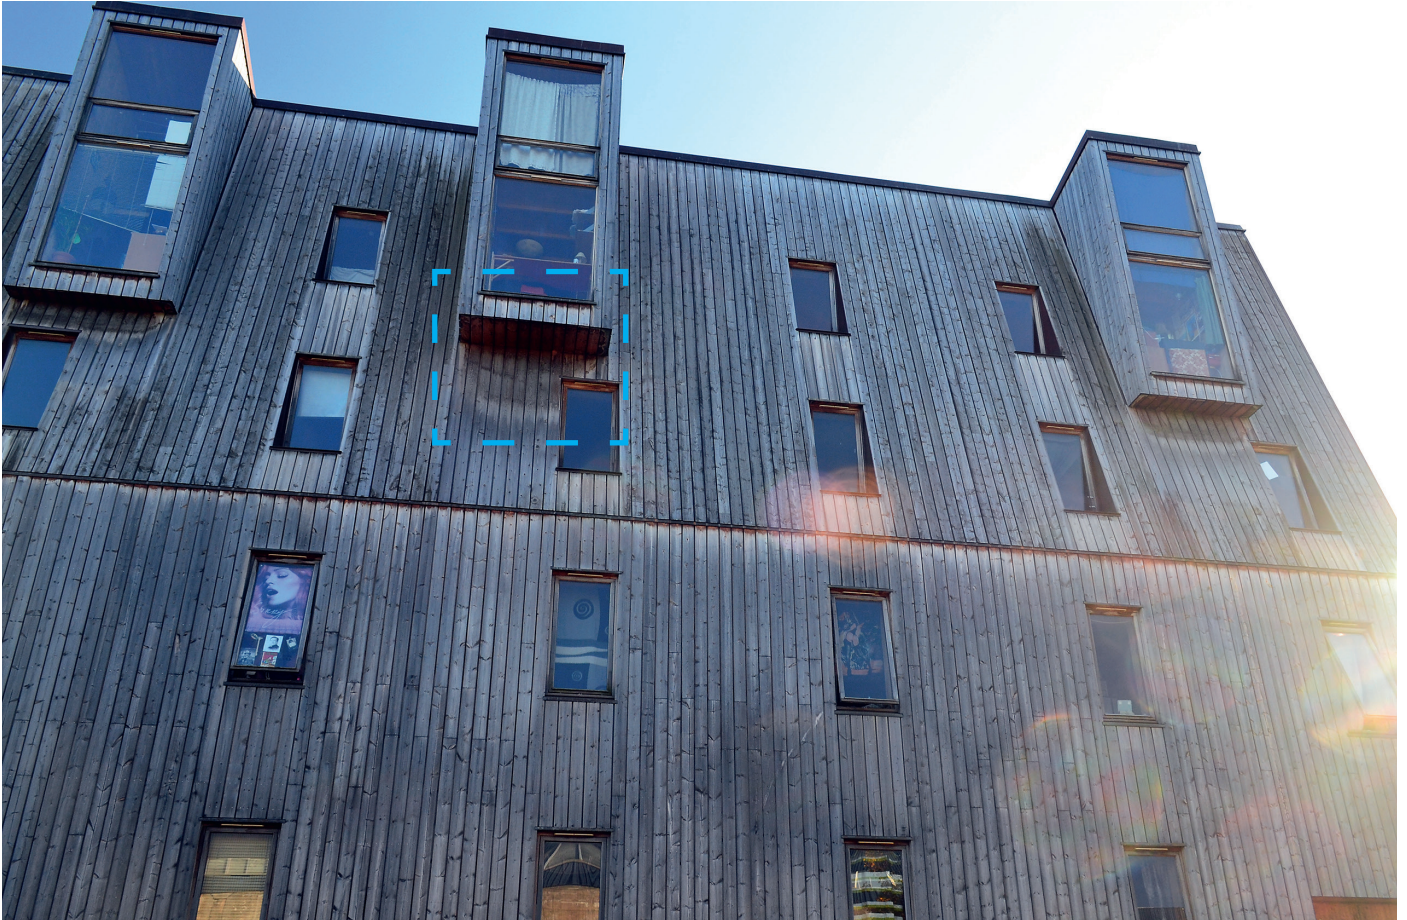
Moisture accumulation in shielded areas can produce special, wavy, aquarelle-like colour effects, such as under eaves and overhangs

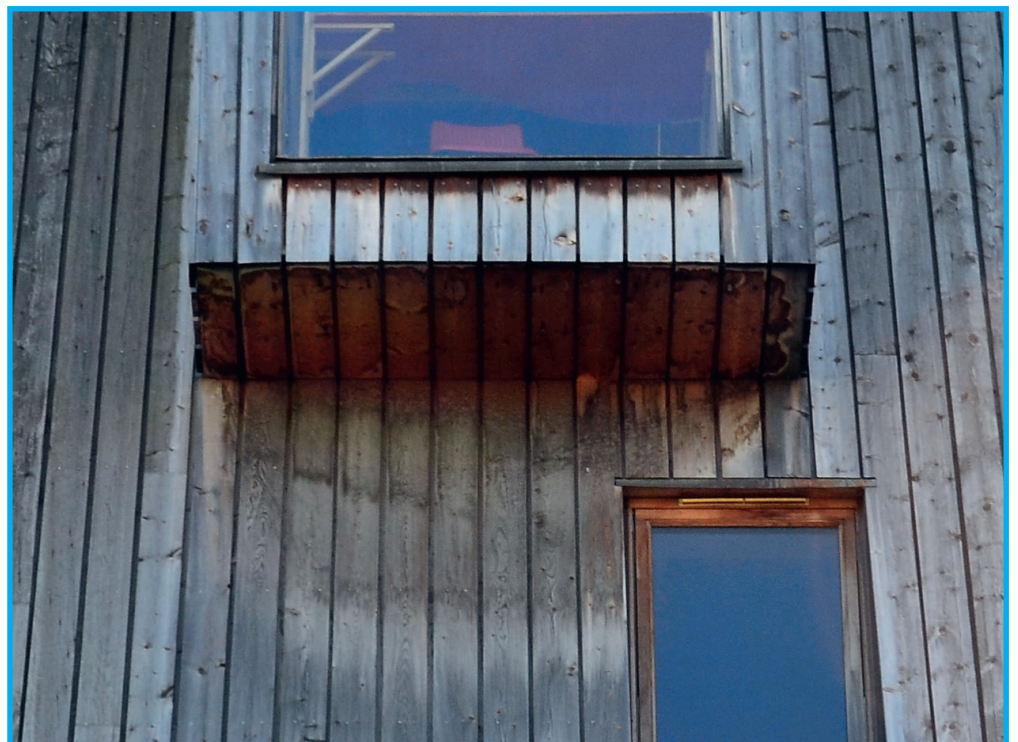
Visible water accumulation under an oriel.

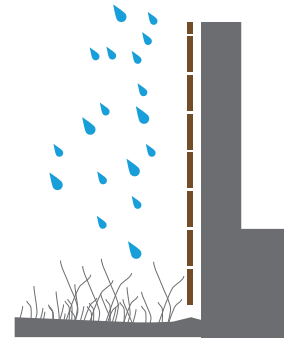
Norwegian National Courts Administration, Trondheim, oiled oak (Arkiplan Arkitekter), 2002

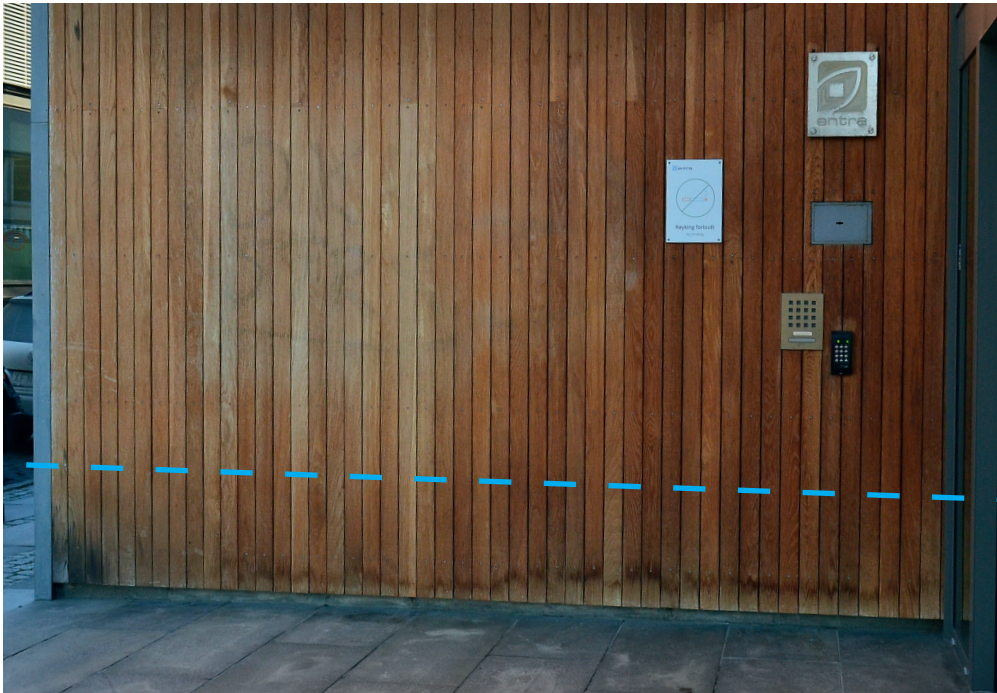
The cladding on the lower part of the wall at the entrance to a building is exposed to splashing. This leads to colour changes and growth of blue-stain fungi. These colour changes can be prevented by increasing the distance between the cladding and the ground.

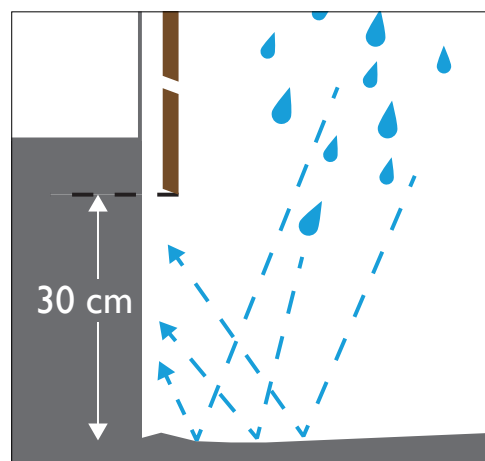
DISTANCE TO THE GROUND: Unless special measures are taken to protect the cladding, a distance of at least 30 cm is recommended between the bottom of the cladding and the ground. This will reduce colour changes in the cladding boards near the ground.

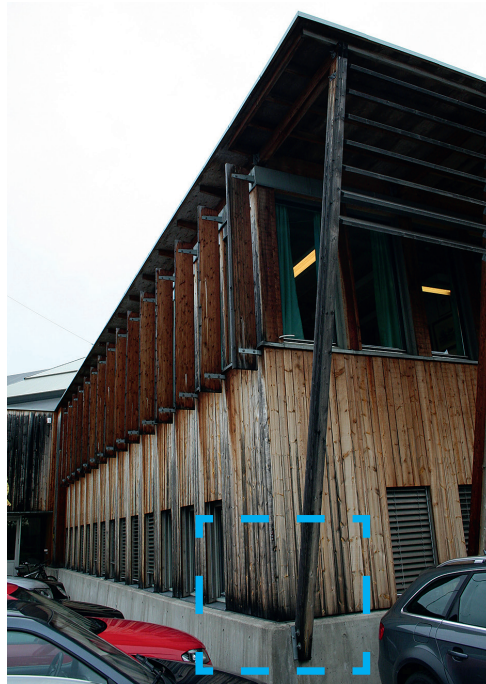
Splashing can also be a problem where the cladding meets the concrete foundation as in this case, where the foundation wall extends further out than the cladding. The lower part of the cladding is clearly marked by wetting and the growth of blue-stain fungi as a result of splashing and possible capillary sorption in the end grain.

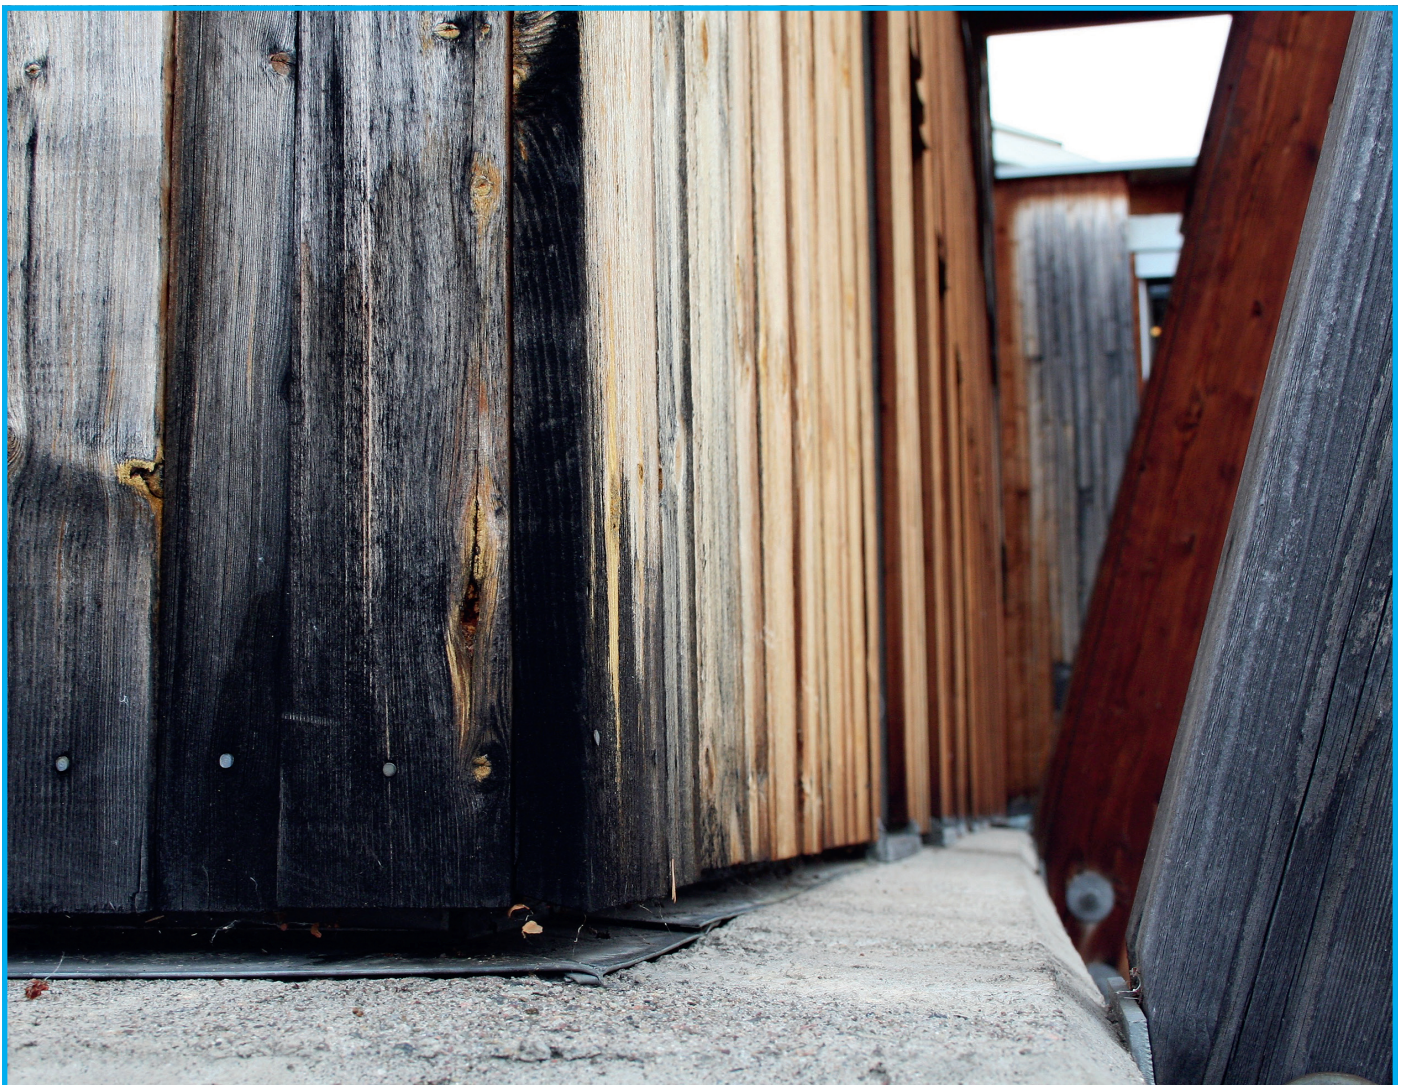
**Ås High School, Ås, aspen
(LMR Architects), 2010**

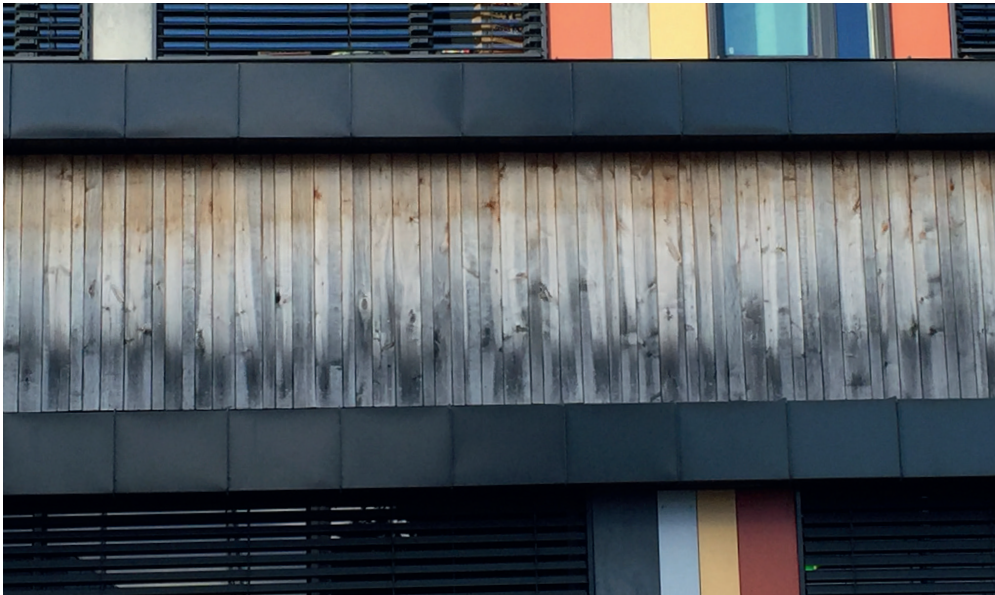
Photo: NIBIO/Lone Ross Gobakken

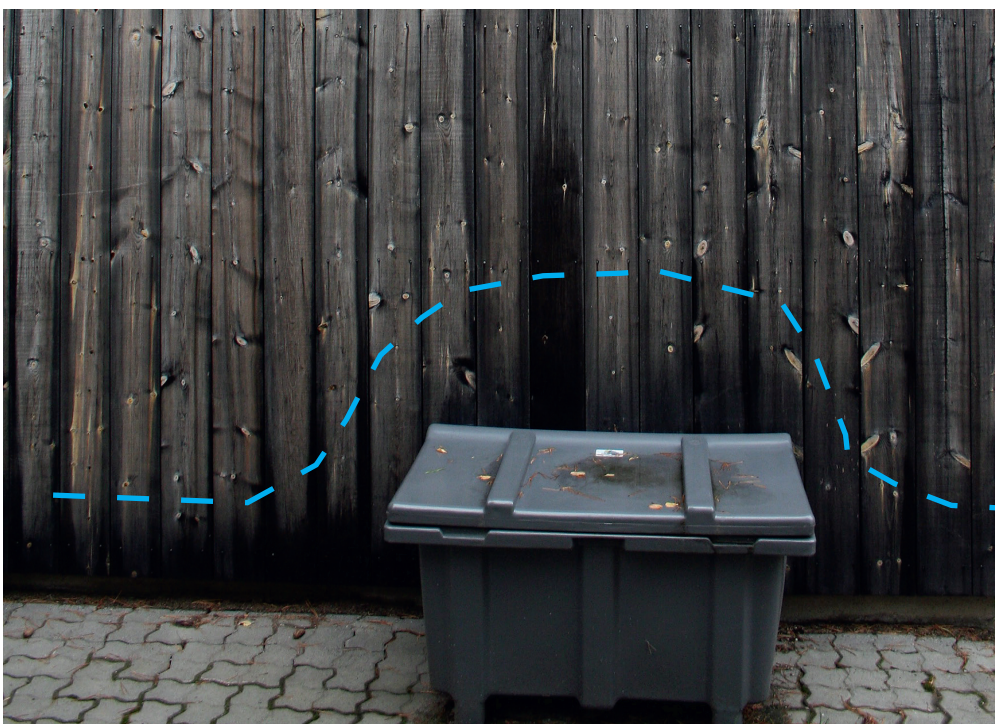
Façade areas highly affected by moisture. The box has enlarged the affected area.

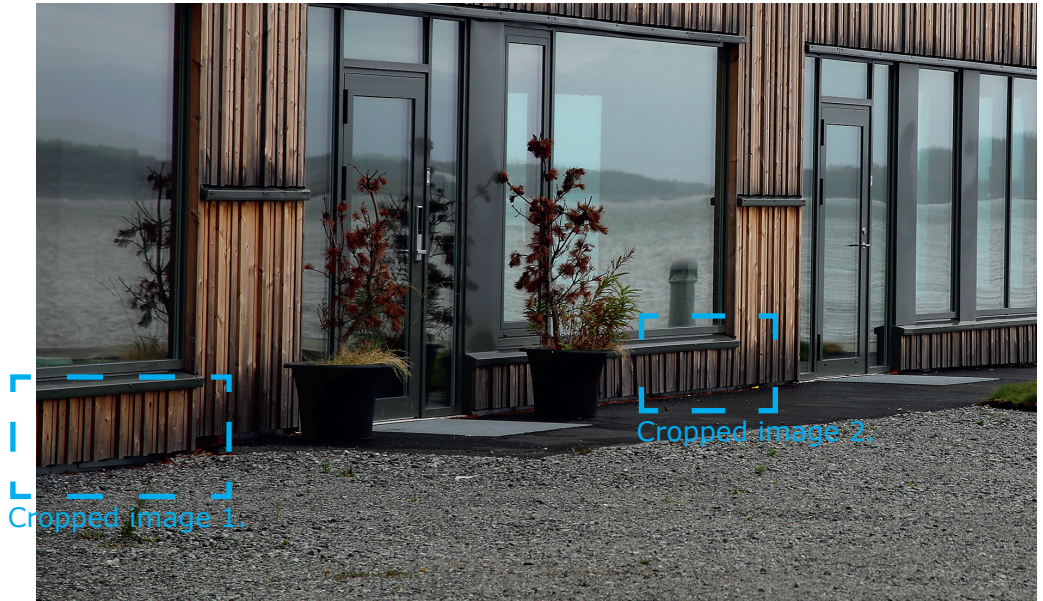
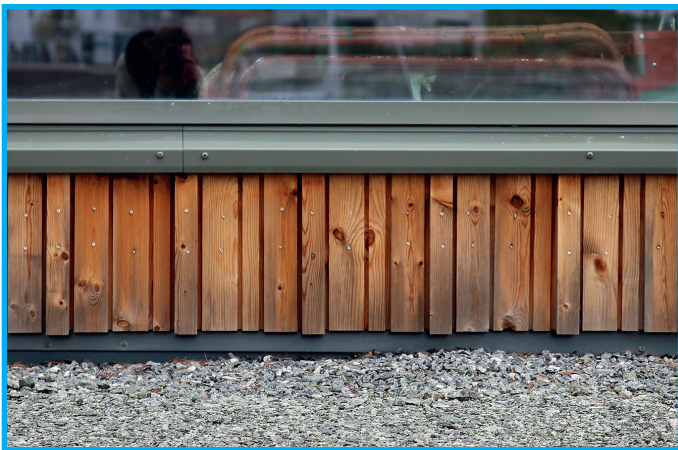
Cladding near the ground that meets gravel

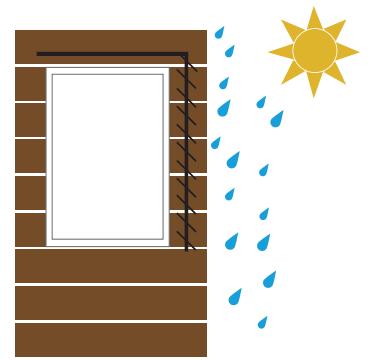
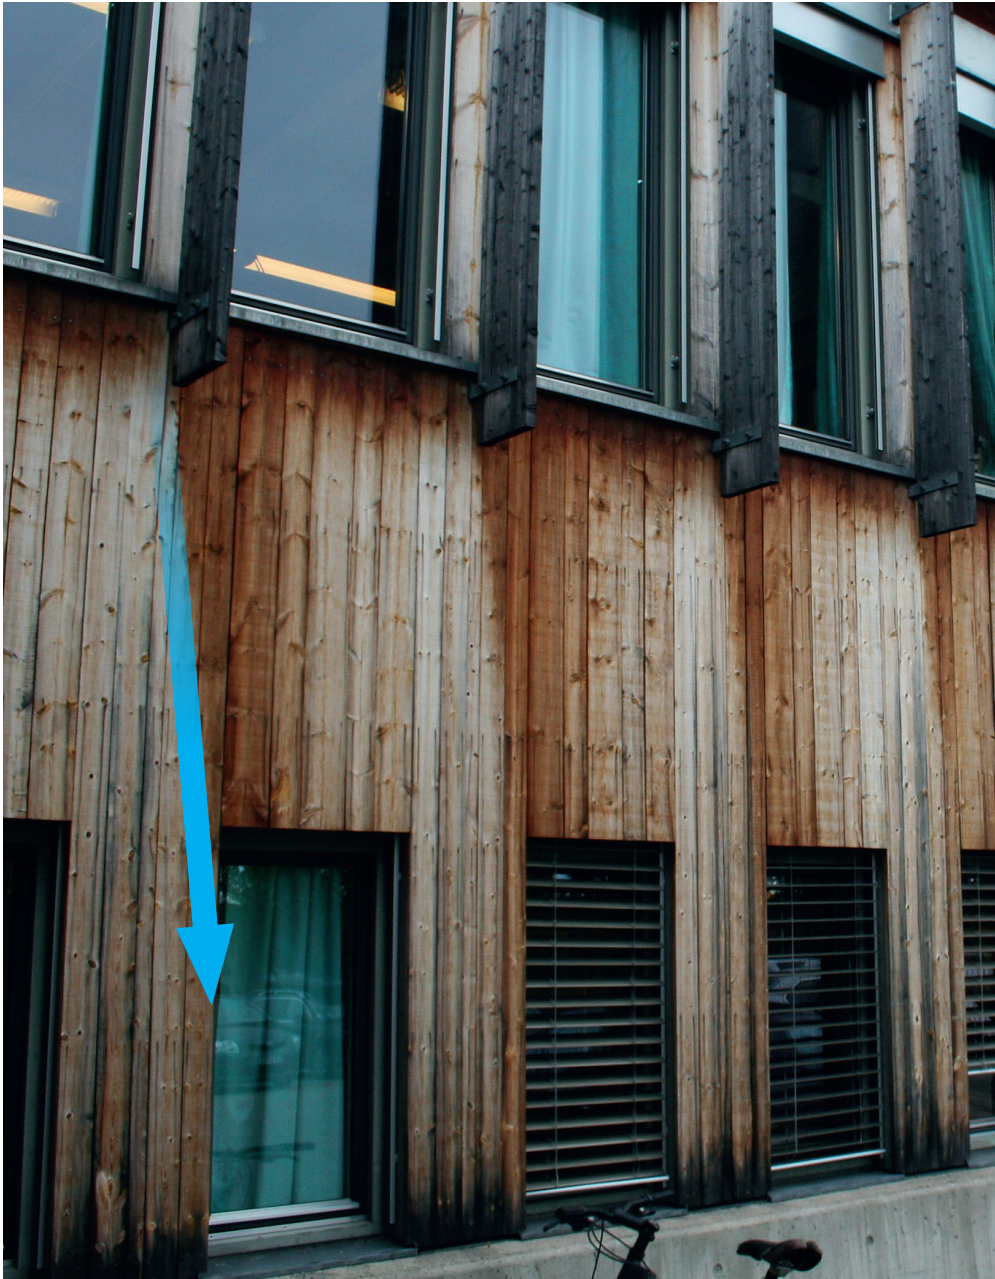
The façade is characterized by the direction from which it takes most of the rain. This can be seen in particular on the rain-exposed side of the sunscreen lamellas, which are marked by leaching and growth of blue-stain fungi. The opposite sides of the lamellas show no signs of leaching. The sunscreens pool rainwater-run-offs and distribute it

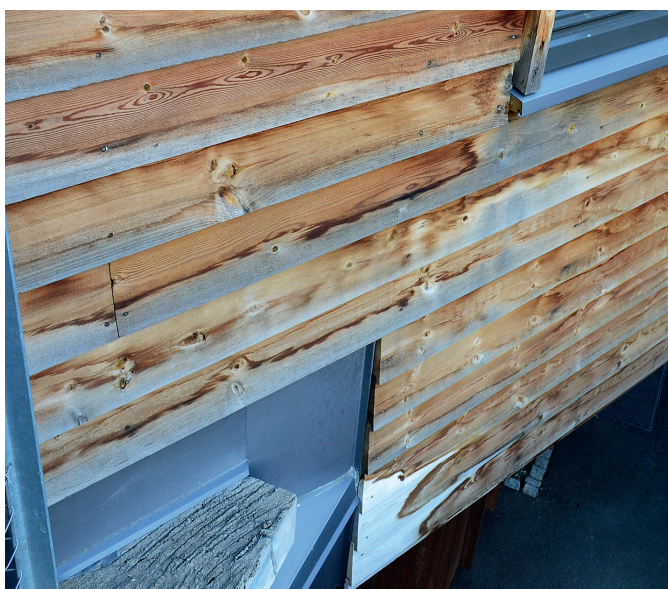
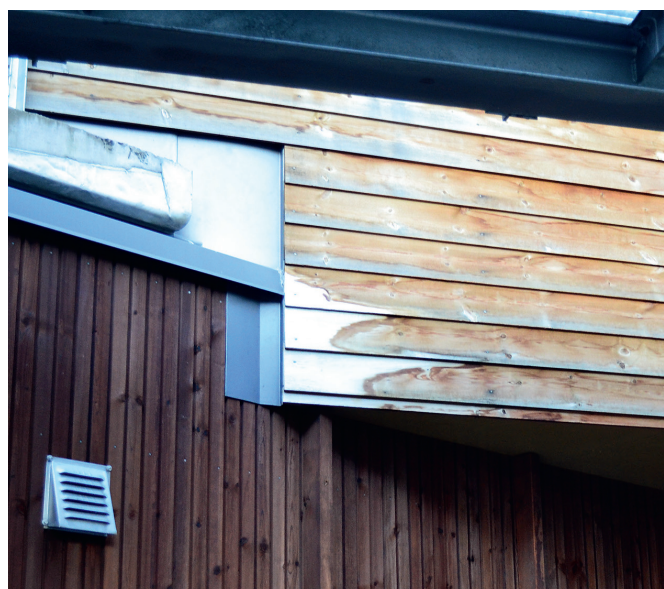
The photo shows a corner of the cladding that has a markedly lighter silver colour. This is a result of large amounts of water being led towards the corner of the façade along the skew girder. This caused heavy leaching of the cladding boards.

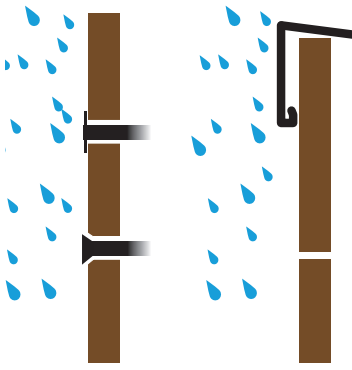
4.8 Fixings, fasteners and hardware

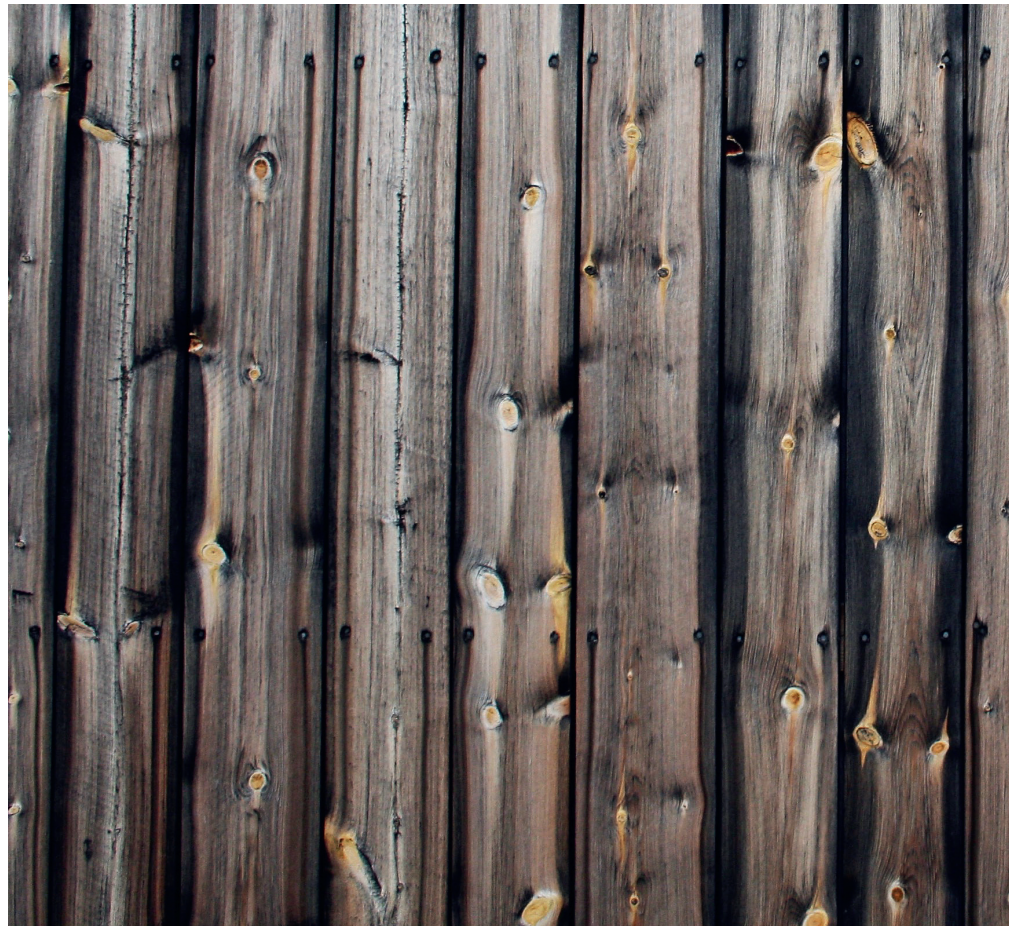
Run-off of rusty water on a Scots pine heartwood cladding.

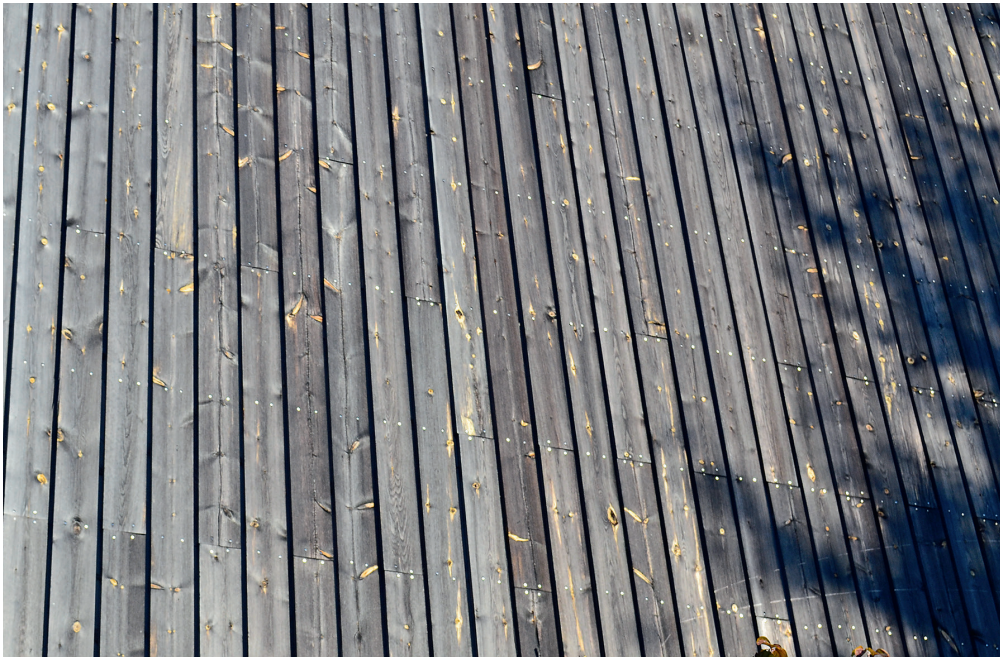
FIXINGS: Use of acid resistant, stainless steel fixings is recommended on unpainted wooden façades. This reduces the risk of colour changes arising from chemical reactions between the fixings and the wood.

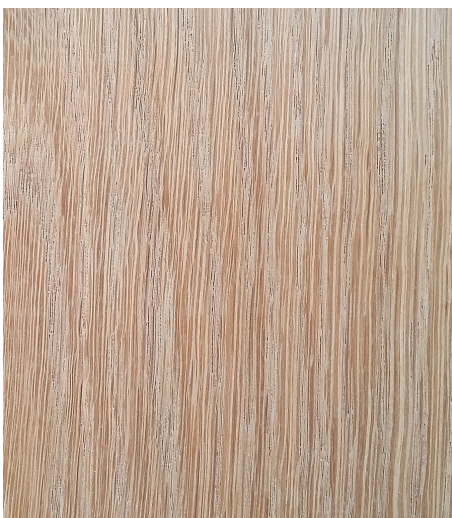
Tannins are chemical substances found in wood that can react with ferrous metals. Oak is rich in tannins and can be greatly discoloured in contact with ferrous metals. Walnut and chestnut are other tannin-rich species that can be similarly discoloured in contact with fixings and hardware containing ferrous metals.

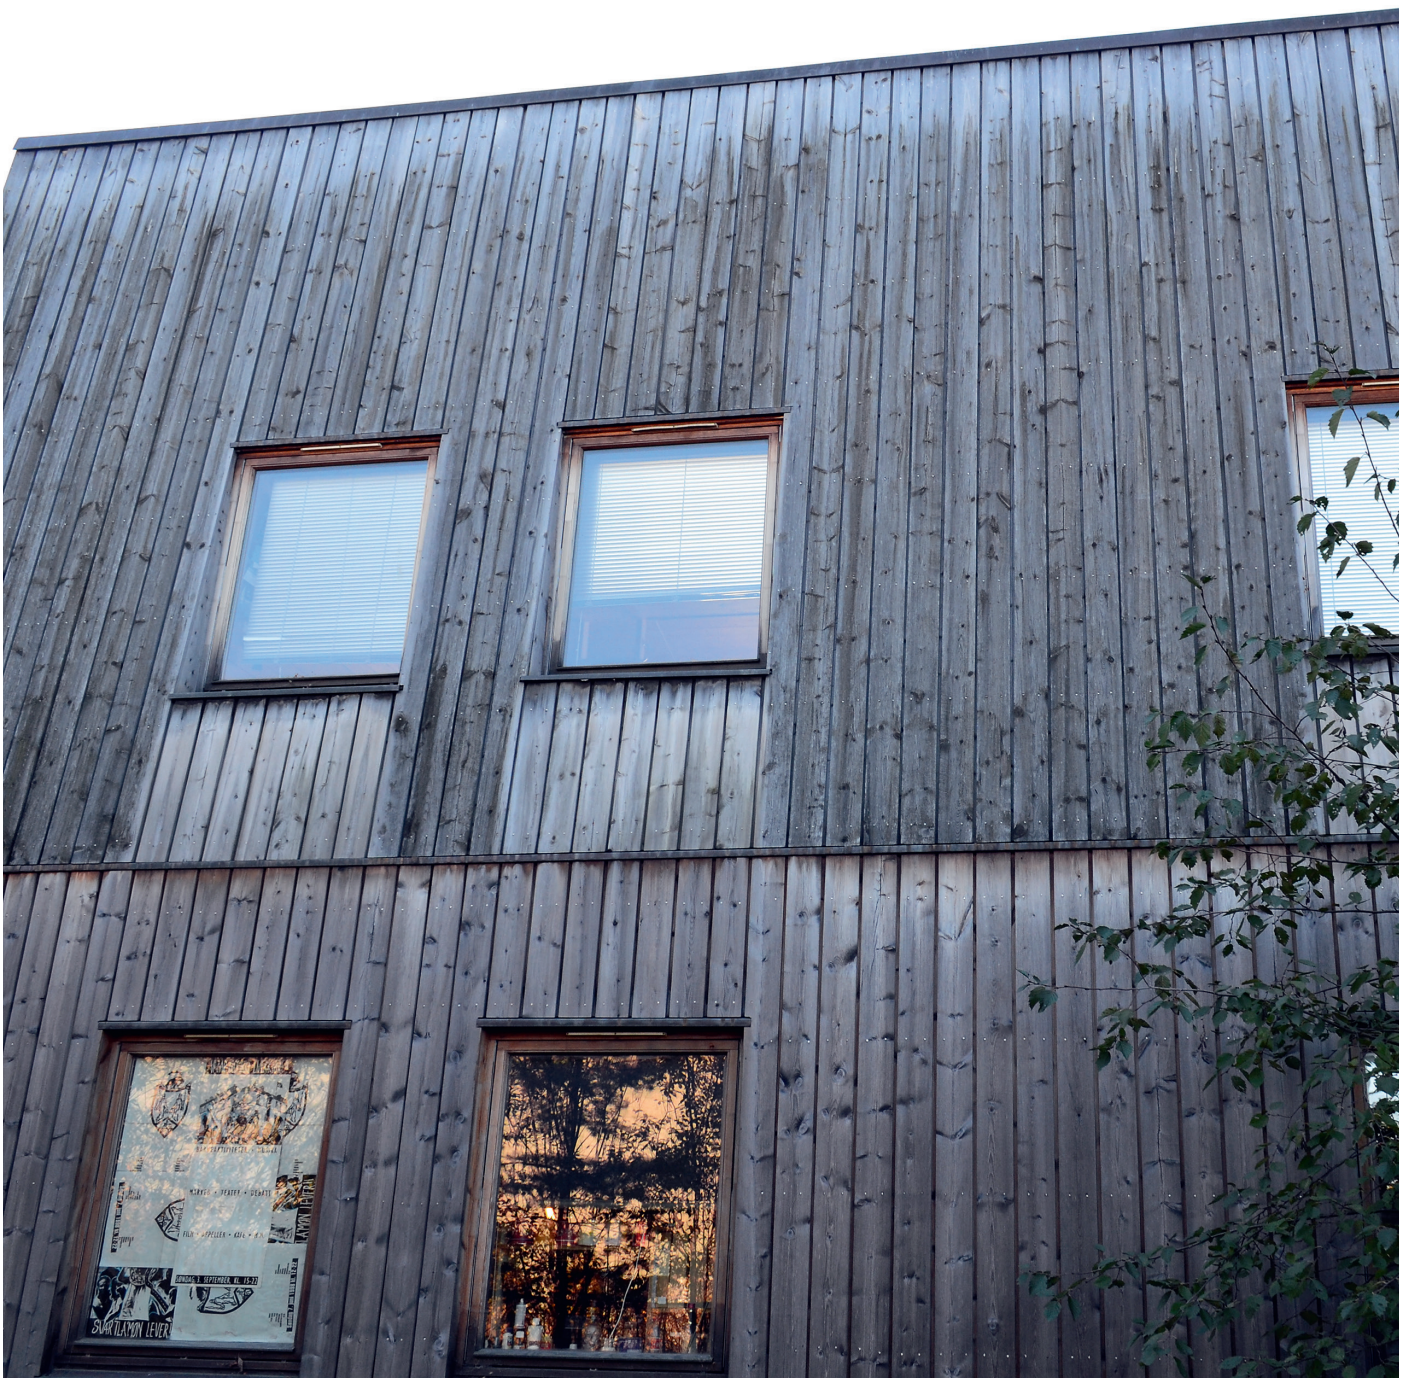
Signs of chemical reactions on flashings and trims

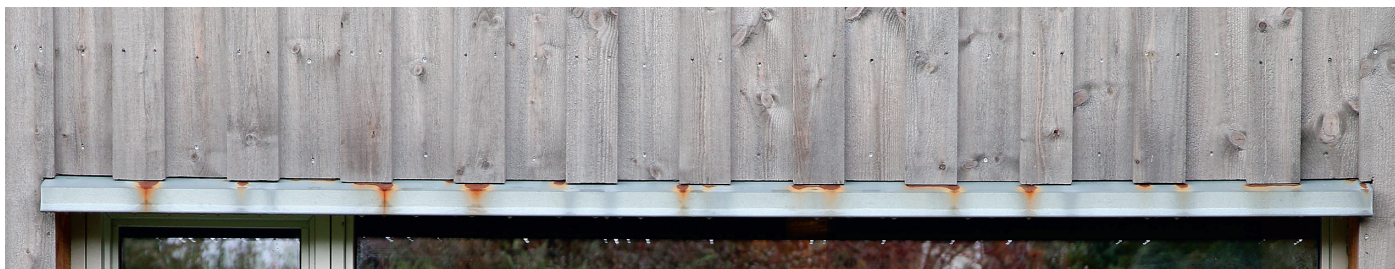
Substances that leach from the pine can lead to corrosion and rust formation on uncoated adjacent metals and alloys. Among other things, acetic acid from Scots metal flashings and trims.

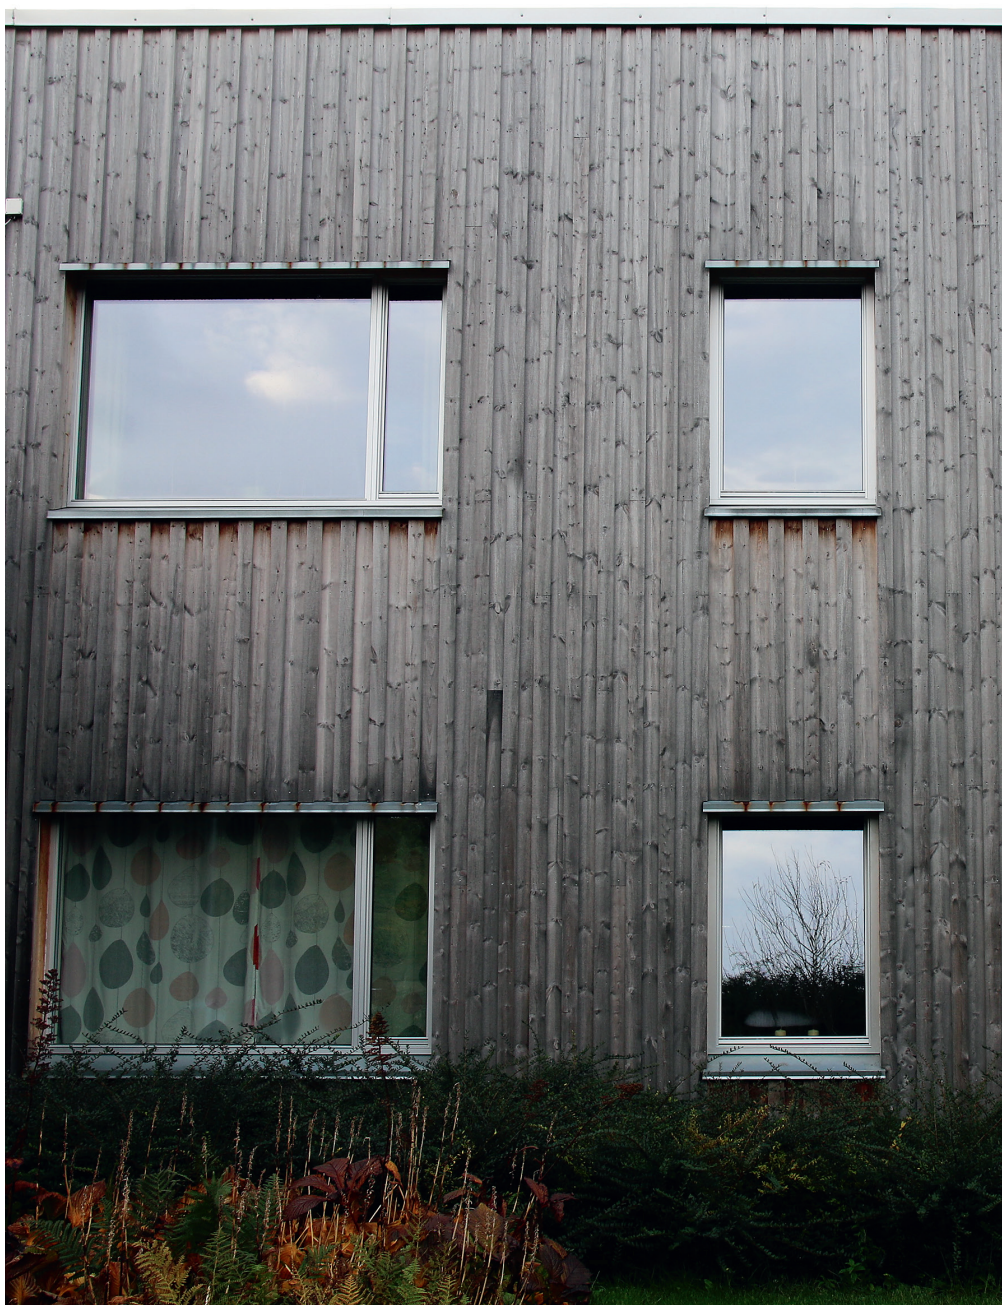
**NINA-building, Trondheim, furfurylated Scots pine
(Pir II Architects), 2013**

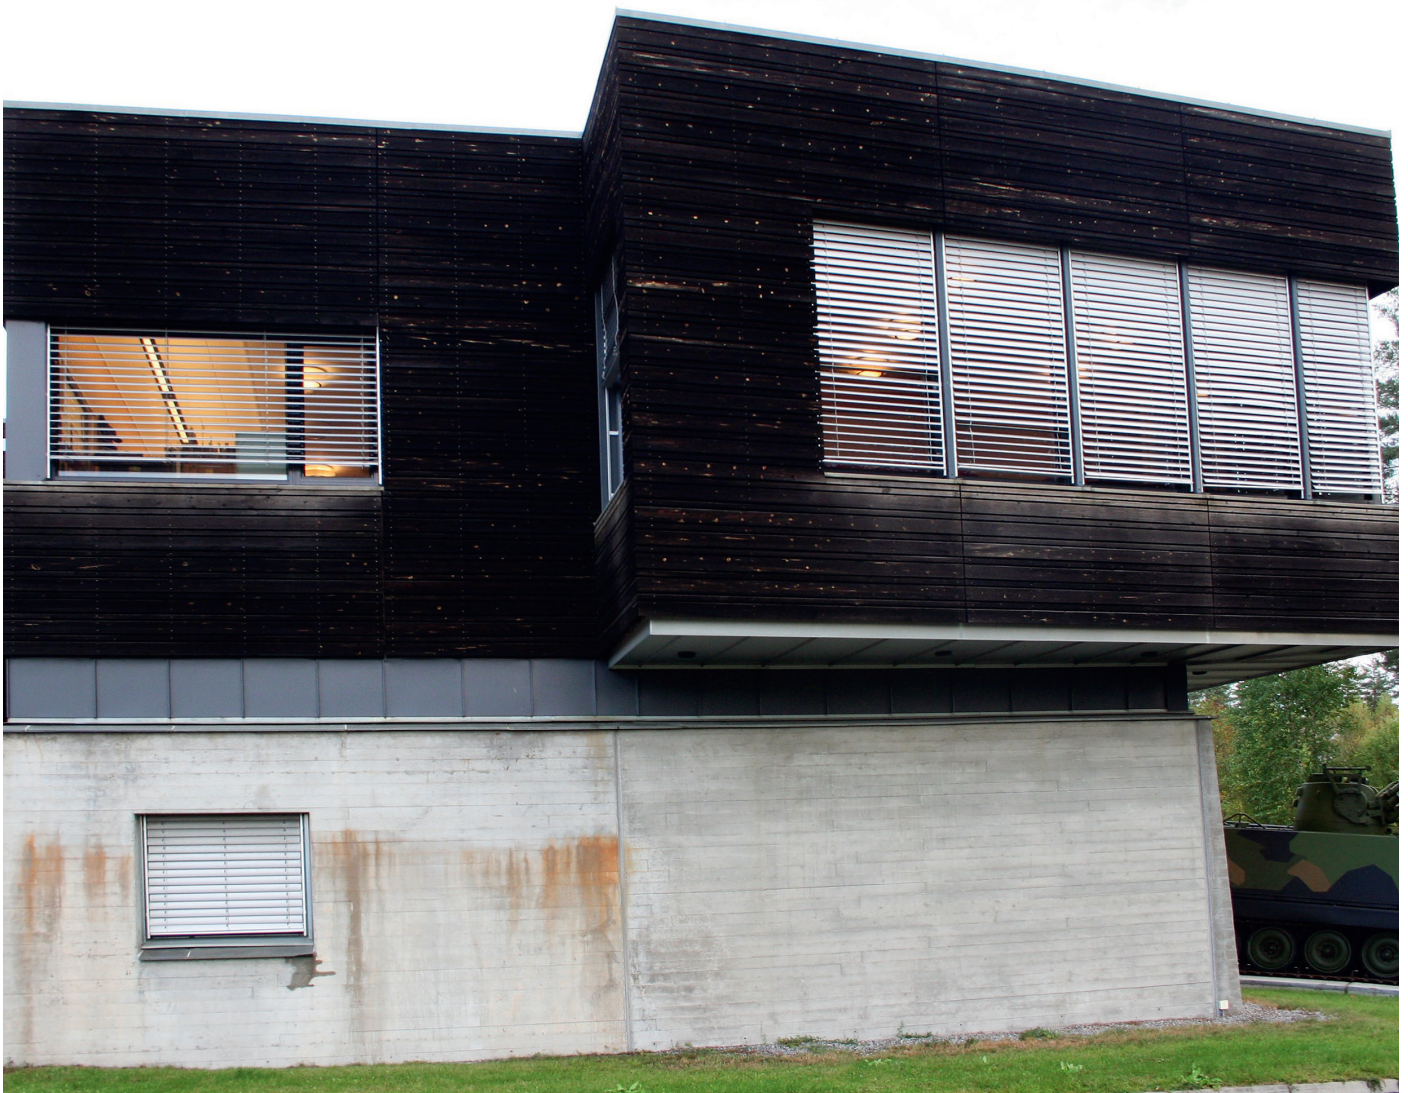
Spills during application and iron sulphate leaching from Scots pine cladding will lead to rusty red discolouration of concrete walls in
