# Impermeable plastic covers for better winter survival of golf course putting greens: Ventilation under the covers during the winter 2020-2021

NIBIO REPORT | VOL. 7 | NO. 181 | 2021

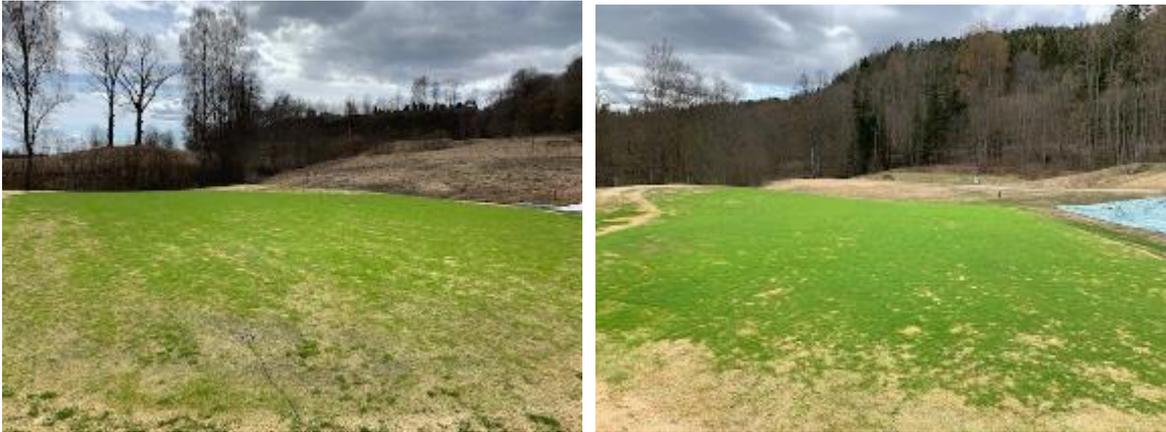
Photo 4. Two greens in Block I at Haga GC shortly after removal of the Green Jacket covers. To the left B4 (treatment 1, see sensor in foreground) and to the right B3 (treatment 2, i.e. programmed ventilation through drainage pipes). Photos: Lee McAndrew.

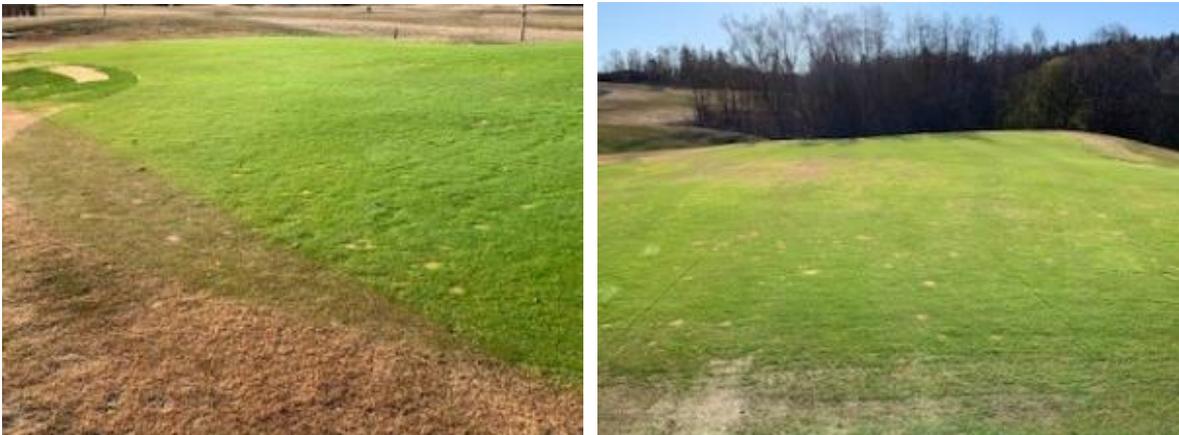
Photo 5. Greens Y1 (left) and Y2 (right) in early April. Effects of Green Jacket winter cover and the Evergreen permeable spring cover were quite conspicuous along the edge of Y1. On Y2 there was a lower area with some damage, most likely because of water under the cover. Photo: Lee McAndrew.

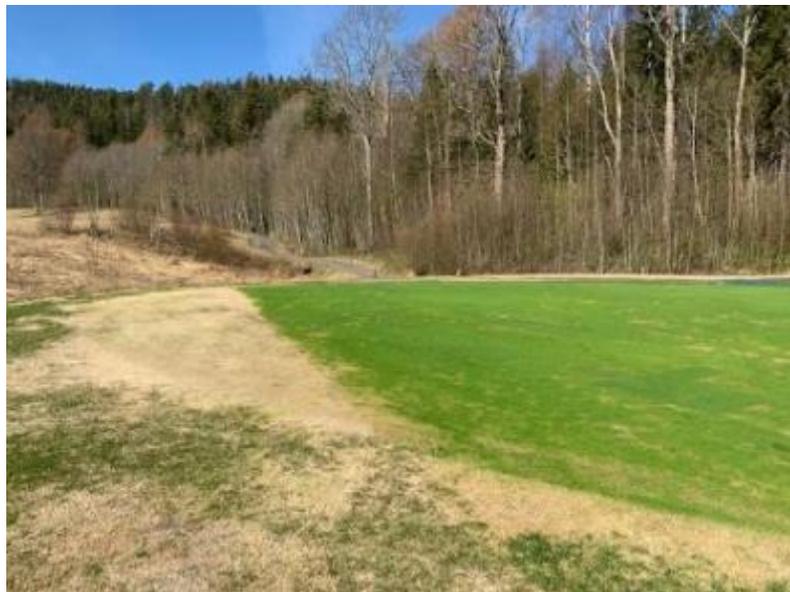
*Photo 9. Green B2 was one of the more shaded greens in block III. On this green, the sensors measured O<sub>2</sub> concentration close to zero before cover removal in March (Figure 6).  
Photo: Lee McAndrew*

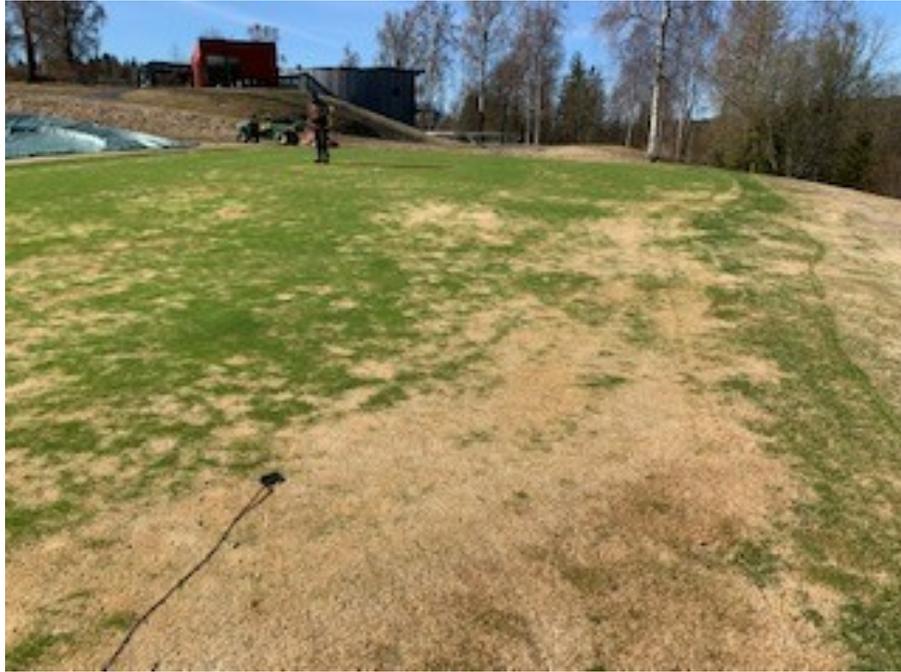
*Photo 10. Green R9 (treatment 4, block 3) suffered significant snow mold damage. Sensor values for this green are shown in Figure 7. Photo: Lee McAndrew.*

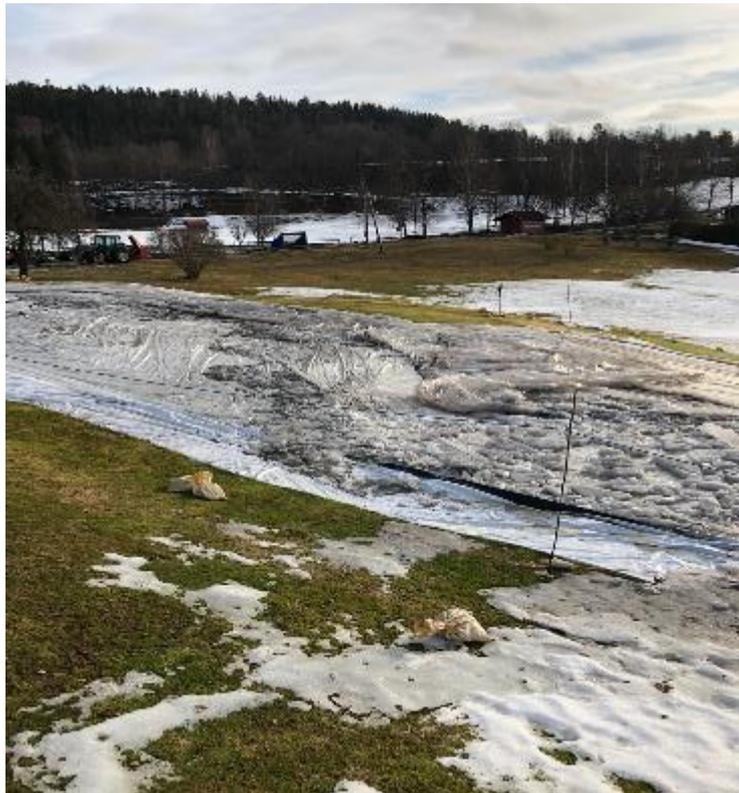
Photo 13. A Christmas blizzard destroyed the coverage of green 18. This photo was taken at snow melt on 24 March. Photo: Guttorm Ray Tuxen.

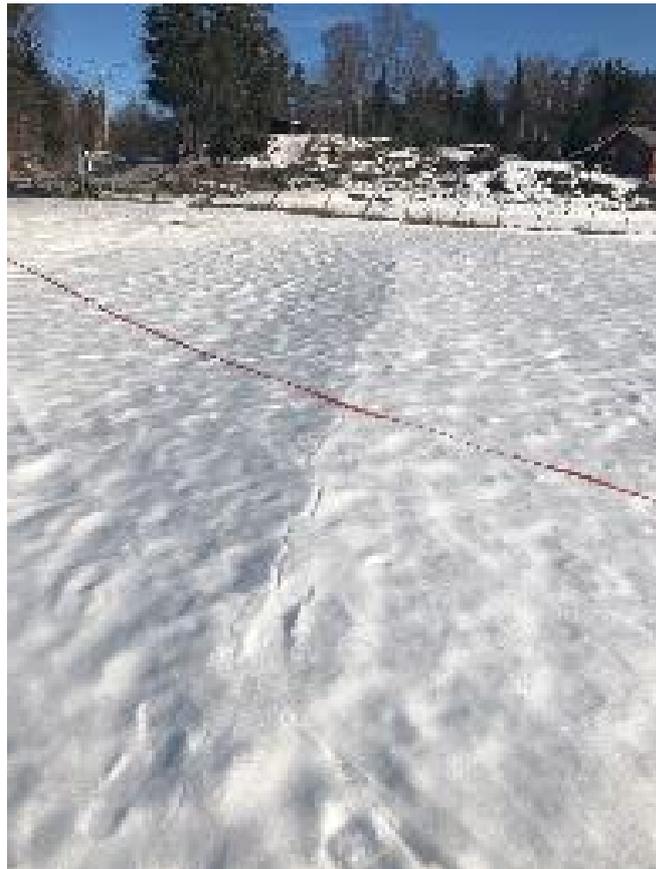
*Photo 15. The snow and ice on green 8 (treatment 3) were lifted and cracked in response to ventilation on 2 March. Photo: Guttorm Ray Tuxen*

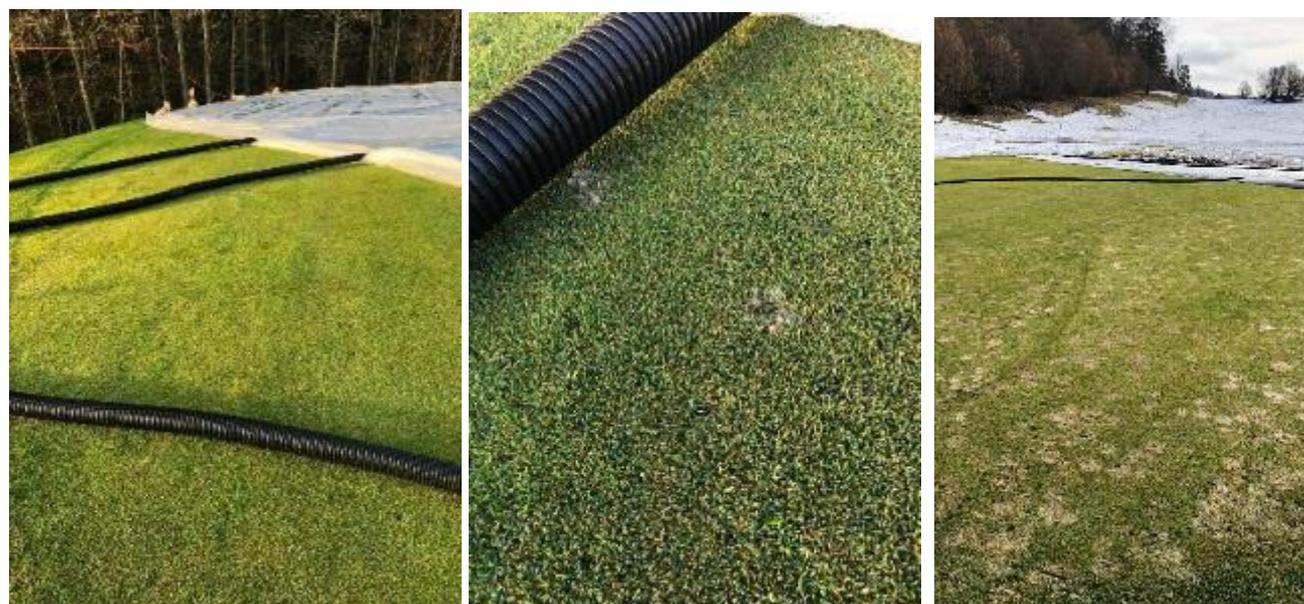
Historically, Green 9 is the green at Bærum that suffers most from microdochium patch. On this green which had been assigned to treatment 2, the course manager removed the plastic from about one third of the green area for a couple of hours on the day after the first programmed ventilation on 20 Dec. Despite the four fungicide applications prior to coverage, he then observed small patches of disease close to the drainage pipes (Photo 17). In spring, it was therefore not surprising that this green had more microdochium patch than any other green on the golf course (Photo 17c).

Photo 17a-c. The shaded Green 9 at Bærum is notorious for microdochium damage. Before the winter 2020-21, this green was assigned to treatment 2 (programmed ventilation through drainage pipes). On 21 December, the plastic sheets were removed briefly from part of the green to check for beginning signs of disease (a,b). The green had been ventilated one day earlier. Symptoms of microdochium patch could then be seen, mostly in the vicinity of the drainage pipes. At cover removal on 25 March, this green had by far the worst attack of microdochium patch – 25% of plot area. Photos: Guttorm Ray Tuxen.

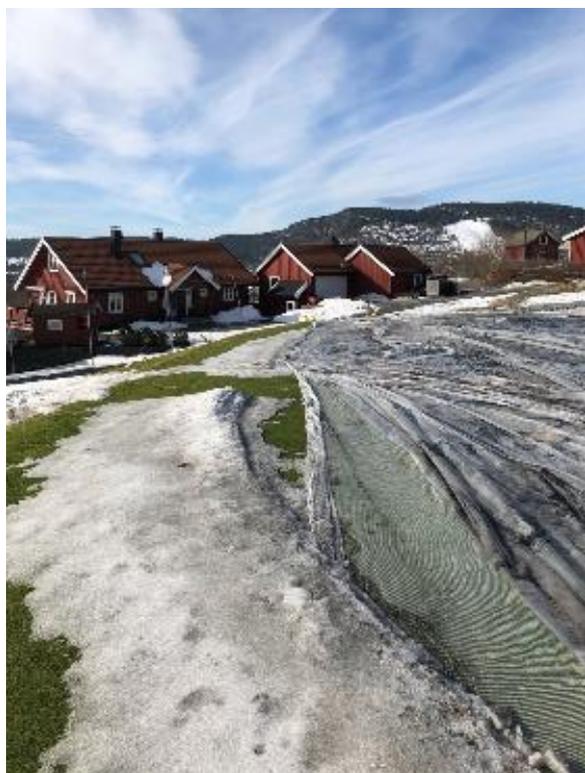
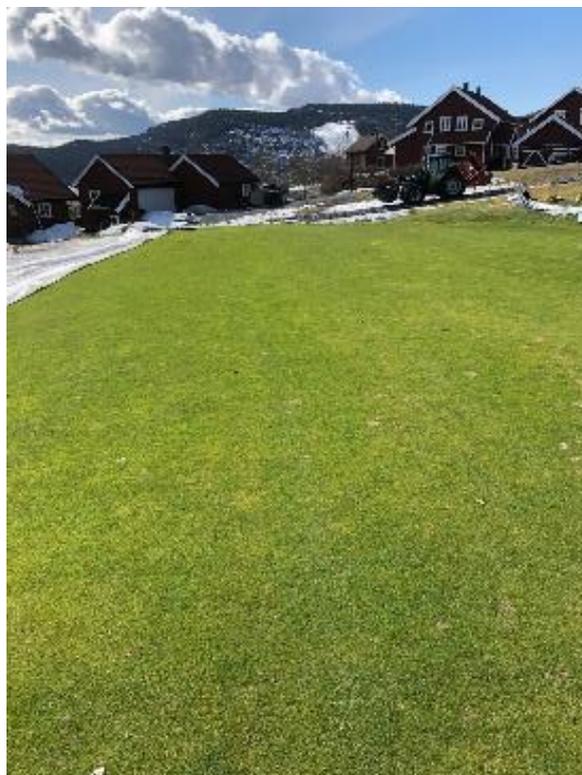
*Photo 18a,b. Green 8 (treatment 3) at the removal of the plastic sheets on 24 March (left) and six days later. The green was practically without any winter damage. Photos: Guttorm Ray Tuxen.*

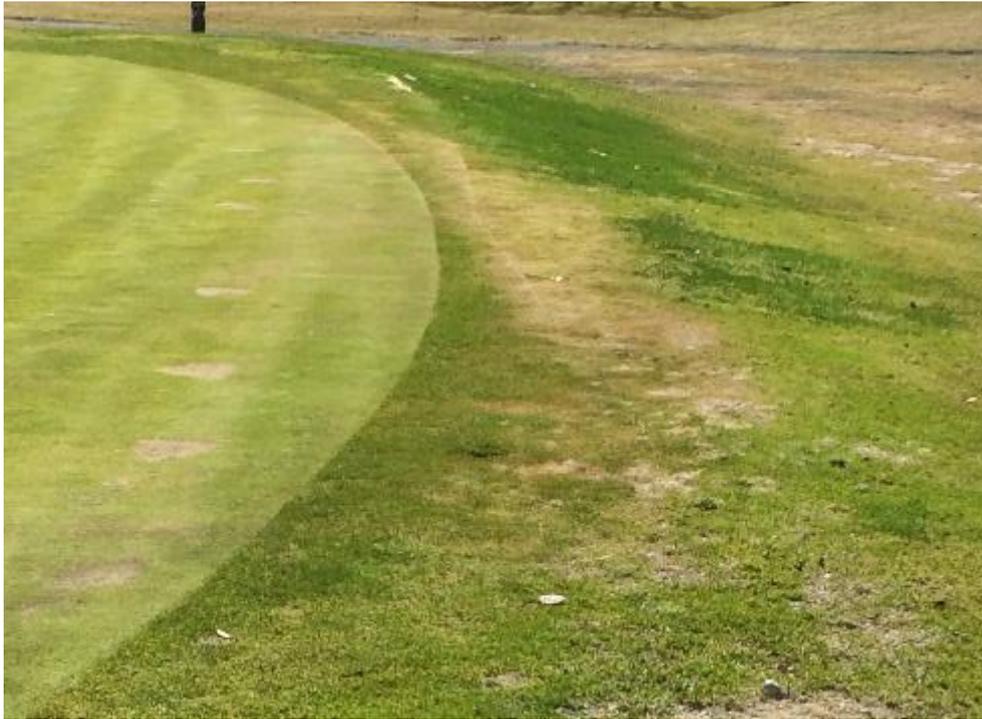
*Photo 20. Green 3 on 22 April. The plastic sheets were too narrow to cover the entire green. Damage was seen where the sand bags had been placed to keep the covers in place. Photo: Trygve S. Aamlid.*

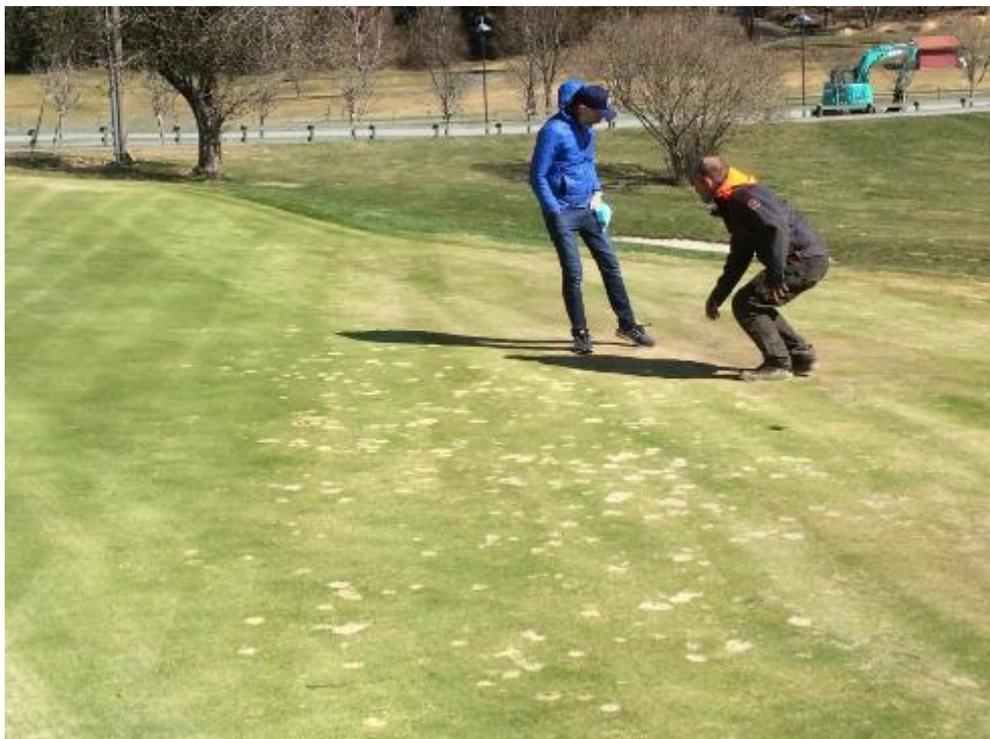
Except of some light damage on Green 18 where the plastic cover had blown off (Photo 20), there was no ice or water damage on the greens at Bærum. Except on Green 9 which suffered 25% damage, the

*Photo 21. From Green 18 which had been partly uncovered by the storm during Christmas week (cf. Photo 13). Green-up on the lower, uncovered part (to the right for Melbye and Tuxen) was much later than on the upper, covered part of the green to then left. Between the two parts there was a belt with severe damage from microdochium patch. Photo taken on 22 April by Trygve S. Aamlid.*

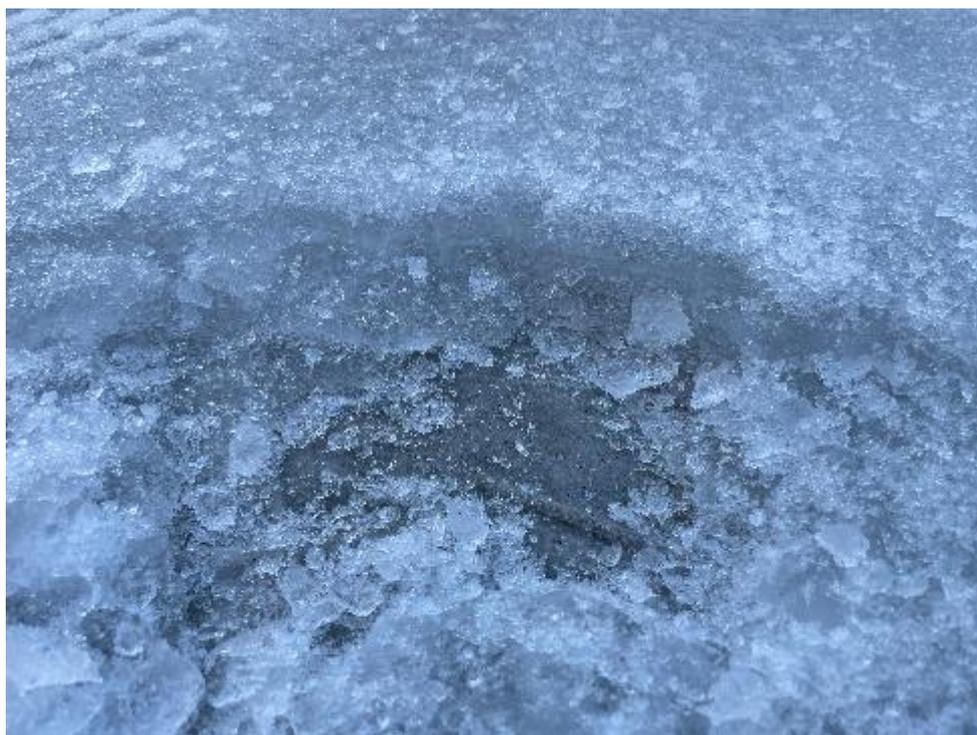
Photo 24. After snow removal on 17 March, a 5-6 cm ice layer could be seen on some of the greens.  
Photo: James Bentley.

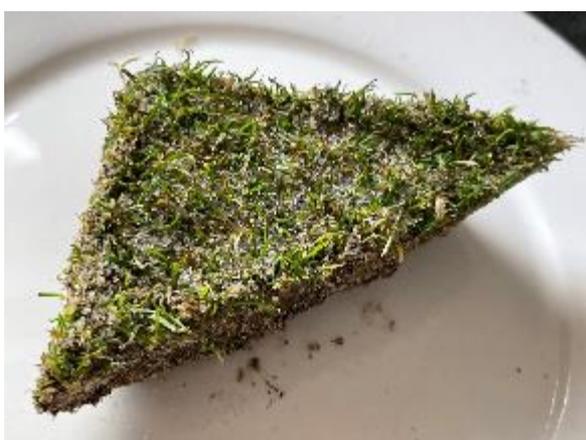
*Photo 25. Samples taken inside on 2 Feb. under the plastic cover on Green 2 showed no winter damage so far.*

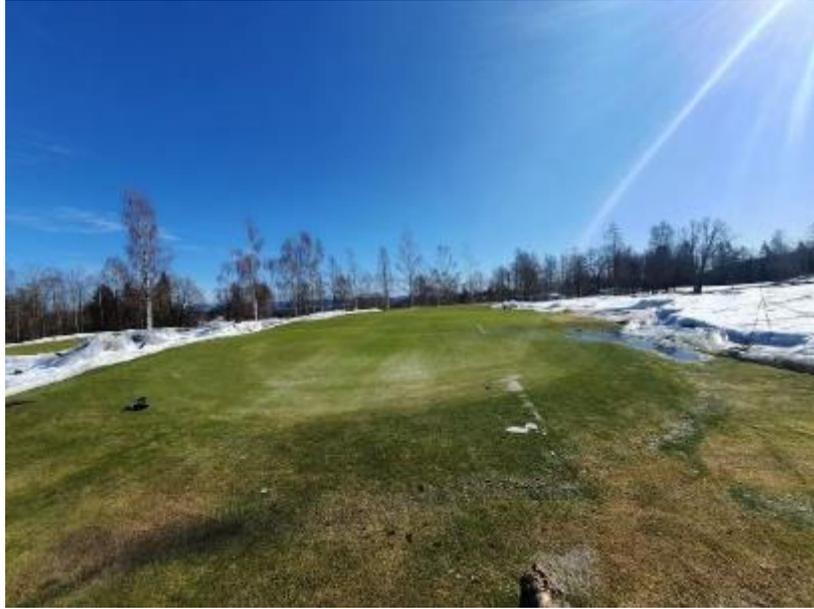
*Photo 27. Green 3 (treatment 5) shortly after the removal of covers on 29 March. A small area suffered damage from ice and melting water. Photo: James Bentley.*

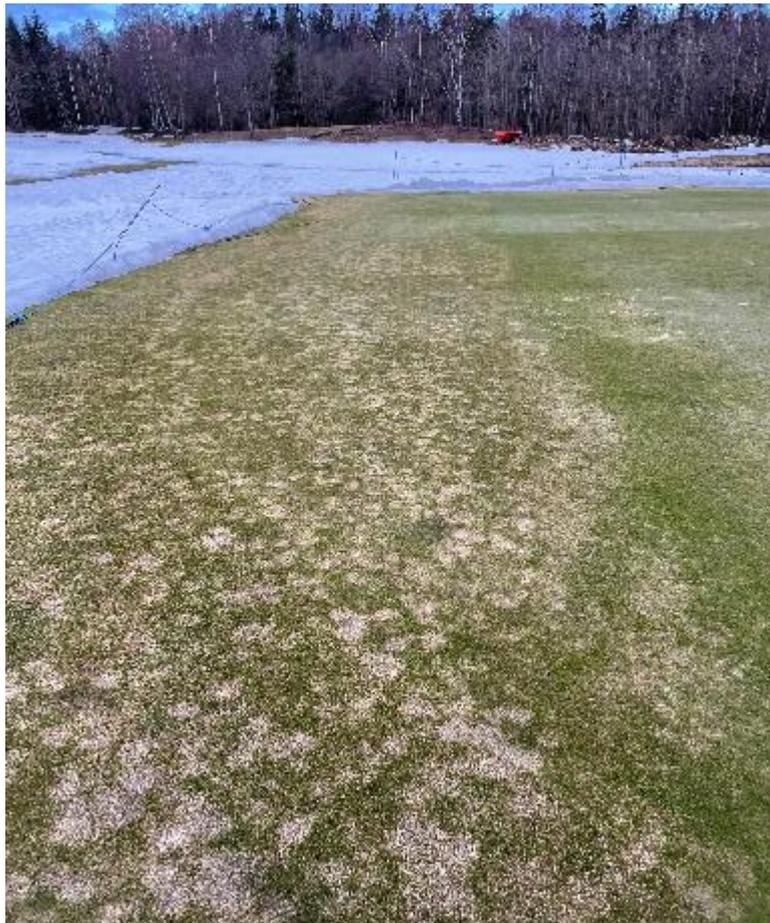
*Photo 28. Green 6 (treatment 3) shortly after the removal of covers on 29 March. There was sever damage from microdochium patch on a part of the green that had been uncovered by the storm on 28 Dec. Photo: James Bentley.*

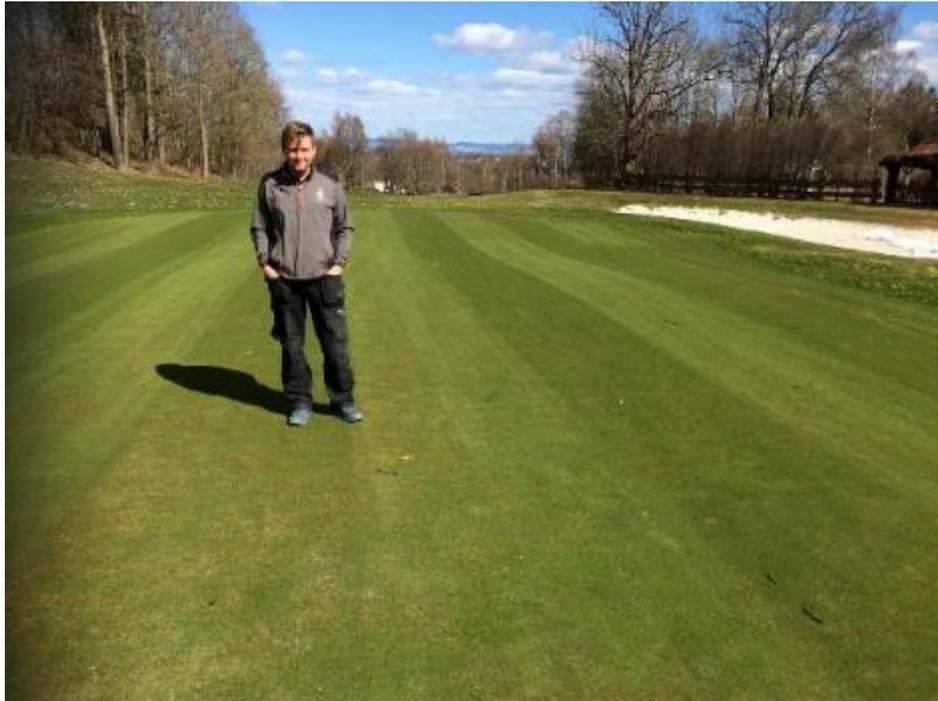
*Photo 29. Course manager James Bentley on Green 14, 22 April. Excellent winter survival despite no ventilation on this green. Photo: Trygve S. Aamlid.*

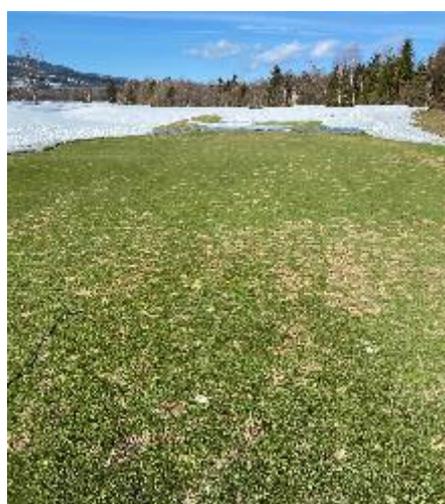
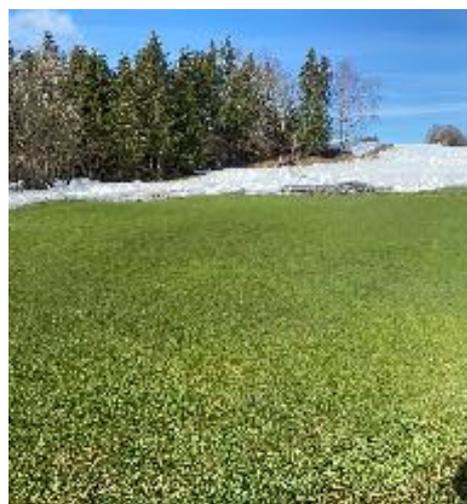
*Photo 31a,b. From Holtsmark shortly after cover removal on 22-24 March. Green 11 (to the left, 10 % annual bluegrass) was severely infected by microdochum patch, but there was very little disease on green 14 (to the right, 20 % annual bluegrass). Photos: Mads Thers.*
