The effect of piling on the preservation of cultural layers

Physical-chemical assessment in a soil profile adjacent to a pile

Thomas Hartnik, Henning Matthiesen

Bioforsk Soil and Environment in collaboration with the Department of Conservation of the National Museum of Denmark

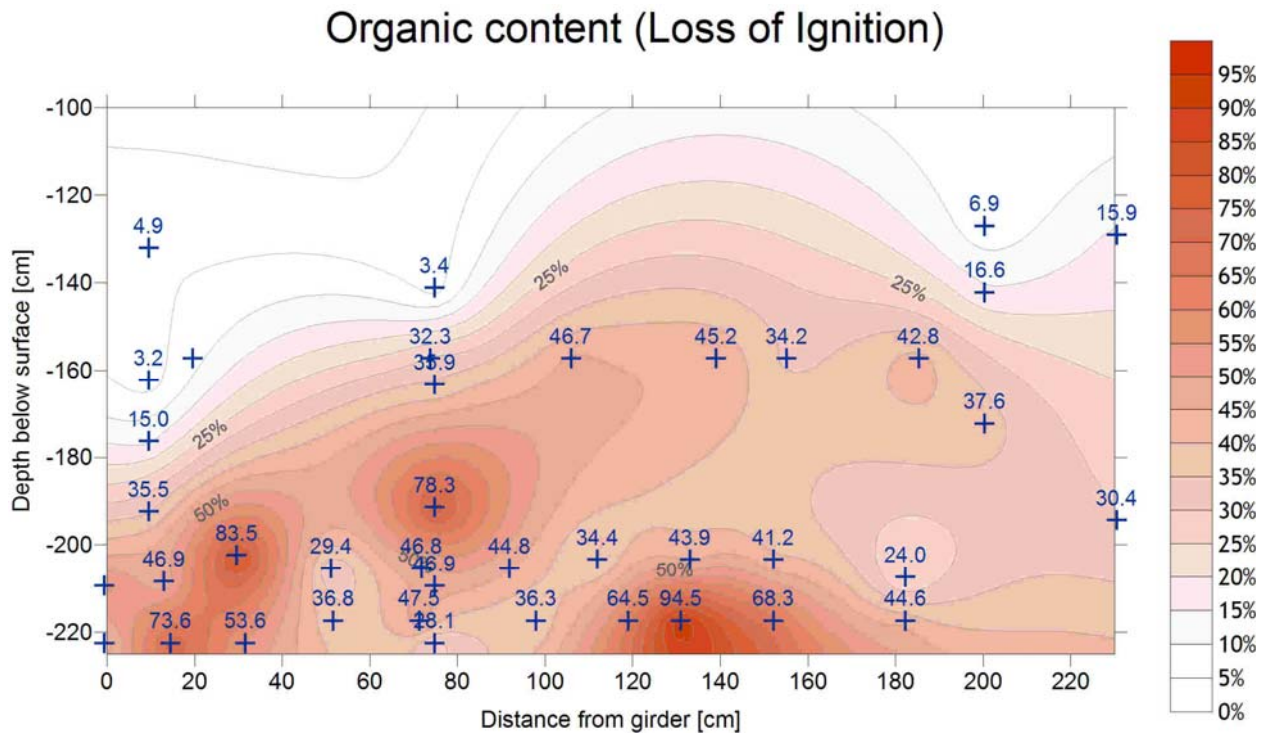
Loss on ignition is the part of a sample that is lost after heating at 560° C for more than 6 hours and represents the portion of organic material in a sample (fig. 8). The organic content in soil varied between 3 to 94%. The lowest organic content was measured in the coarse refilling material near the girder and above the cultural layers near the surface. Highest organic content was measured at a depth of 190 to 225 cm where timbers and organic deposits were located. In the cultural layers below 180 cm the organic content varied between 24 and 95%. A gradient with increasing organic material was found with increasing distance from the girder (and refilling material) at 160 cm depth.

Figure 8: Organic content (loss on ignition) in the soil of the north eastern profile

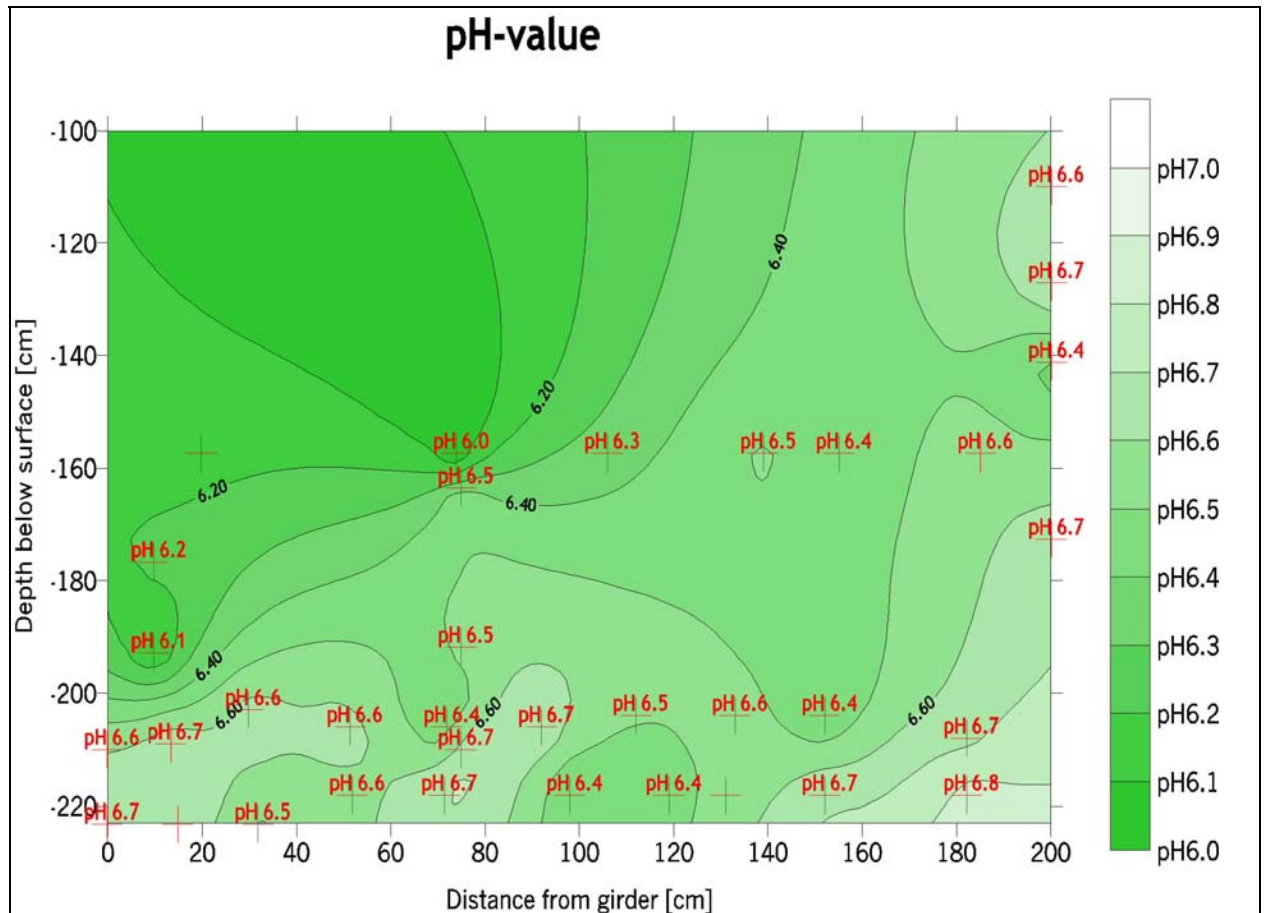
pH-value varied only slightly in soil between pH6.0 and pH6.8. Lowest pH-values were measured near the girder and in the areas with higher oxygen saturation. At major depth below 200 cm and at great distance from the girder the pH-value was higher with values between pH 6.4 and 6.8.

Figure 10: pH-value in the soil of the north eastern profile

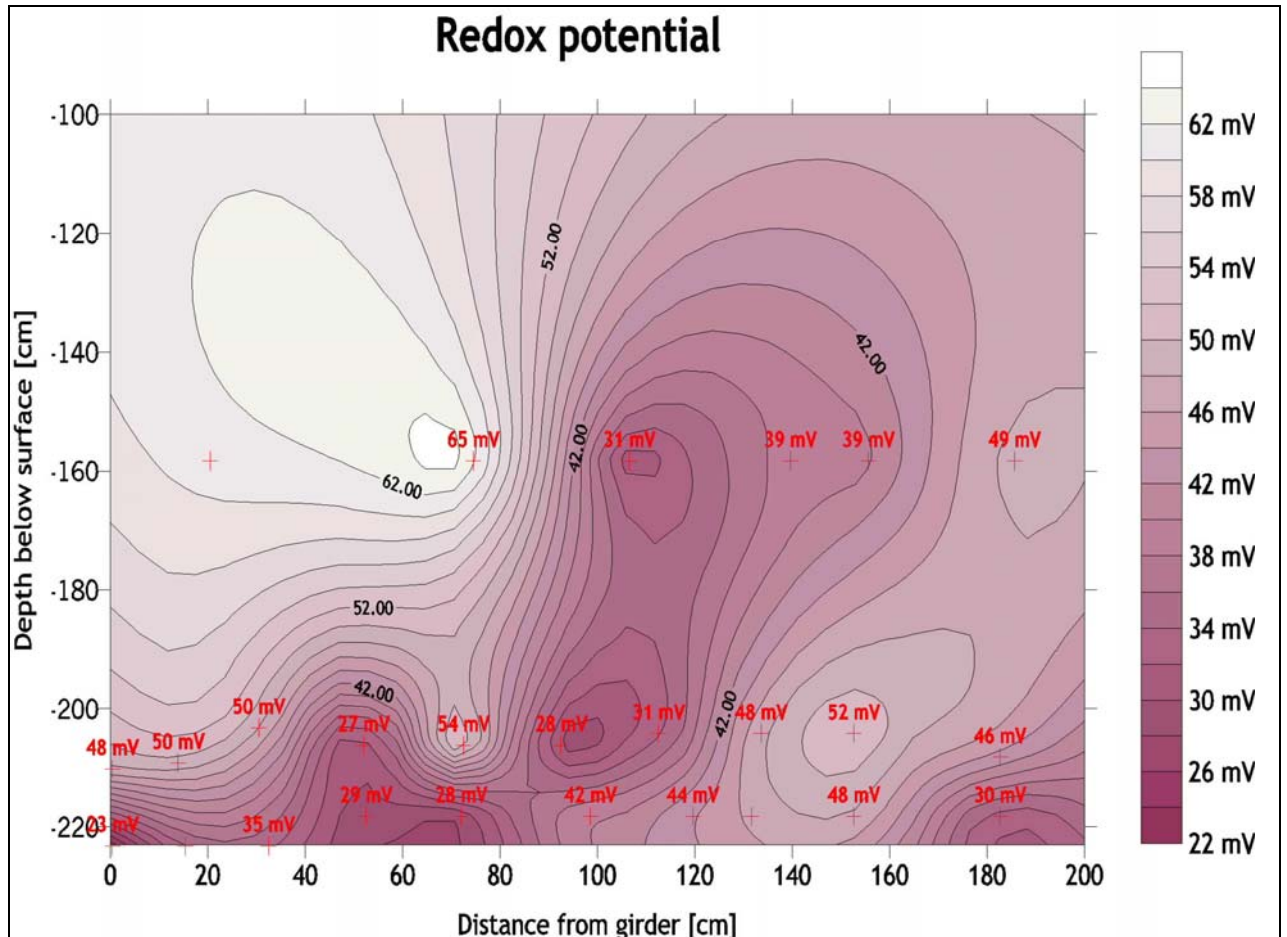
The redox potential in the north eastern profile varies only slightly between 23 and 65 mV (fig. 11). The highest redox potential was measured in the sampling point where the highest oxygen concentration was measured, i.e. in the area near the girder with coarse refilling material. Lowest values (<30 mV) were measured in major depth of the profile and at a distance of 100 - 140 cm from the girder. At a greater distance from the girder redox potential increases again.

Figure 11: Redox potential (standard electrode potential) in the north eastern soil profile

The redox potential reflects the redox conditions only partly. The distribution of high and low redox potentials approximate the redox conditions in the soil profile, however, the range between 23 and 65 mV is rather small and indicates aerobic and nitrate reducing conditions (Chapelle et al. 1996; Bjerg et al. 1995). Christensen et al. (2000) concludes that redox potential is not a suitable parameter for the characterisation of the dominant redox processes and at best should be used qualitatively. The impracticality is explained by the fact that the redox potential reacts very sensitively only on the concentration of reduced and oxidated iron compounds but not on other redox couples.
