Effect of riparian vegetation on stream bank stability in small agricultural catchments

Dominika Krzeminska^{a,*}, Tjibbe Kerkhof^b, Kamilla Skaalsveen^a, Jannes Stolte^a

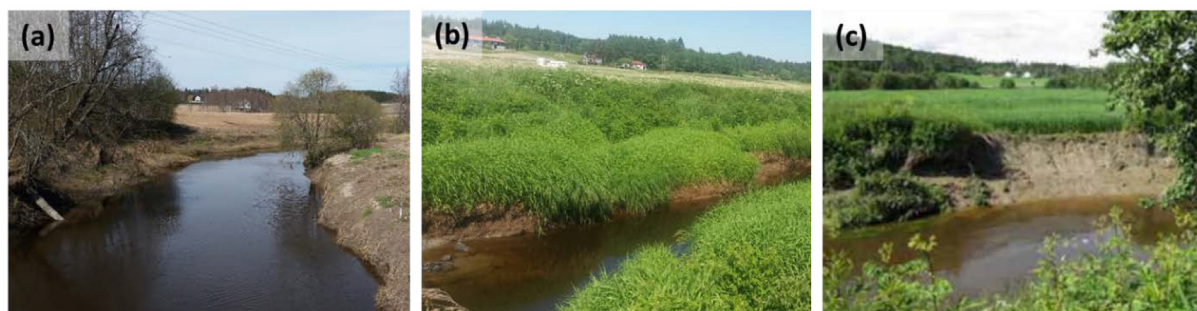
Fig. 1. Examples of observed undercutting processes and associated slope failures in small agricultural catchments in Eastern Norway: (a), Hobøl River and (c) Lier River.

The main cause of the streambank failures observed in small agricultural catchments in Eastern Norway is undercutting of bank toe and resulting steepening of the slope (Fig. 1; Skarbøvik et al., 2014; Skarbøvik, 2016) while the triggers are either hydrological factors (snow melt, intensive/prolonged rainfall) or human activity (using heavy machinery close to the edge of streambanks). Majority of the erosion events are observed in spring and autumn when the flooding risk is high (Skarbøvik and Bechmann, 2010): during the drawdown phase, the confining pressure of the water in the streams disappears and (partly-) saturated stream banks tend to fail (e.g. Jia et al., 2009). Relatively planar failure surface are commonly observed in the area (Fig. 1).

There are few limitations of the current version of BSTEM that influence the stability analysis. Presented modeling results do not account for potential seasonal changes in additional root cohesion, that we observe in the field (Fig. 6) and that is confirmed by other studies (e.g.: Pollen-Bankhead and Simon, 2009). During winter and early spring the vegetation is dormant and additional cohesion coming from the roots can be smaller or even negligible, especially in case of grass cover. Moreover, additional load coming from vegetation weight is not included in stability calculations. This, in turn, might be important in case of trees cover (e.g.: Ott, 2000; Pollen, 2007). It is also necessary to mentioned pre - assumed planar failure plan as a general limitation of BSTEM model. However, in our case, this assumption is valid as planar plane are commonly observed in the area (Fig. 1).

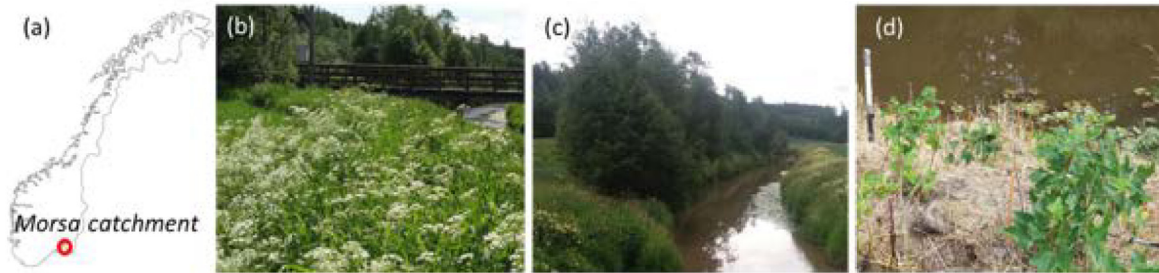
Fig. 2. Location of the monitoring plots (a) and pictures from the plots: (b) grass plot, (c) trees plot, (d) shrubs plot.

Hydrological monitoring of two plots representing vegetation typical for Norwegian agriculture areas (Fig. 2): mixed grass (root depth up to 20 cm) and trees (root depth more than 100 cm) were installed. Additionally, on the site with mixed grass, redcurrant berry bushes (*Ribes rubrum* 'Jonkheer van Tets') have been planted (in July 2016). All plots are located within distance of 50 m to ensure similar soil and environmental conditions. The height of the bank, at all three test plots, is 4 m above riverbed, while the slope varies greatly: 27.5°–32.6° for the grass plot, 39°–54° for the trees plot and 24.7°–39.7° for the shrubs plot. No visible soil stratification was observed within vertical profiles during installation of the equipment.

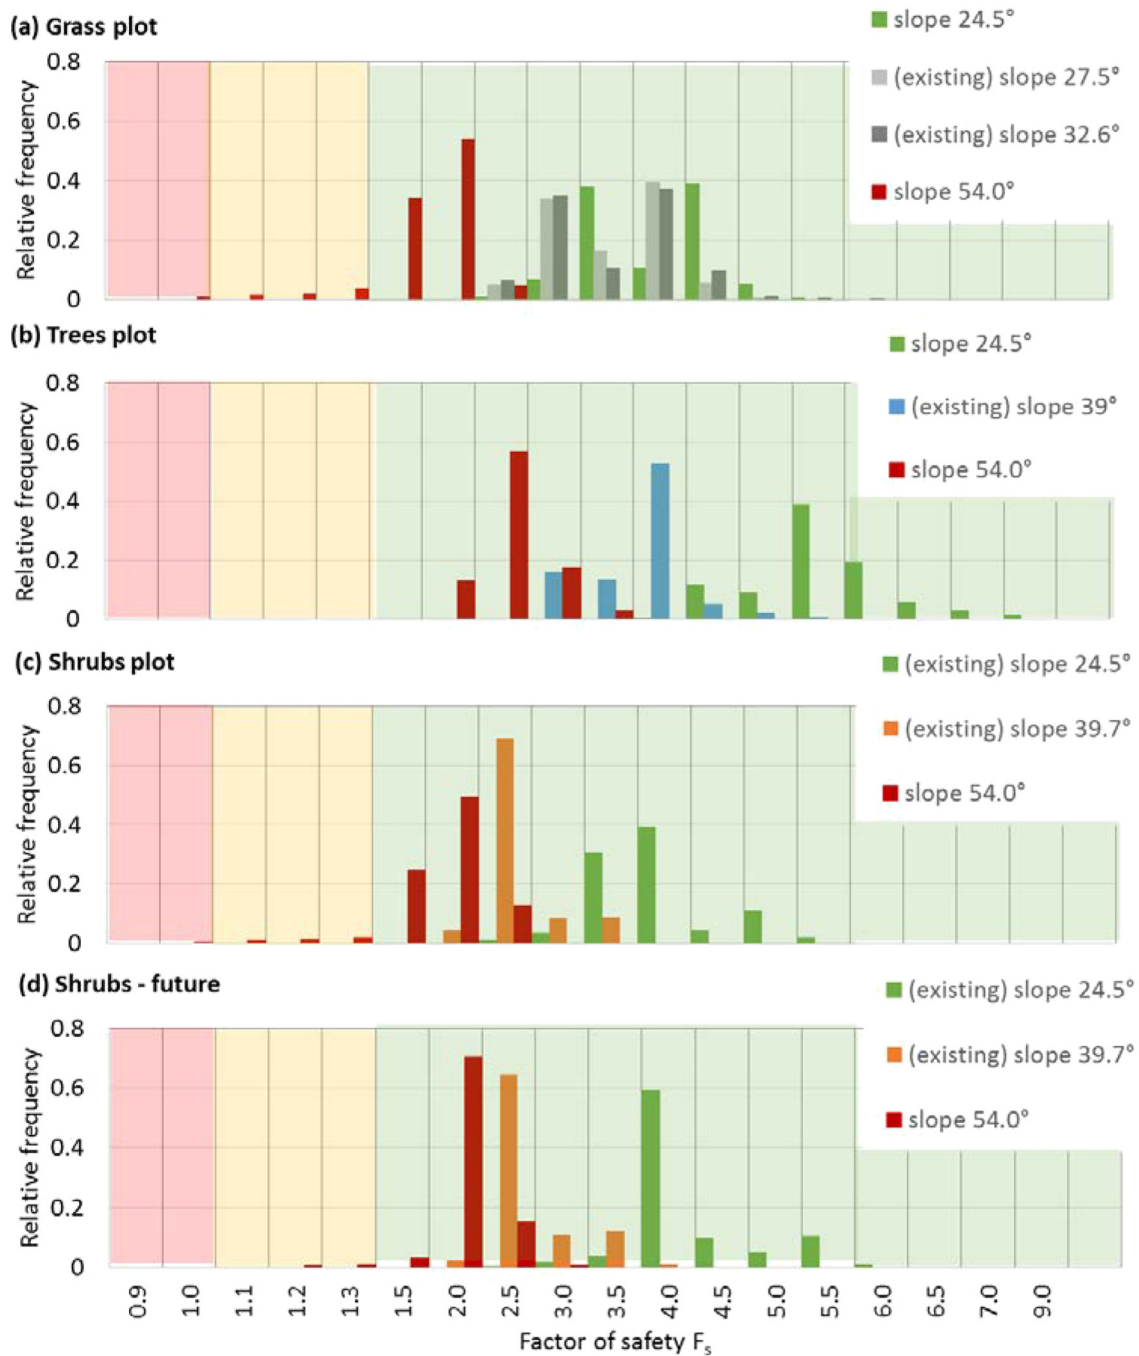
Fig. 9. Histograms of FS for all simulated scenarios. Shaded areas indicate stability classes according to the BSTEM model: red – unstable slope; yellow – conditional stability; green – stable slope. (For interpretation of the references to colour in this figure legend, the reader is referred to the web version of this article.)

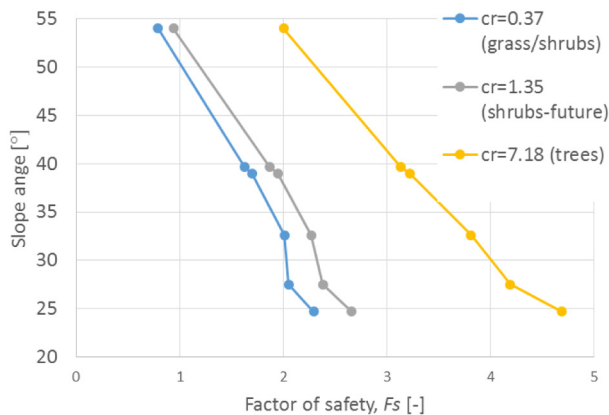
Fig. 11. Relationship between calculated F_s and potential slope angle, depending on the level of additional root reinforcement.

The observed hydrological responses together with slope stability analysis suggest that investigated vegetated buffer zones give mostly a mechanical aid to bank stabilization, with the hydrologic effects considered as less important. Slope stability depends on the differences between GWL and WL_{stream} and hydrological effects should be visible in lowering of GWL . In our case, the trees plot showed the most stable stream bank conditions (Fig. 8), even with the higher groundwater levels, as a result of simulated high root reinforcement (Table 4). Every 0.8 kPa of additional root cohesion (difference between $c_{r,grass} = 0.37$ kPa and $c_{r,shrubs-future} = 1.35$ kPa) can compensate between 20 cm (in case of slopes with 54.0° inclination) and 25 cm (in case of slopes with 24.7°) of GWL increase (Fig. 10). Moreover, Additional cohesion from the roots compensates the slope inclination and

the level of the compensation differ depending on the reference slope angle (Fig. 11).
