Bioforsk Report

Vol. 5 No. 128 2010

Some Characteristics of the Vansjø-Hobøl (Morsa) Catchment

Eva Skarbøvik and Marianne Bechmann

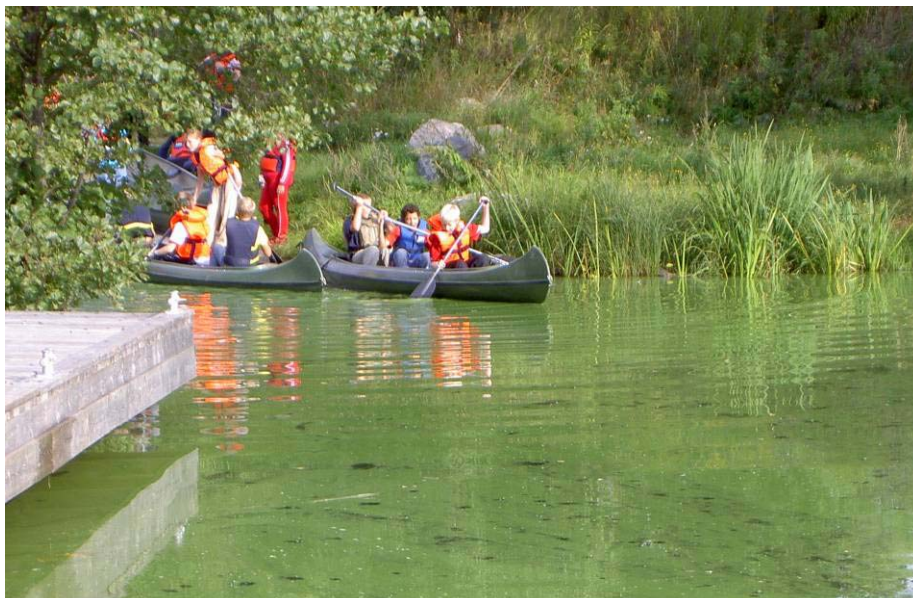
Figure 1. Lake Vansjø has many user interests - the lake is amongst others used for boating and recreation. Harmful algal blooms the latter years have resulted in less attractive conditions, as in 2005 when this photo was taken from the River Mosseelva. Photo: Eva Skarbøvik.

The Vansjø-Hobøl or Morsa Catchment is an important catchment for many reasons. It is one of the catchments in Norway most affected by agricultural runoff and therefore also eutrophication and harmful algal blooms; it has been a pilot catchment in the implementation of the EU Water Framework Directive (WFD); and it has a number of different user interests (Figure 1).

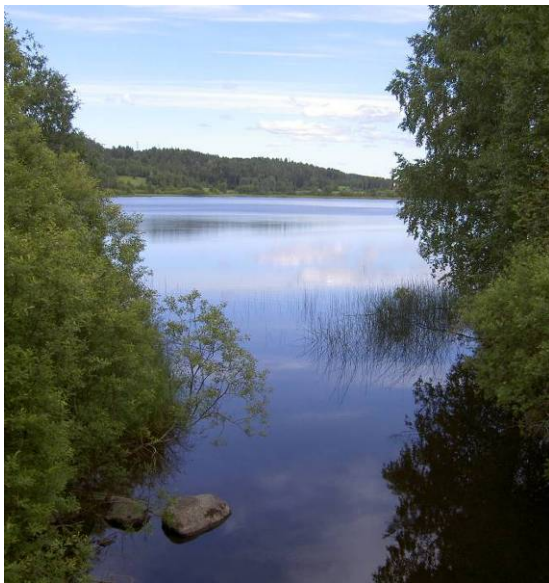
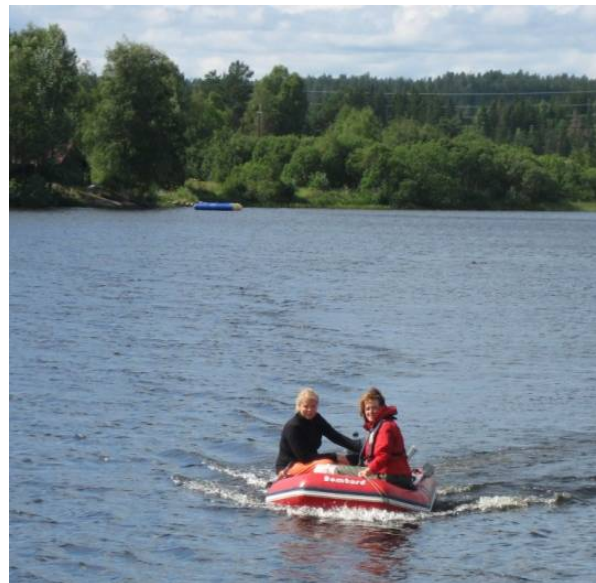
Figure 4. Two of the upstream lakes, Lake Mjær (left; photo E. Skarbøvik) and Lake Våg (right, photo: NIVA).

The main river in this catchment starts in the northern part of the drainage area and runs through forested areas. Downstream of Lake Mjær (Figure 4) the river is called the Hobølelva River. Downstream of Lake Mjær large parts of the catchment area is used for agriculture, and River Hobølelva is here meandering through clay-rich soils. In addition to agricultural runoff, the erosion of the river banks results in a marked increase in both suspended sediment and nutrient loads (the marine clay is rich in the phosphorus-rich mineral apatite). The tributary River Kråkstadelva joins the main river some 12 km downstream of Mjær. River Kråkstadelva is also draining agricultural fields and its waters carries sediments and nutrients that are added to the main river. River Hobølelva then runs through two waterfalls, one at Høgfoss where there is a mill and a hydrological water gauge, and one at Kure where there is a monitoring station for water quality. River Hobølelva drains into Lake Vansjø at a delta and wetland area called Mosseros.

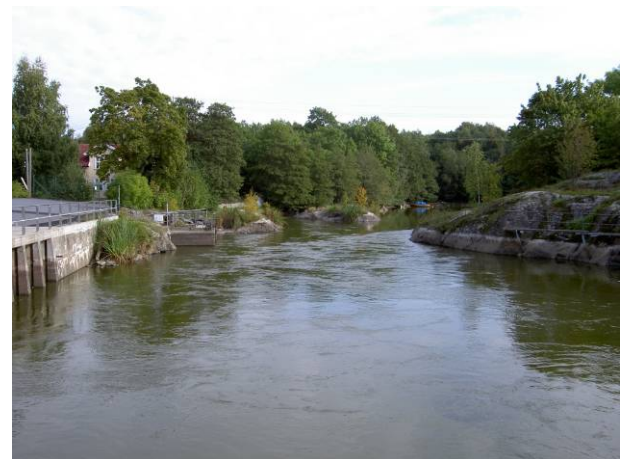
Figure 5. In addition to a hydrological station in River Hobølelva at Høgfoss, there is a water discharge station at Moss Dam (above) and a hydrological station has recently been installed in the Guthus Creek (left). There are also water level gauges in the lakes, in Lake Vansjø at Rødsund Bridge. Photos: E. Skarbøvik.

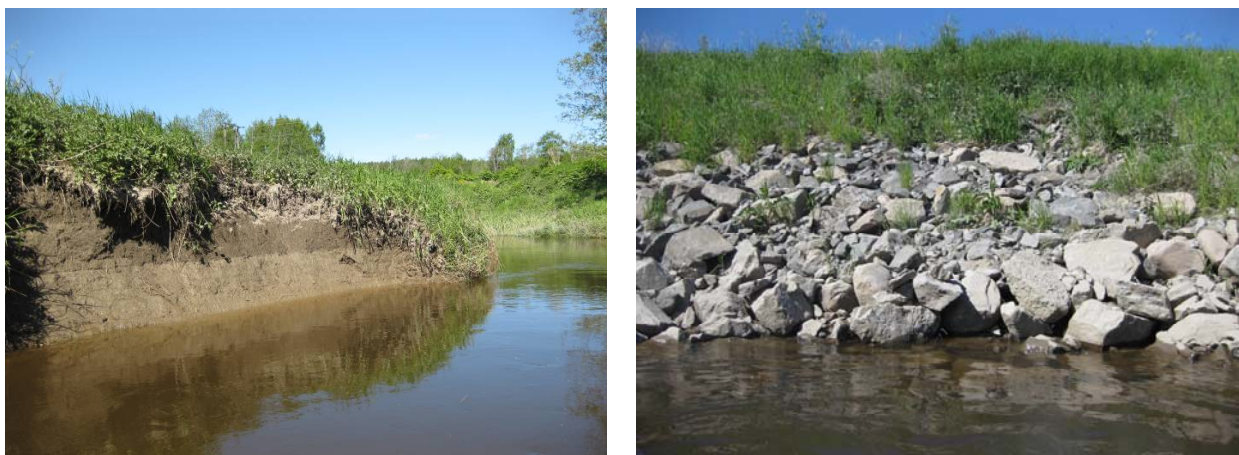
Figure 8. The erosion in River Hobølrelva is rather large (left) and erosion protection works have therefore been implemented in 2010 (right). Photos: E. Skarbøvik.

Some erosion protection works are presently ongoing in Hobølrelva downstream of Lake Mjær (Figure 8).

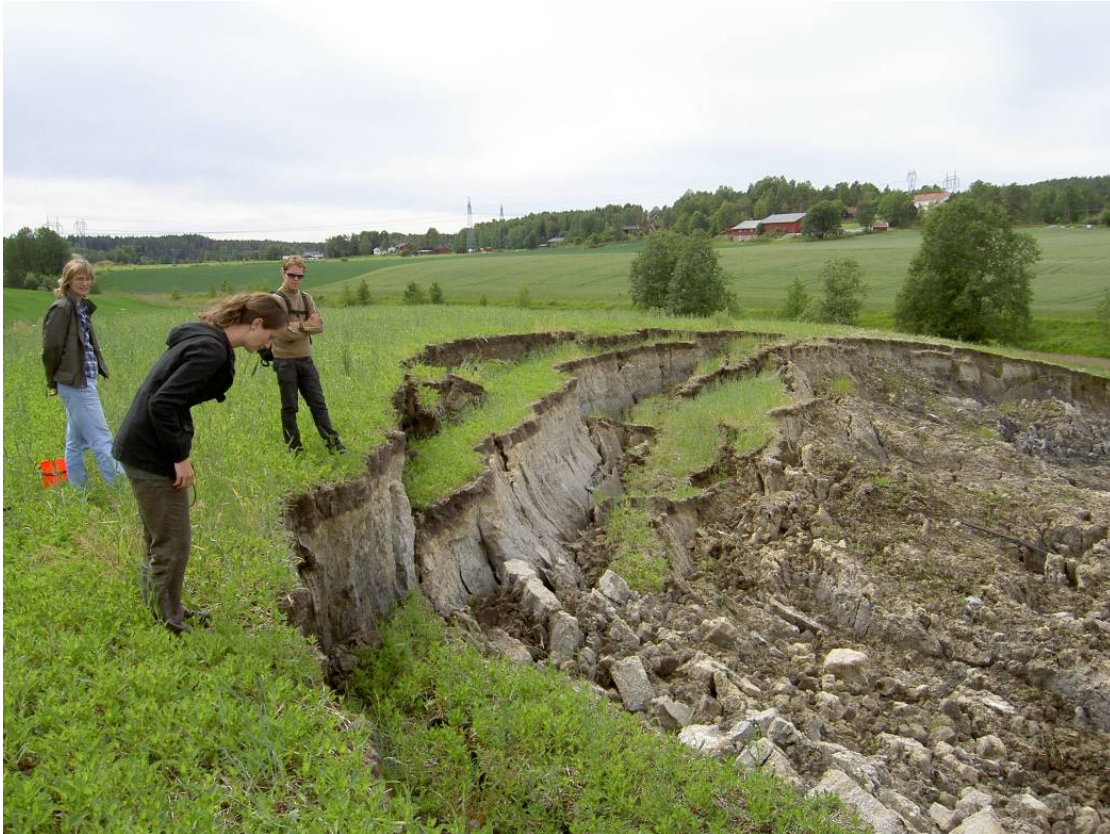
Figure 10. A clay avalanche in 2008 removed soil from a field and into River Hobølelva, not far from its outlet in Lake Vansjø's eastern basin. Photo: E. Skarbøvik.

Diffuse pollution usually increases in years with heavy rains and high water discharges. In the last years, clay avalanches have contributed significantly to increased suspended sediments and phosphorus in the river system (Figure 10).

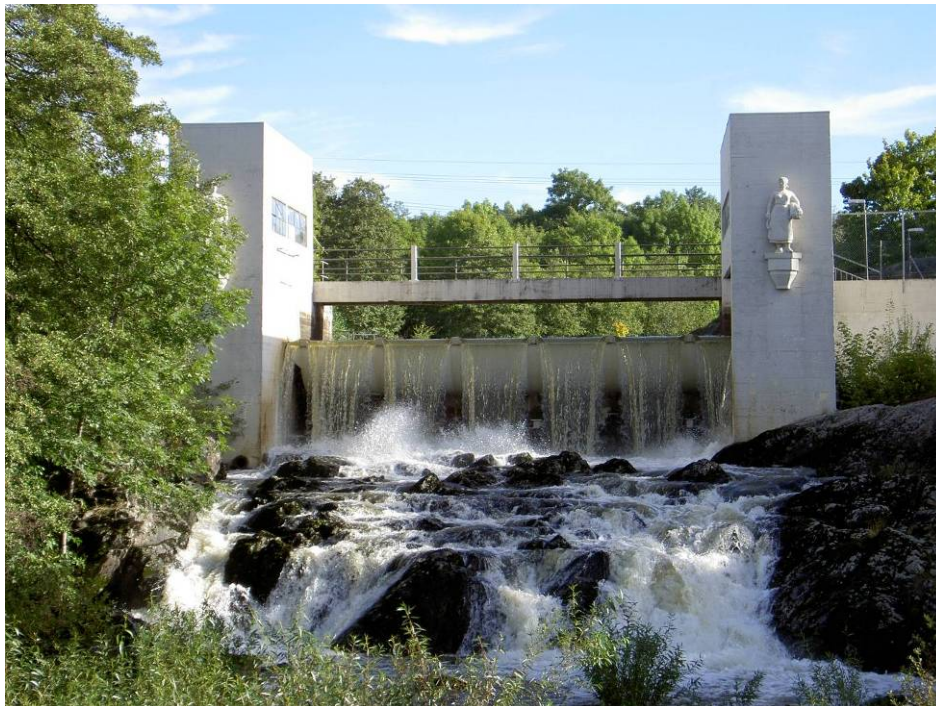
Figure 11. The dam at Moss in 2005, during an experiment where water was released from the dam in order to assess impacts on lake water quality. Photo: E. Skarbøvik.

Environmental concerns in terms of algal blooms have led to questions as to whether or not a change in the operation regulations of Moss dam could improve the water quality of the lake. Temporary permission to change the operation routines were given by NVE (the Norwegian Water Resources and Energy Directorate) in order to be able to carry out investigations. The results are presented in several reports (Skarbøvik et al. 2005, 2006, 2007b, Skarbøvik 2008, Skarbøvik and Rohrlack 2009); a final report will be produced in 2011. The two main options are to keep water levels as high as possible during summertime in order to dilute the nutrients as much as possible; or to maintain a stream of water through the dam at Moss. The latter seems to be beneficial for the water quality in the lower parts of the catchment, based on preliminary results from the investigations. Figure 11 shows Moss dam during a relatively substantial release of water from Lake Vansjø in 2005; the release was followed up with investigations on water quality before and after.

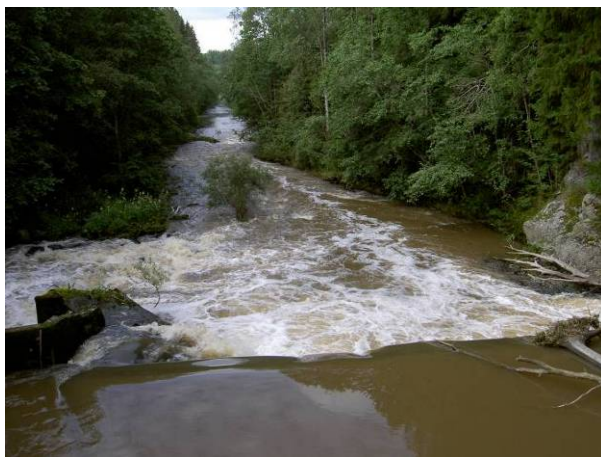
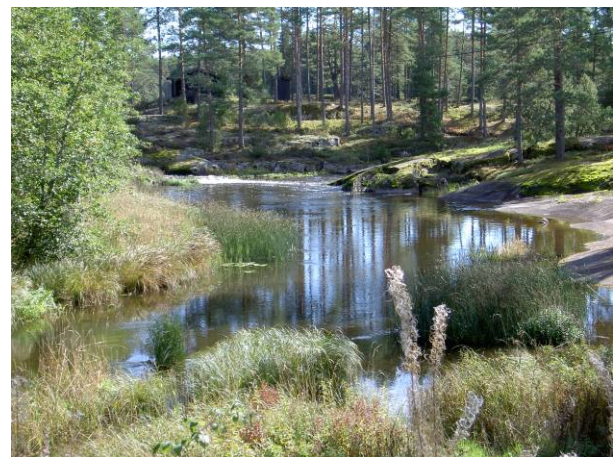
Figure 14. Two of the tributaries to the eastern basin, or Storefjorden. To the left, River Hobølelva at the Kure waterfall during a flood in summer 2007, to the right River Svinna at the bridge of Klypen, during summer 2006. Photos: E. Skarbøvik.

Average concentrations of sediments, nutrients and bacteria are shown in Table 8. The variations are relatively large from station to station. In the creeks, total phosphorus (TP) concentrations are especially high in the Støa and Huggenes Creeks; whereas the rivers with the highest TP levels are River Kråkstadelva and River Veidalselva. Total nitrogen levels are usually high at stations that also have high TP levels. Coliform bacteria are most abundant in River Hobølrelva at Kure (Figure 14), in River Kråkstadelva, and in the creeks Ørejordet, Årvold and Guthus.

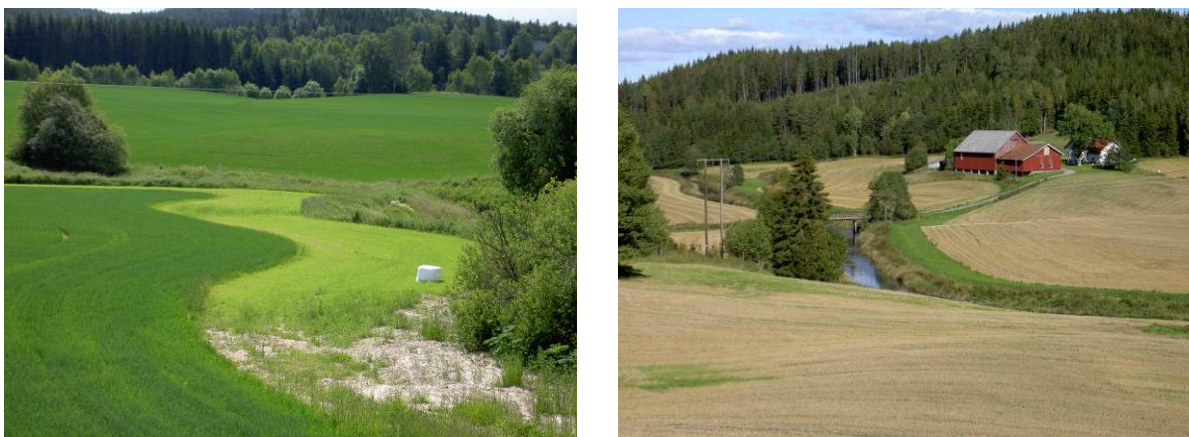
Figure 17. Buffer zones in the catchment of Vansjø-Hobøl. Photos: E. Skarbøvik.

Buffer zones have been established amongst others in the eastern part of the basin. Along e.g. River Hobølleva and Kråkstadelva, there is now commercial grass production in these zones, and only nitrogen is applied as fertiliser. The zones are intended to stop the surface runoff from the fields to the rivers, and may also protect against river bank erosion depending on vegetation used. The effect of buffer zones on nutrient and suspended sediment concentrations in surface water has been evaluated for Norwegian conditions by Syversen (2002). Figure 17 shows two examples of buffer zones in the eastern part of the catchment.
