Plant selection for roadside rain gardens in cold climates using real-scale studies of thirty-one herbaceous perennials

Kirstine Laukli ^{a,c,*}, Hilde Vinje ^b, Trond Knapp Haraldsen ^d, Eva Vike ^a

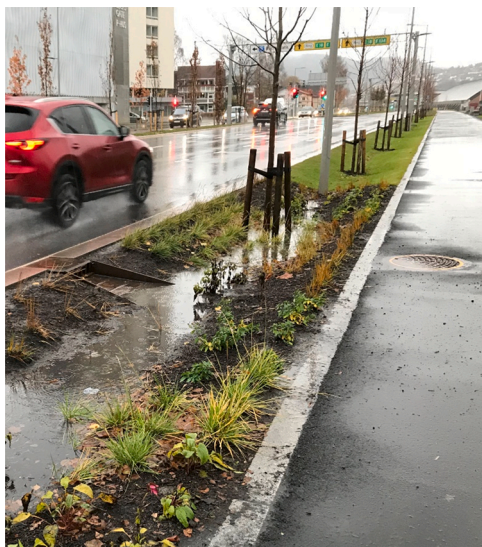
Fig. 2. A rain garden (RG 1) with a drain that directs surface water from the road into the rain gardens during the growing season. In winter, the road water is directed away from the rain gardens to prevent the influx of de-icing salt. The trees are growing in tree planters (not visible on the surface). Photo: Kirstine Laukli.

The rain gardens were planted with trees with approximately 9-m spacing (Fig. 2), and perennials, as described in 2.2 were established as a groundcover. Each tree was placed in a 4-m-long tree planter in contact with the underground. A structure was built up between each tree planter, as shown in Fig. 3. All groundcover plants were part of the study, both in the tree planters and in between. The growth media consisted of two layers of rain garden soil, as shown in Fig. 3, and a 5–10 cm thick layer of garden/park waste compost as a mulch, as described by Laukli et al. (2022). Both types of rain garden soil had a medium sand texture [1–3 % clay, 4–8 % silt, 40–43 % fine sand (0.06–0.2 mm), 39–46 % medium sand (0.2–0.6 mm), and 6–12 % coarse sand (0.6–2.0 mm)]. In the raingarden topsoil, compost and

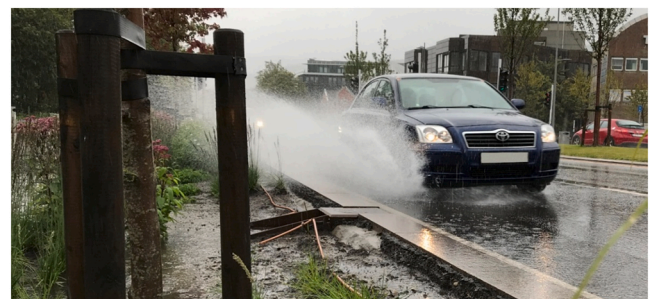
Fig. 4. Splashes from the road in rain garden 1 (RG 1), Bjørnstjerne Bjørnsons Street, Drammen, Norway. Photo: Kirstine Laukli.

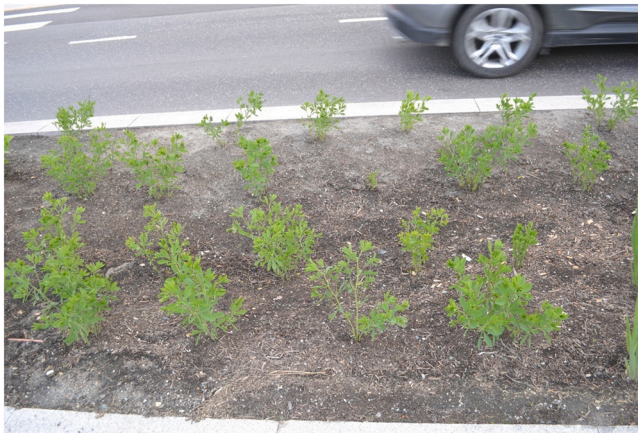
Fig. 5. Grey road dust deposited upon the compost layer is clearly visible, particularly on the roadway side of the rain garden. Photo: Trond Knapp Haraldsen.

After the first winter, a crust layer of road dust was found over the compost layer. The thickness of this crust varied from a few millimetres to approximately 1 cm. Three random samples were collected on 28 March 2019, the mean values of which are presented in Table 3. The compost layer was sampled from the roadway, bottom, and walkway zones of one rain garden on 12 April 2019. The compost samples were extracted down to the surface of the topsoil. Soil samples were also collected from the same rain garden as the compost samples on 26 June 2019 from the roadway, bottom, and walkway zones. When collecting soil samples, the compost layer was pushed aside, and samples of the topsoil were extracted down to a depth of 20 cm. Although no soil samples were collected from the reference field in 2019, soil from this area was collected on 30 April 2022.
