## Environmentally friendly use of timber in harbour infrastructure

NIBIO REPORT | VOL. 6 | NO. 34 | 2020

Environmentally friendly use of timber in harbour infrastructure/ Miljøvennlig bruk av tre i havneinfrastruktur

Moss Havn KF

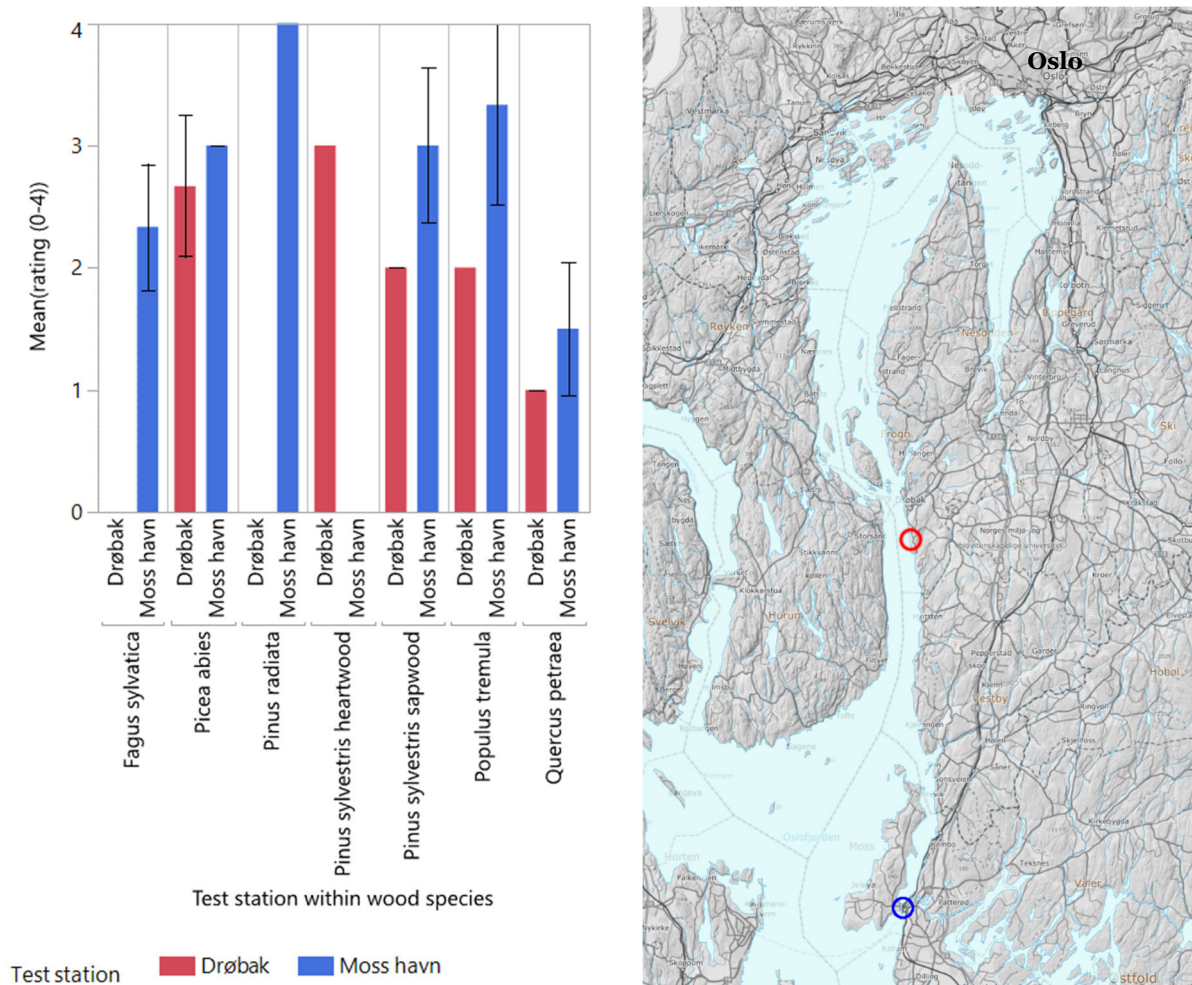
The data from the Drøbak test site are used to compare and illustrate the activity of wood borers in Moss harbour. Untreated wood samples showed generally heavy attack and untreated radiata pine wood samples even failed during the exposure (see Figure 5). Experience from the Drøbak test site in 2018 revealed a slightly lower attack rate in 2019. A description of the different rating classifications can be seen in Figure 10.

Figure 5. Attack rating after 4 months of wood borer attack (Shipworm) in untreated wood species in Moss harbour and Drøbak (left) and overview of the test site area (right); the exposed untreated wood material was beech (*Fagus sylvatica*), spruce (*Picea abies*), radiata pine (*Pinus radiata*), Scots pine heartwood and sapwood (*Pinus sylvestris*), aspen (*Populus tremula*), and sessile oak (*Quercus petraea*)

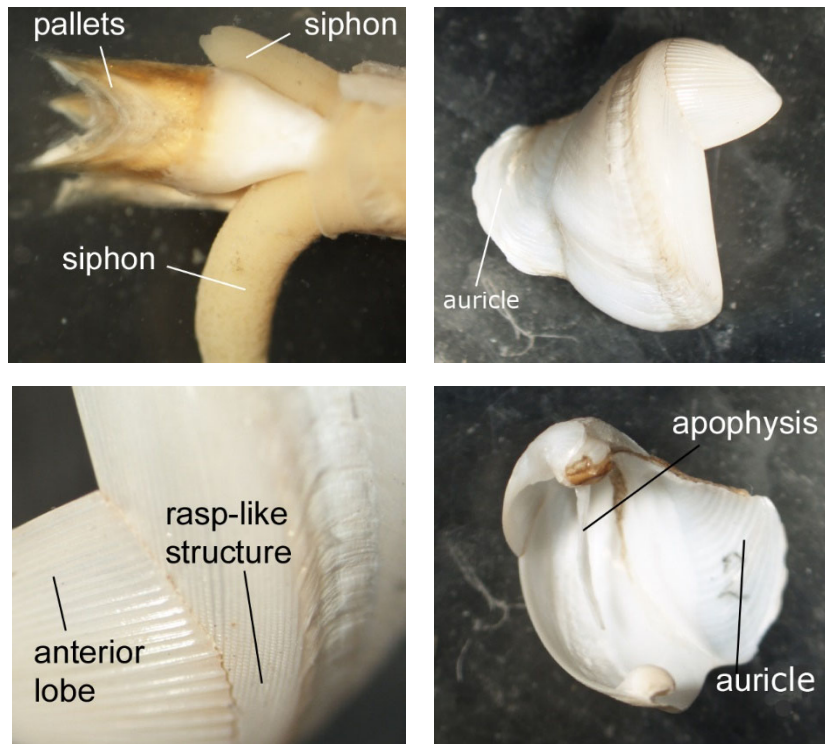
**Figure 7.** Identification features of pallets and shell valves on *T. navalis*; forked pallets and siphons (upper photo, left); interior shell with auricle (upper photo, right); exterior shell with rasp-like structure (lower photo, left); interior shell with apophysis (lower photo, right); Photo Kathe Rose Jensen (source: European Network on Invasive Alien species).

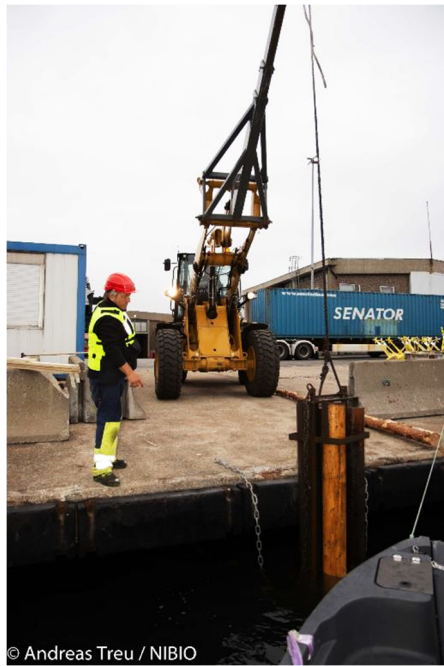
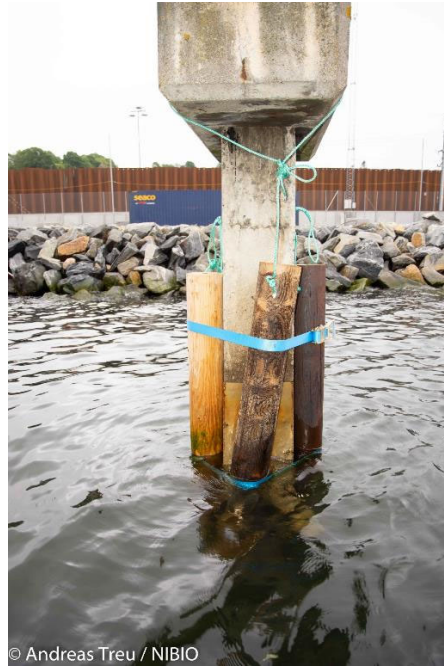
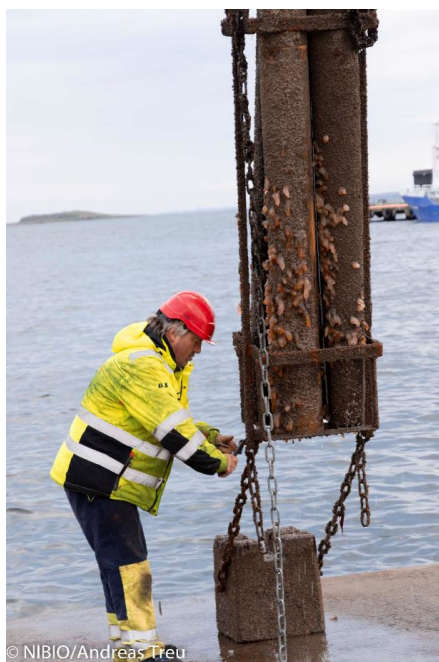
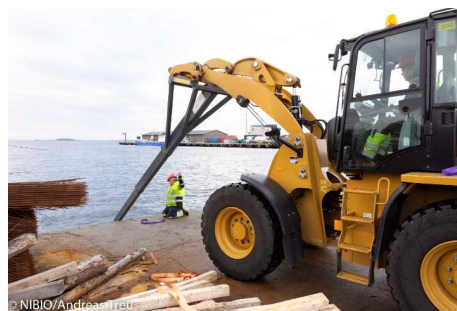
**Figure 13.** Exposure of wood poles in Moss harbour at four test sites; Three treatments (creosote, satric, WOPAS) and one untreated pole were exposed per site. The samples were tied to existing poles (upper right) or exposed using retainers (left, upper and lower)

The untreated poles showed heavy attack in the sapwood zone after four months of exposure, Figure 14. The treated poles performed well and showed no attack except for samples treated with creosote, where shipworm has entered the untreated heartwood zone from the lower unprotected transverse side of the pole (Figure 14).

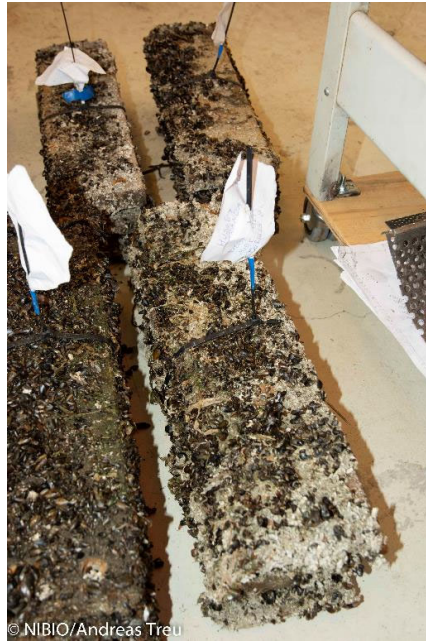
Figure 16. Wooden steps after 4 month in the Oslofjord

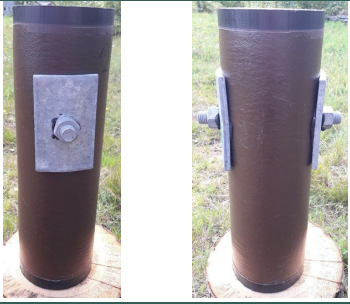
<p>No water uptake</p>
<p>French bolt (10 mm), fitted with round washer. Pre-drilled with 7 mm drill. Threaded mastic between disc and plastic sheath.</p>
