Sampling for wood decay analyses of cable car trestles and houses at Svalbard

Field report

NIBIO REPORT | VOL. 9 | NR. 12 | 2023

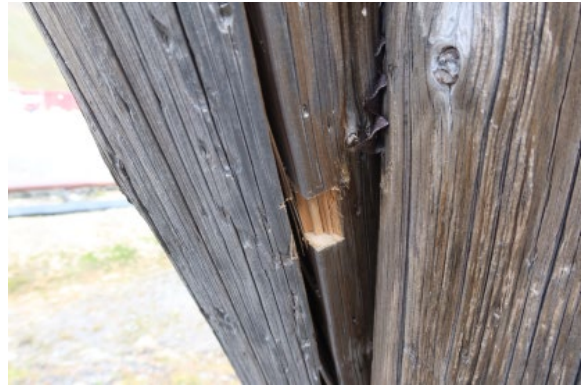
Leg NW, soil contact, before sampling

Leg NW, soil contact, after sampling

Leg NW, above ground, before sampling

Leg NW, above ground, after sampling

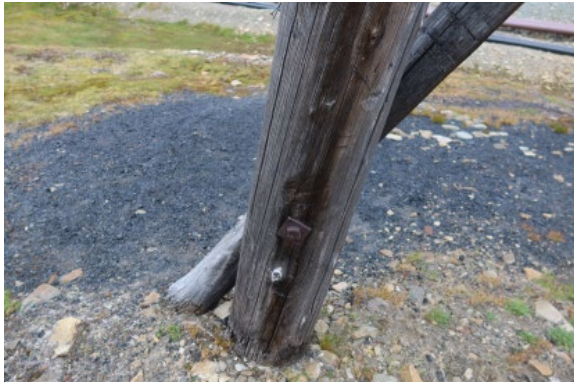
Leg SE, soil contact, before sampling

Leg SE, soil contact, after sampling

Leg SE, above ground, before sampling

Leg SE, above ground, after sampling

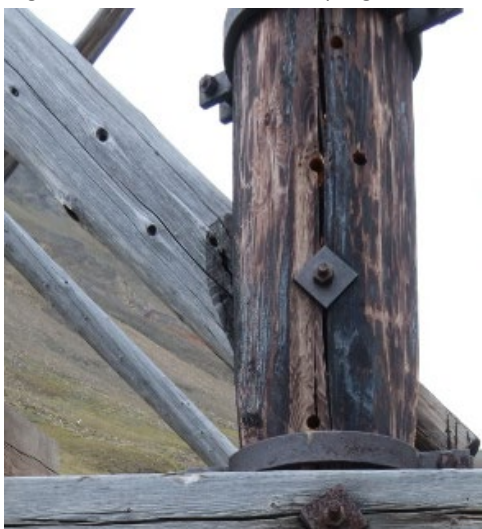
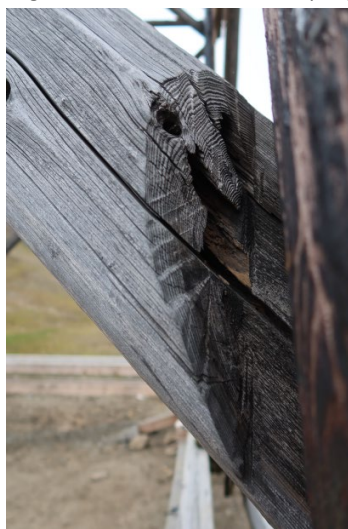
Leg NW, soil contact, before sampling

Leg NW, soil contact, after sampling

Leg NW, above ground, before sampling

Leg NW, above ground, after sampling

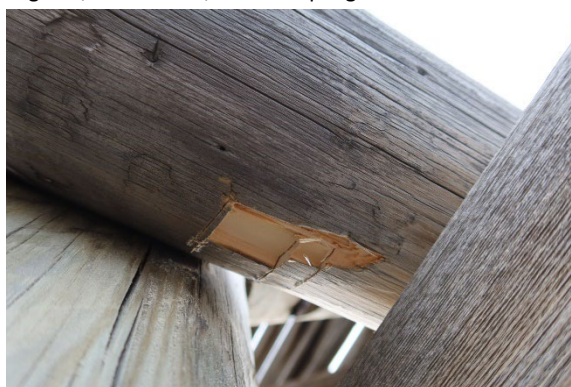
Leg NW, above ground, before sampling

Leg NW, above ground, after sampling

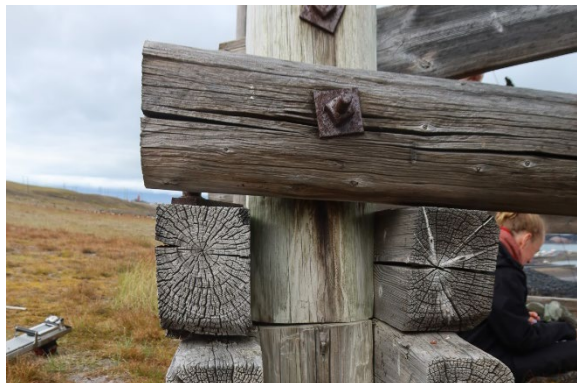
Leg SE, above ground, before sampling

Leg SE, above ground, after sampling

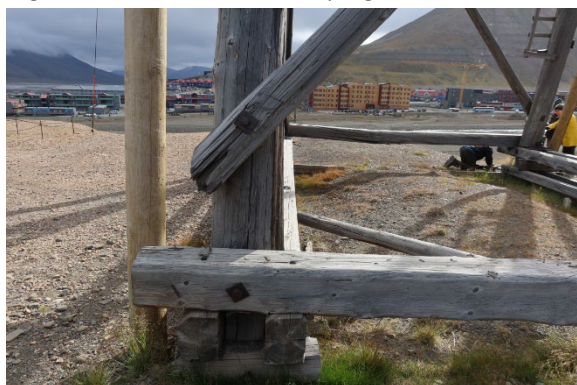
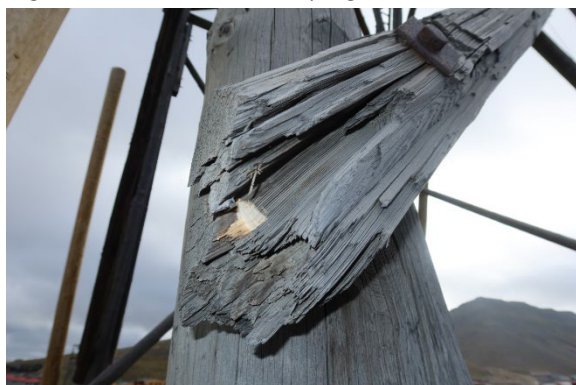
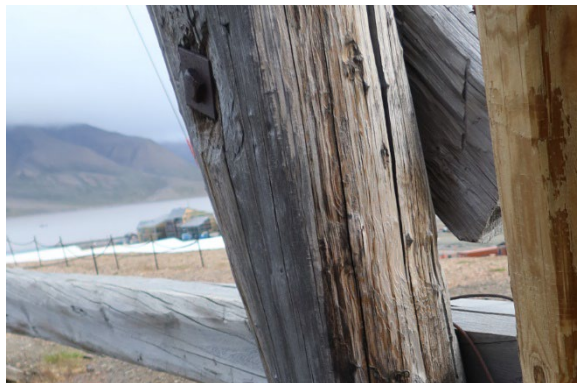
Photos before and after wood sampling

On this cable car trestle, restoration work has started, but has apparently stopped without being completed. There is no visible damage and apparently the trestle is in good condition. The trestle is very tall and stands right next to the road. It can therefore potentially pose a major danger to passers-by.

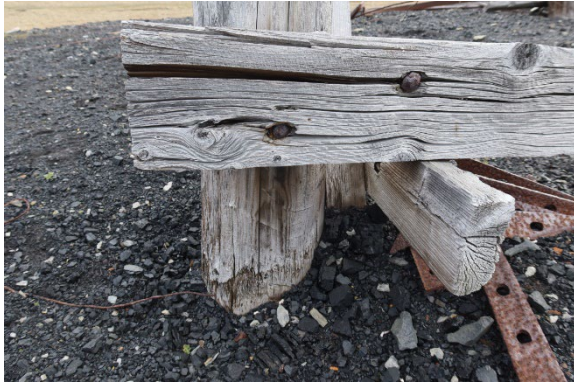
Leg NW, soil contact, before sampling

Coal deposits around the legs of the cable car trestle. The cable car trestle seems to be in relatively good condition, but signs of possible decay in two legs (NW and SW). Structures further up seems to be in good conditions. Located close to the “taubanestasjon” and probably quite frequently visited by tourists and locals who use the cabins nearby.

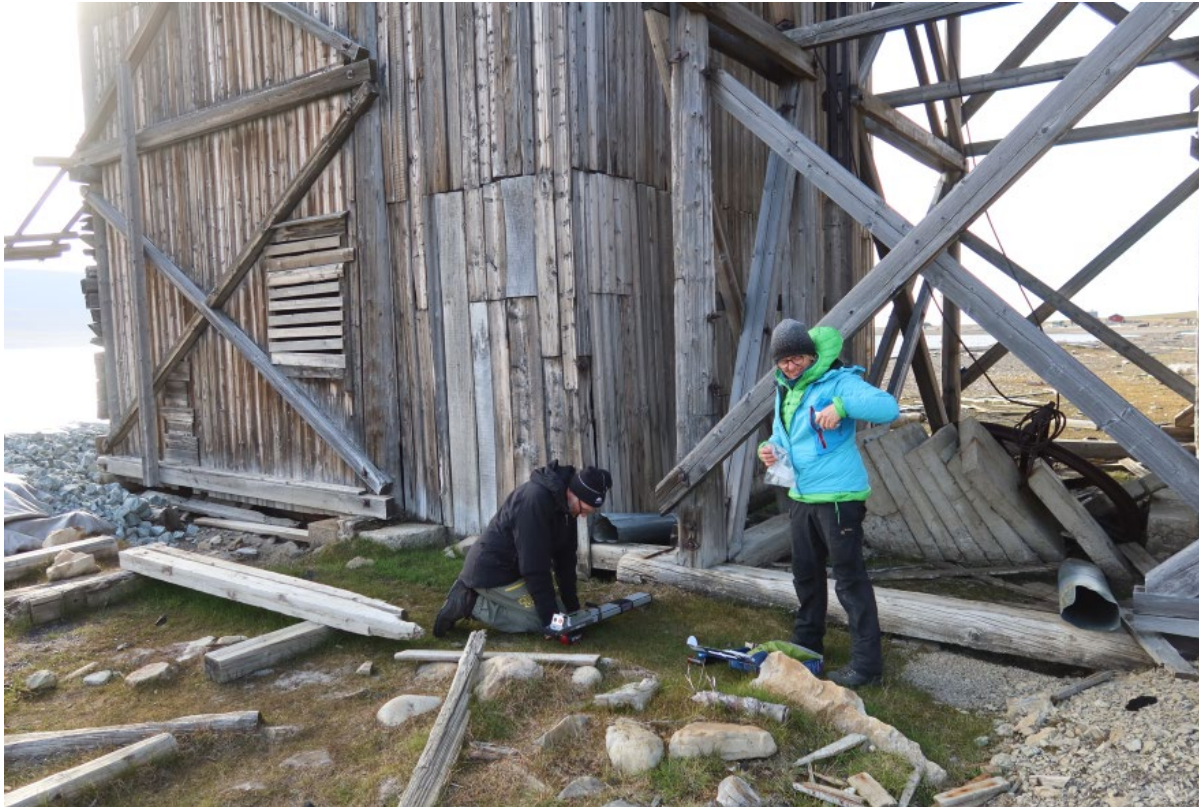
“Taubanestasjonen”, 93041-14. East side. Drilling, awl probing and sampling on beam beneath post, in the middle of the photo

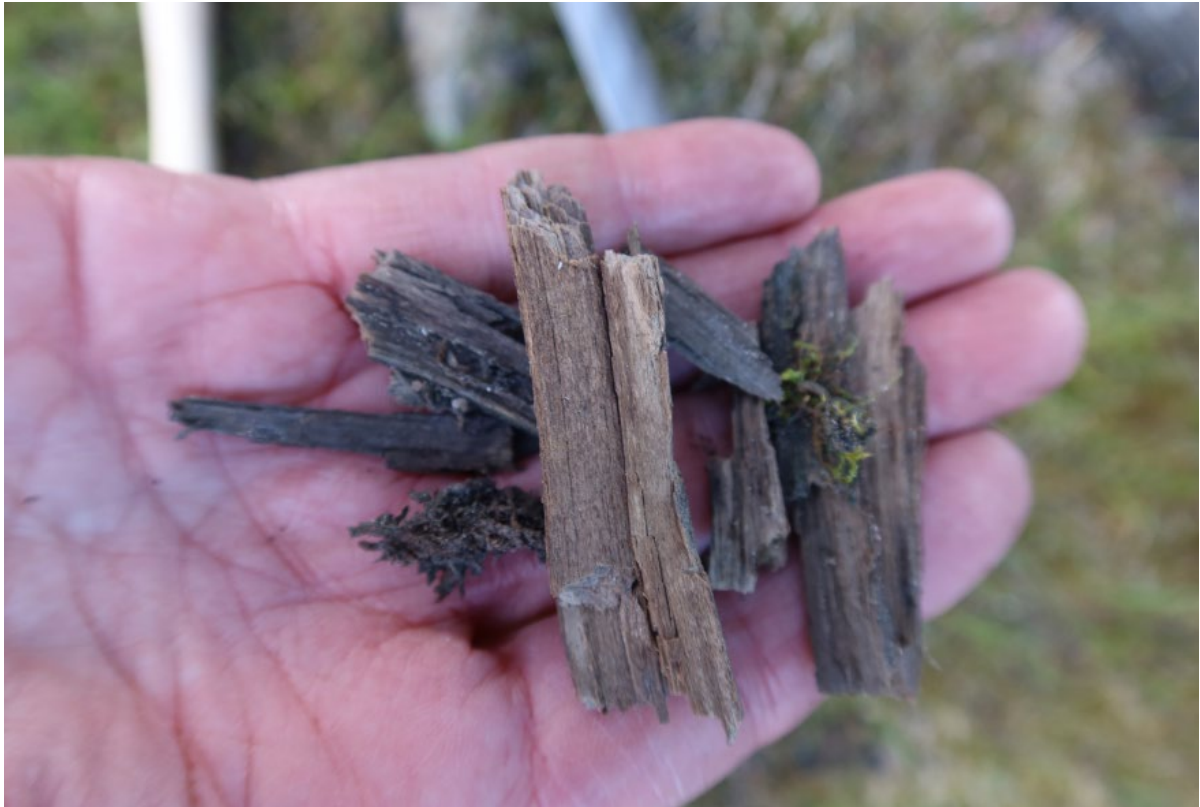
"Taubanestasjonen", 93041-14. East side. Sample taken from wood in ground contact, directly below the point of drilling

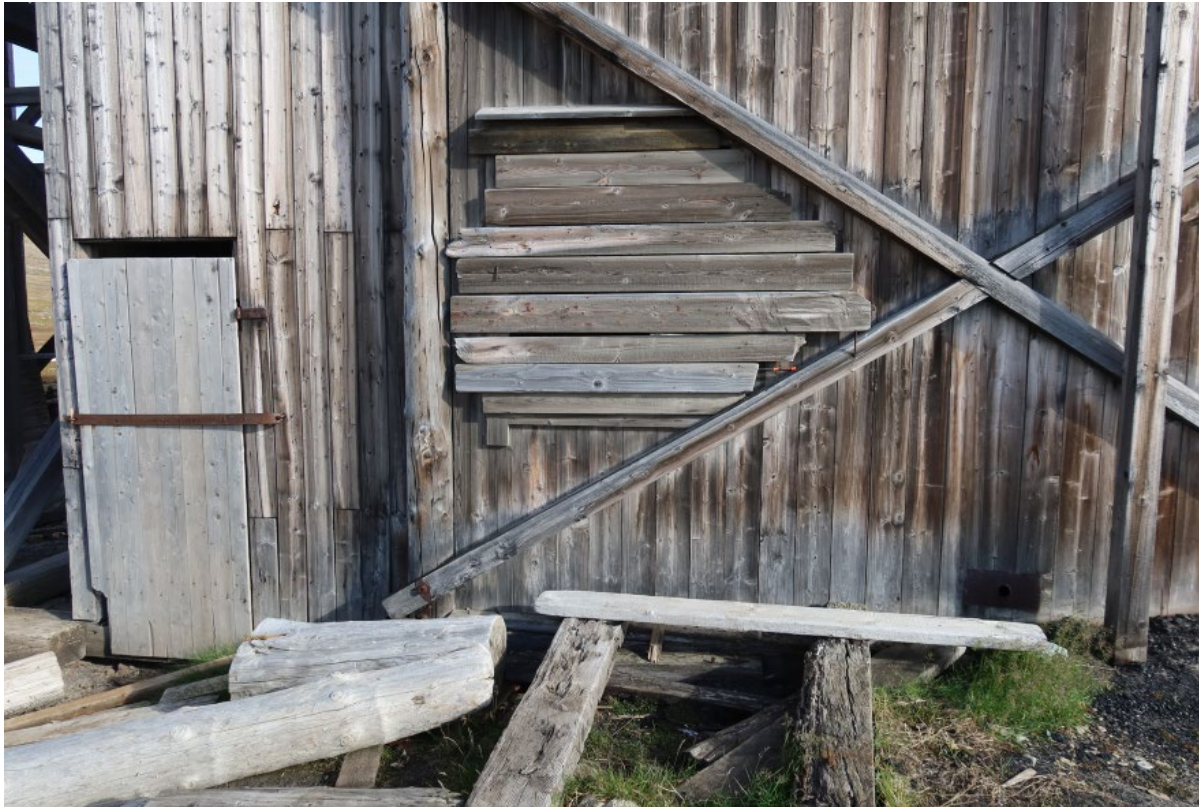
"Taubanestasjonen", 93041-14. West side, awl probing in end grain of boards covering window

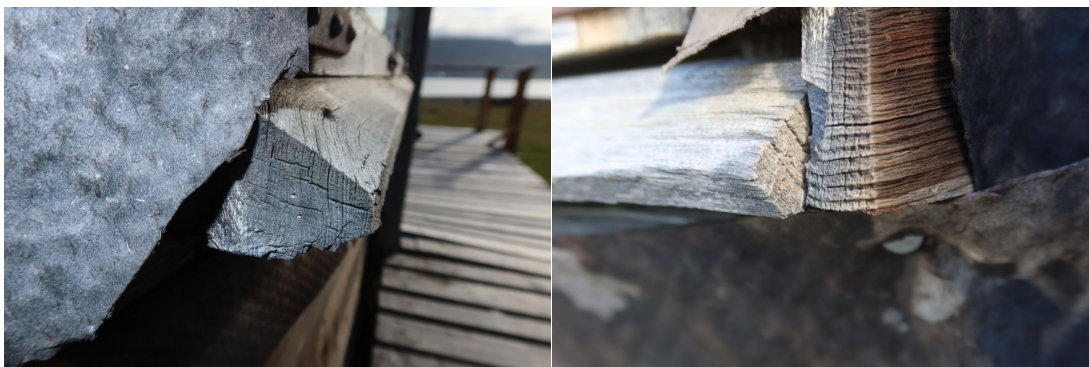
“Gamlemessa”, western facing window. Awl probing in end grain of weatherboard below window

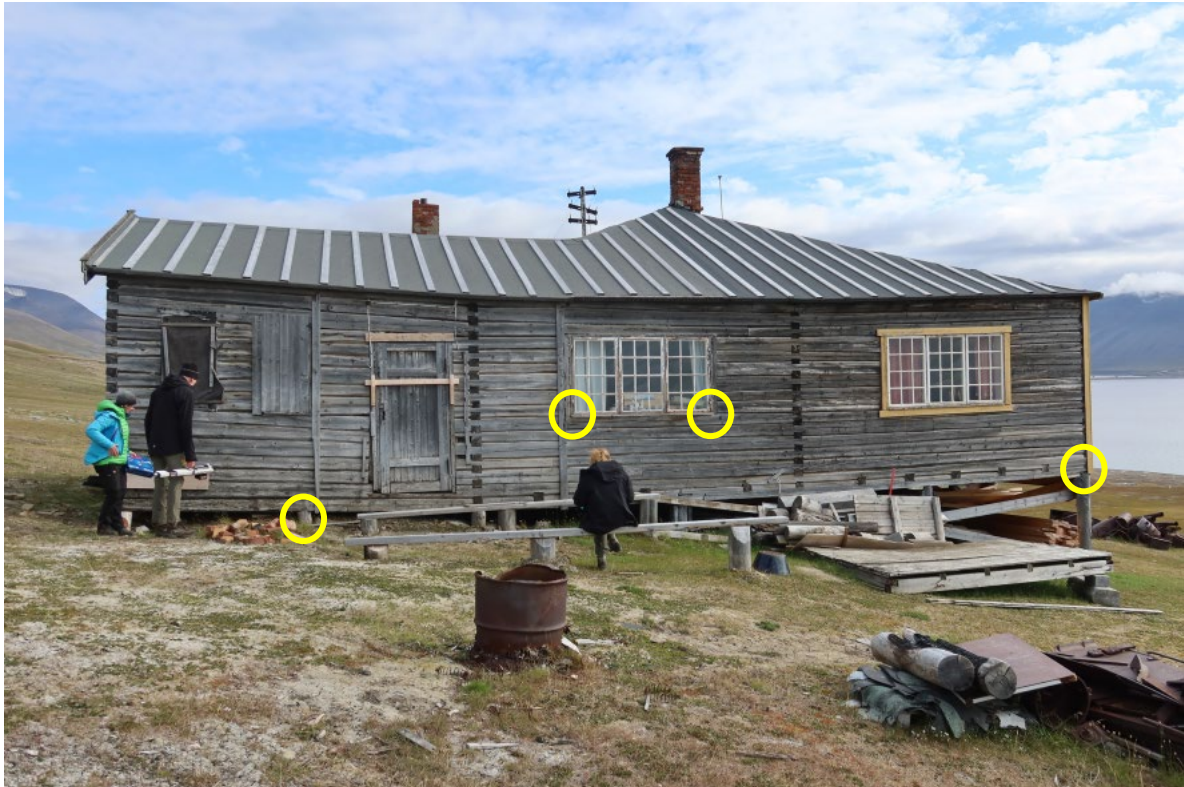
“Direktørboligen”, façade facing west. Points of sampling/drilling/awl probing indicated

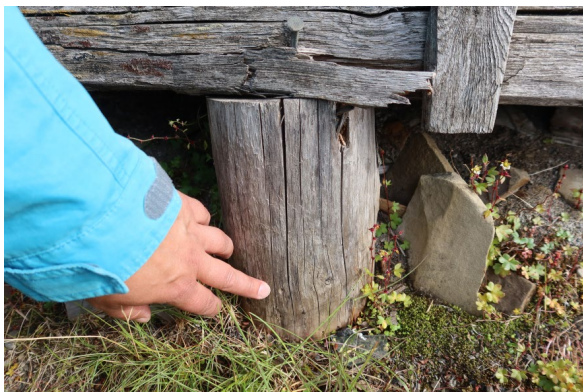
“Direktørboligen”, western facing side. Pile supporting bottom beam, before sampling. Point of drilling indicated

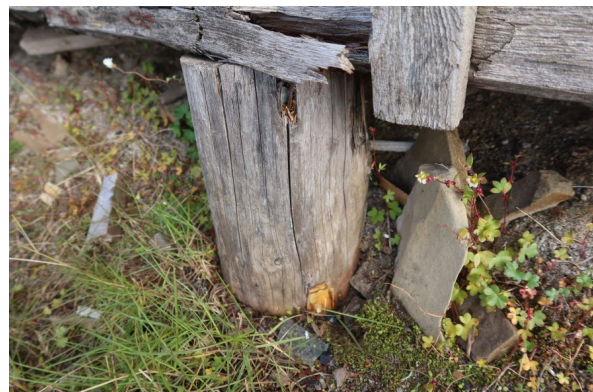
“Direktørboligen”, western facing side. Pile supporting bottom beam, after sampling

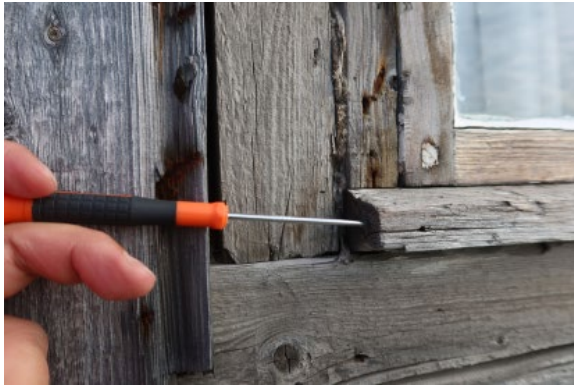
“Direktørboligen”, western facing side. Awl probing performed on end grain of weatherboard beneath main window

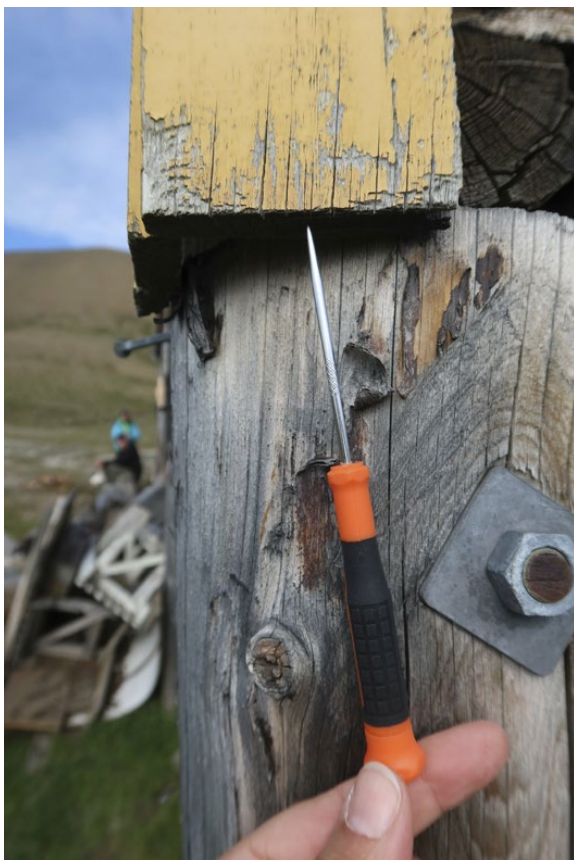
“Direktørboligen”, southwest corner. Awl probing performed on end grain of boards covering the corner

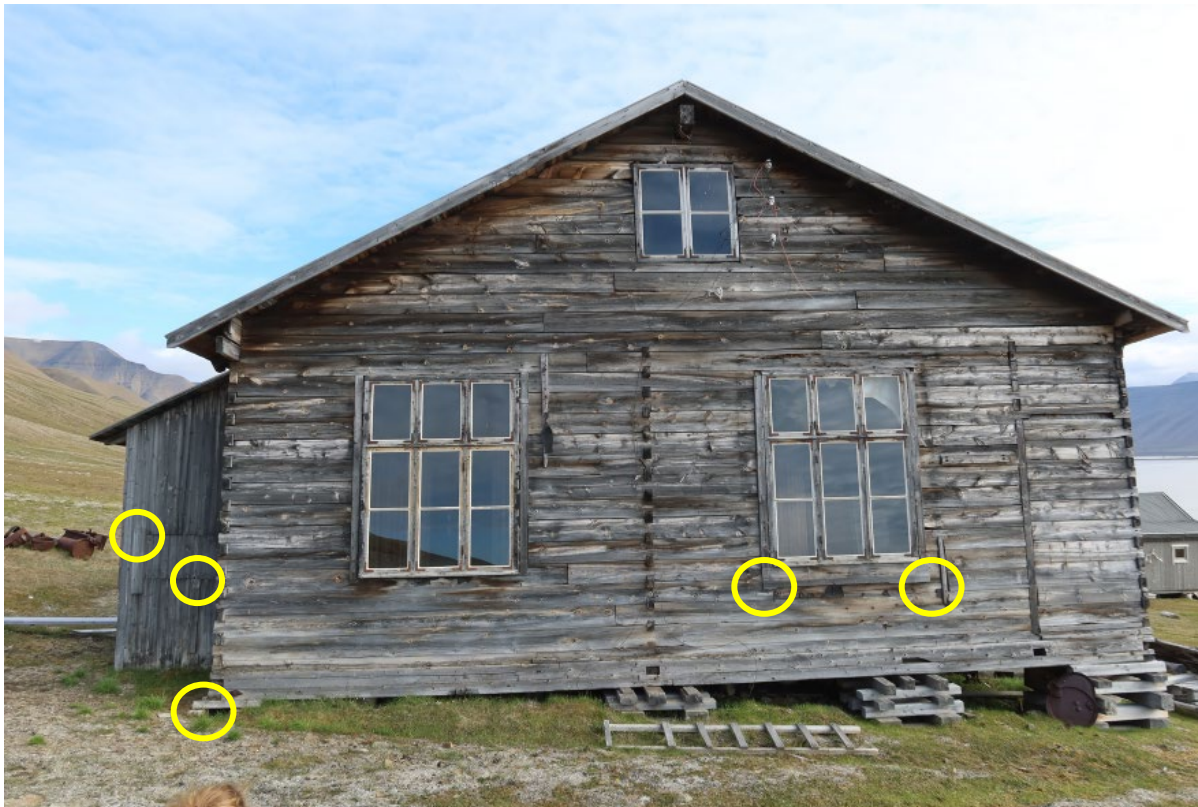
“Boligbrakke”, façade facing west. Points of sampling/drilling/awl probing indicated

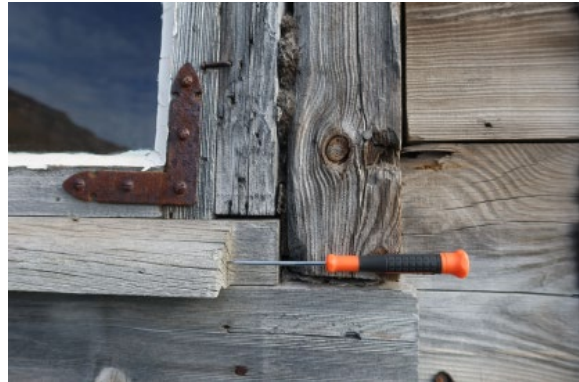
“Boligbrakke”, western facing side. Awl probing performed on end grain of weatherboard beneath southern window

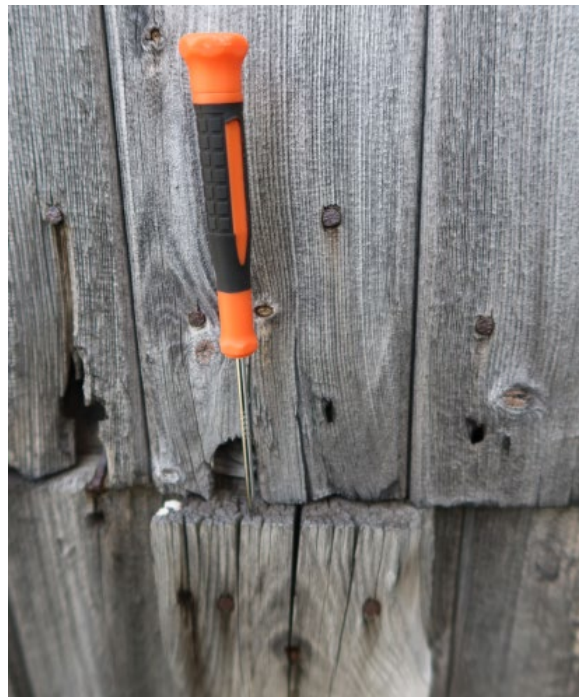
“Boligbrakke”, western facing side of covered porch. Awl probing performed on end grain of protruding board

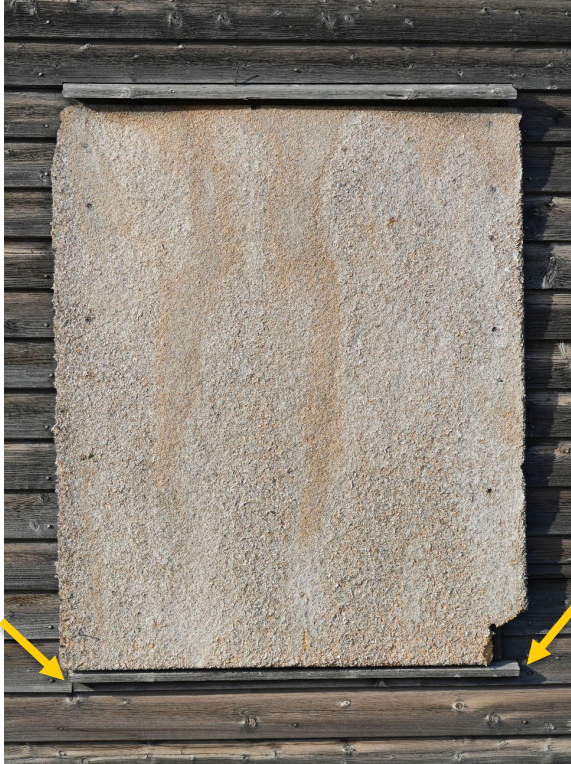
“Sætra”, south-west facing side. Awl probing performed on end grain of weatherboard beneath window.

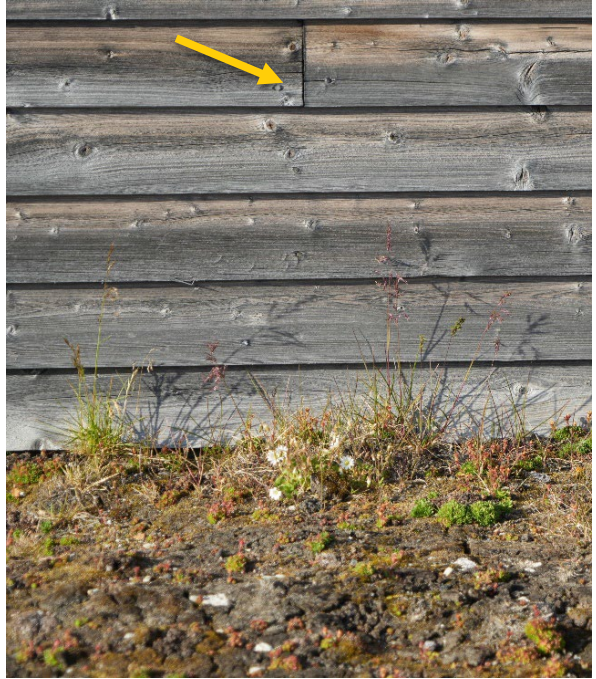
“Sætra”, south-west facing side. Awl probing performed on end grain of panel board beneath window.

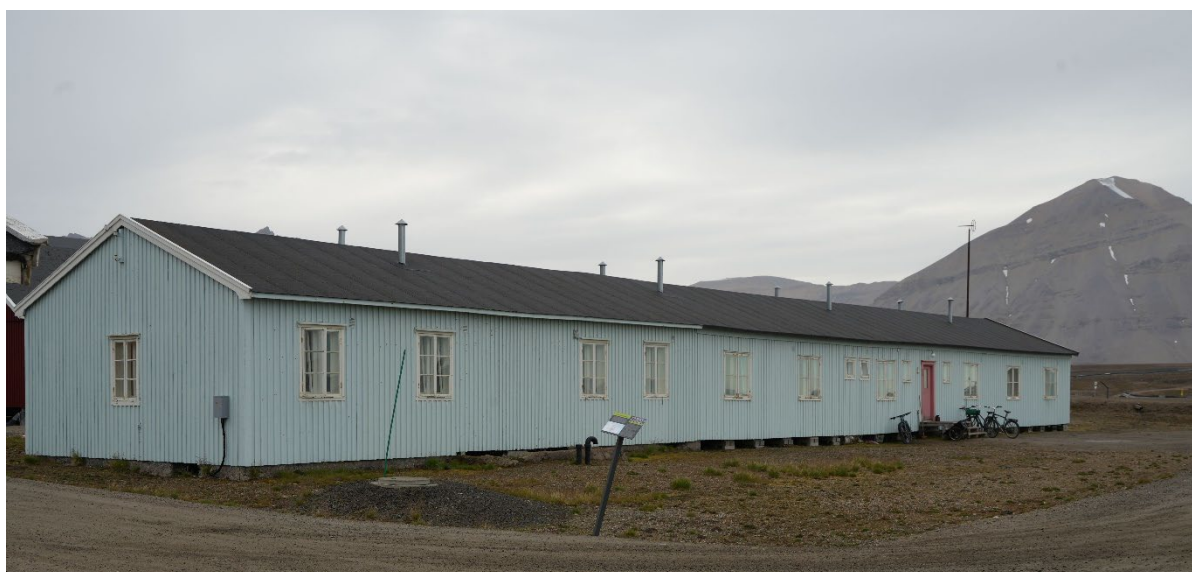
“Mexico”, façade facing north-east. Awl probing taken from the façade facing south-west.

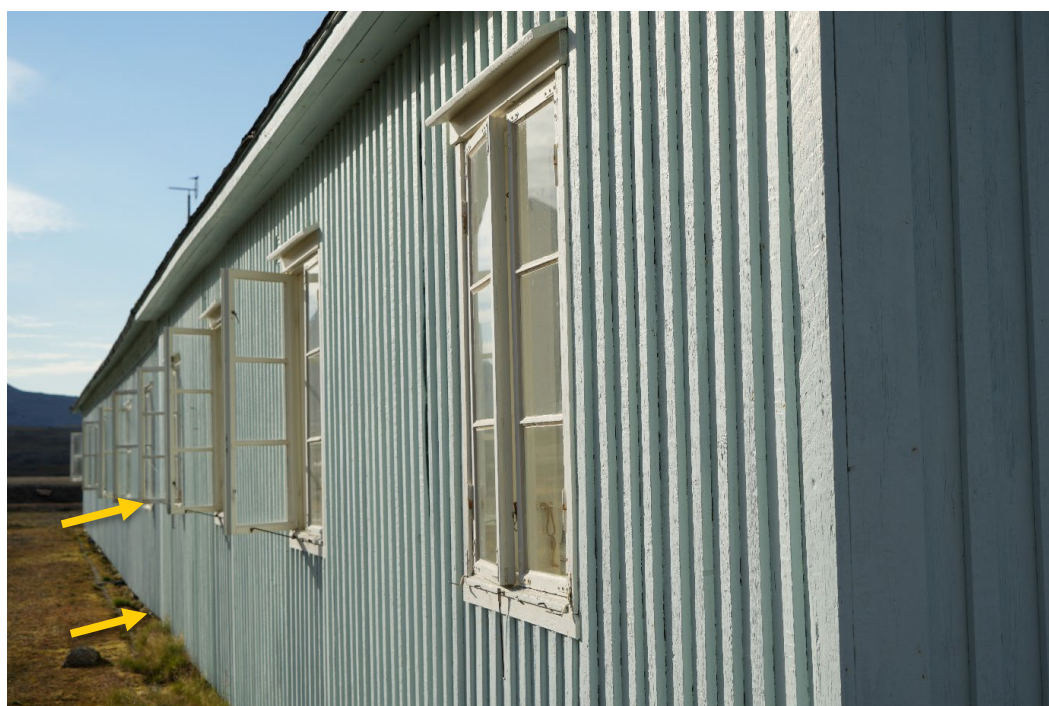
“Mexico”, façade facing south-west. Awl probing taken from window nr 4 from the corner, and from the panel underneath the window, next to the small stone.

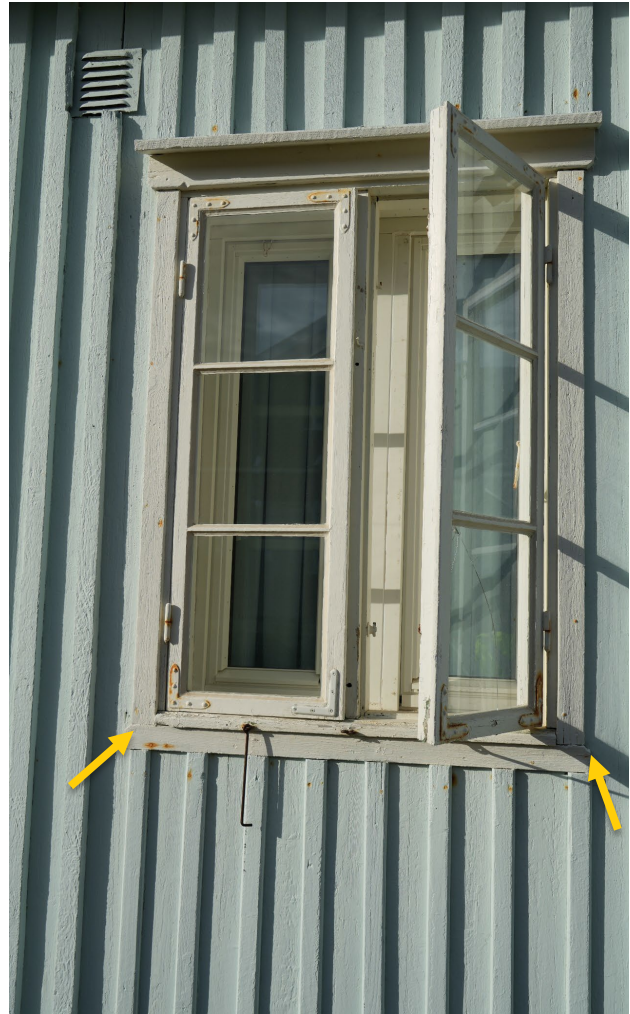
“Mexico”, façade facing south-west. Awl probing performed on end grain of weatherboard beneath window

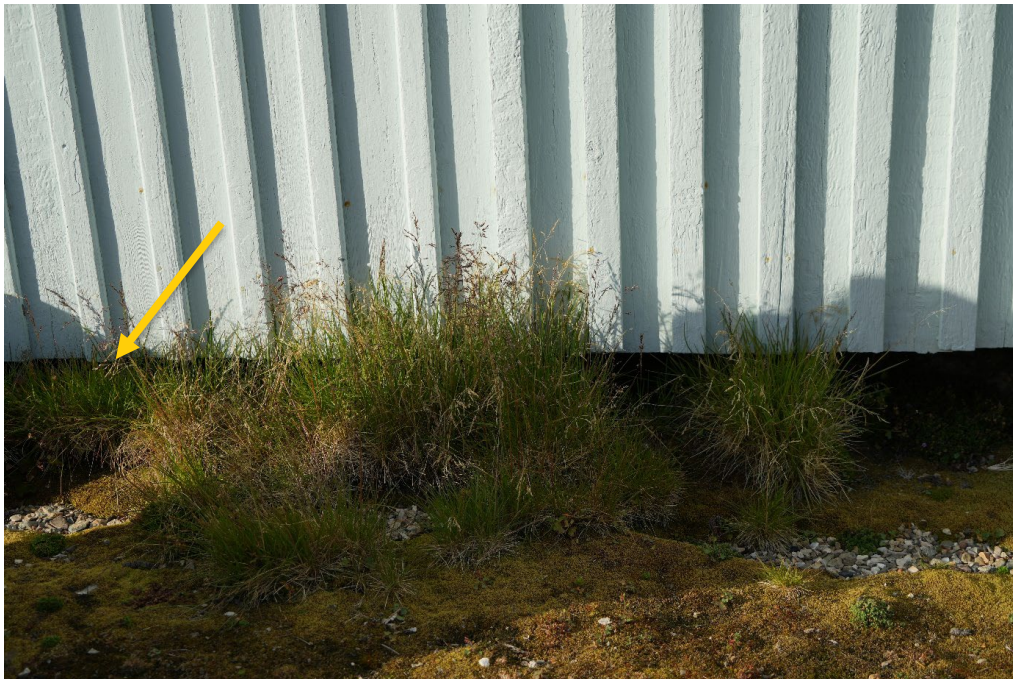
“Mexico”, façade facing south-west. Point of awl probing indicated

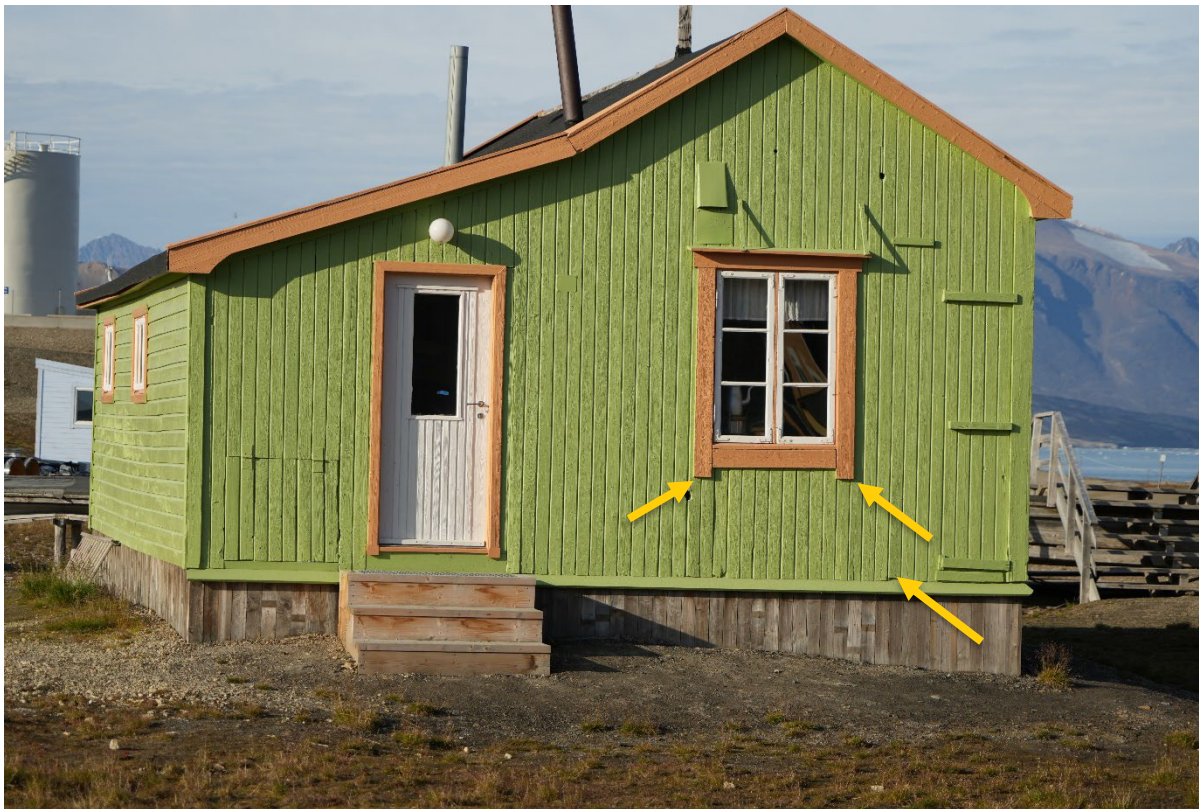
“Museumshytta”, façade facing south-west. Points of awl probing indicated

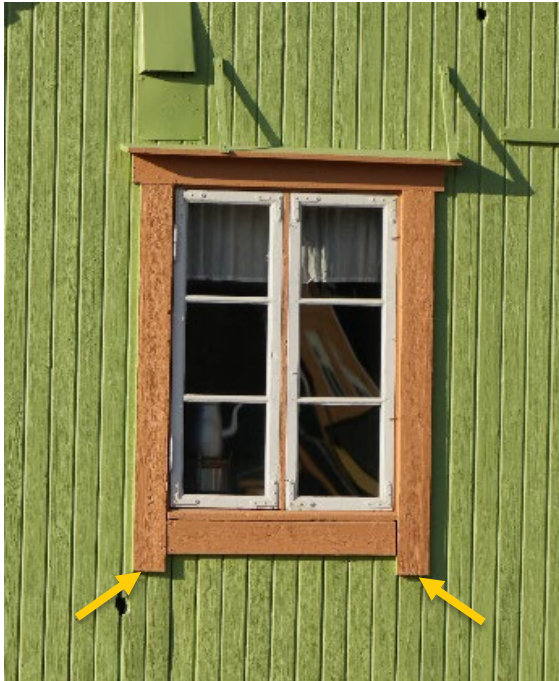
“Museumshytta”, façade facing south-west. Points of awl probing indicated. Awl probing performed on end grain of weatherboards aside window

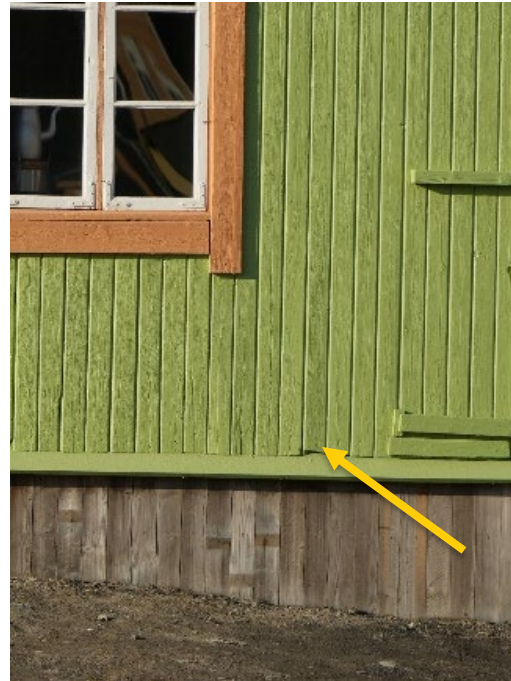
“Museumshytta”, façade facing south-west. Point of awl probing indicated

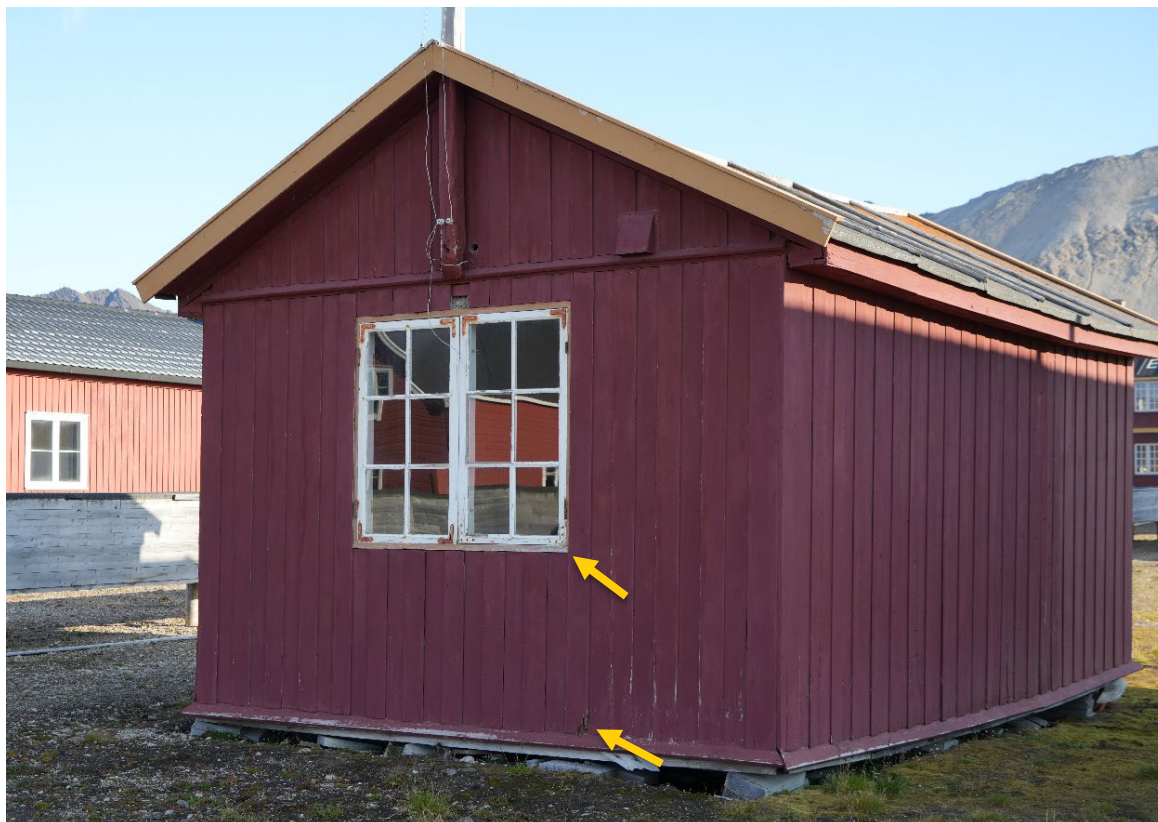
“Museum/Veteranhytta”, façade facing north-east. Only facadewith window. Points of awl probing indicated

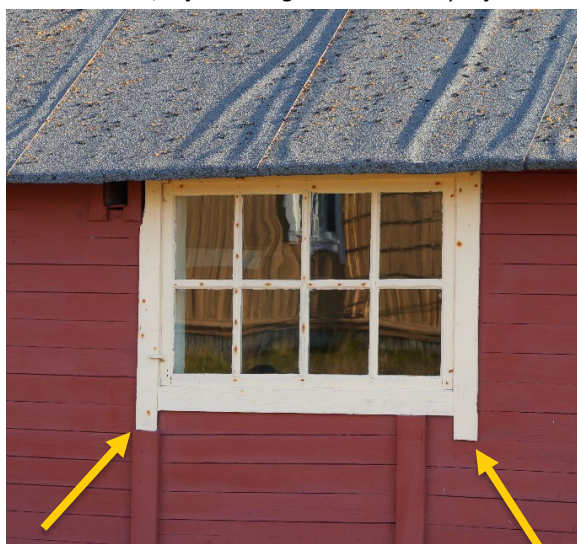
Green Harbour, window on façade facing north-east. Point of awl probing indicated. Awl probing performed on end grain towards north-west of weatherboard aside window

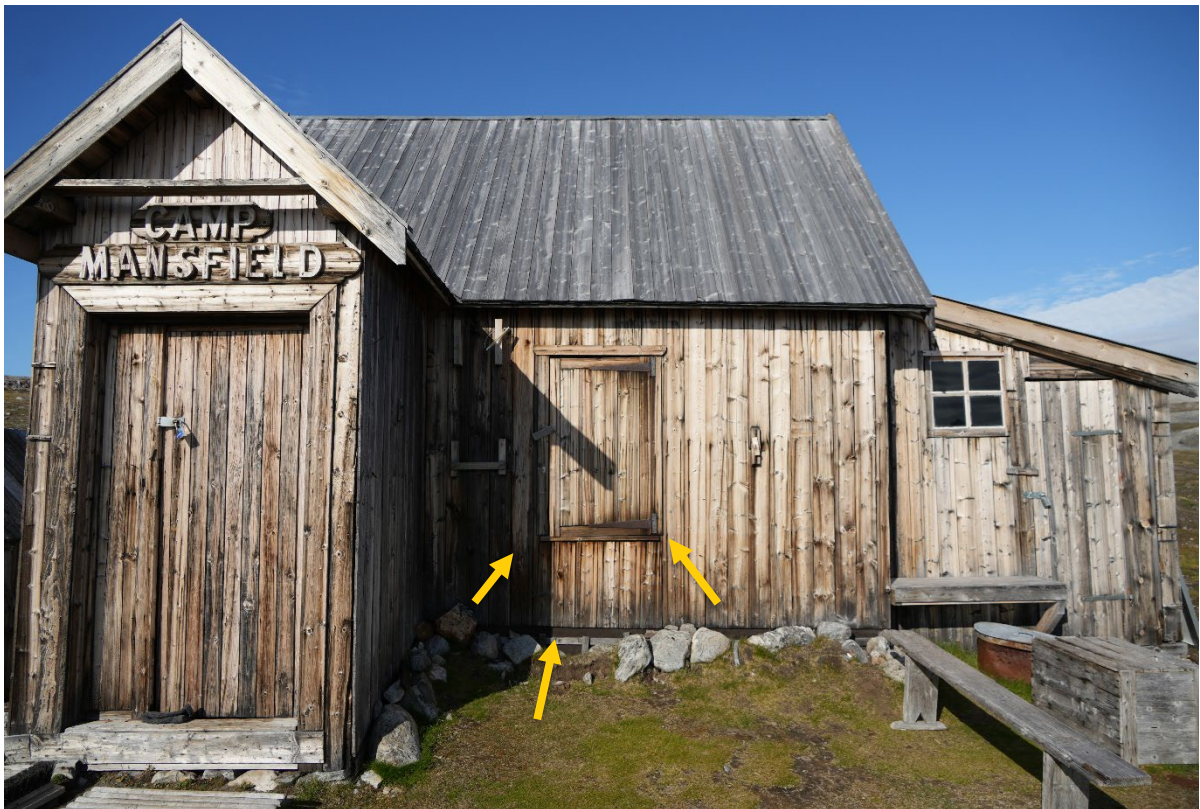
Camp Mansfield, façade facing south. Points of awl probing indicated

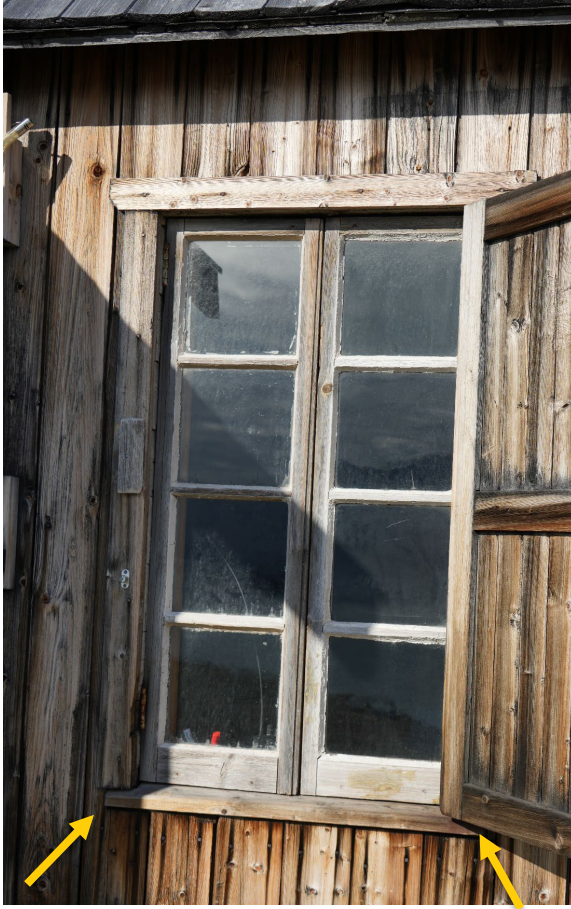
Camp Mansfield, façade facing south. Point of awl probing indicated. Awl probing performed on end grain of weatherboard beneath window

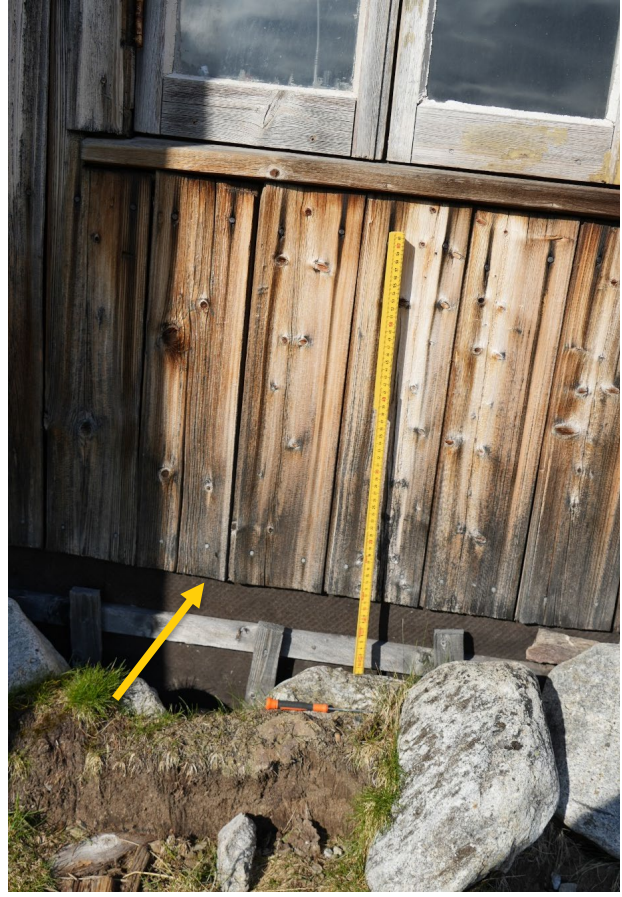
Camp Mansfield, façade facing west. Point of awl probing indicated. Awl probing performed on end grain of panel

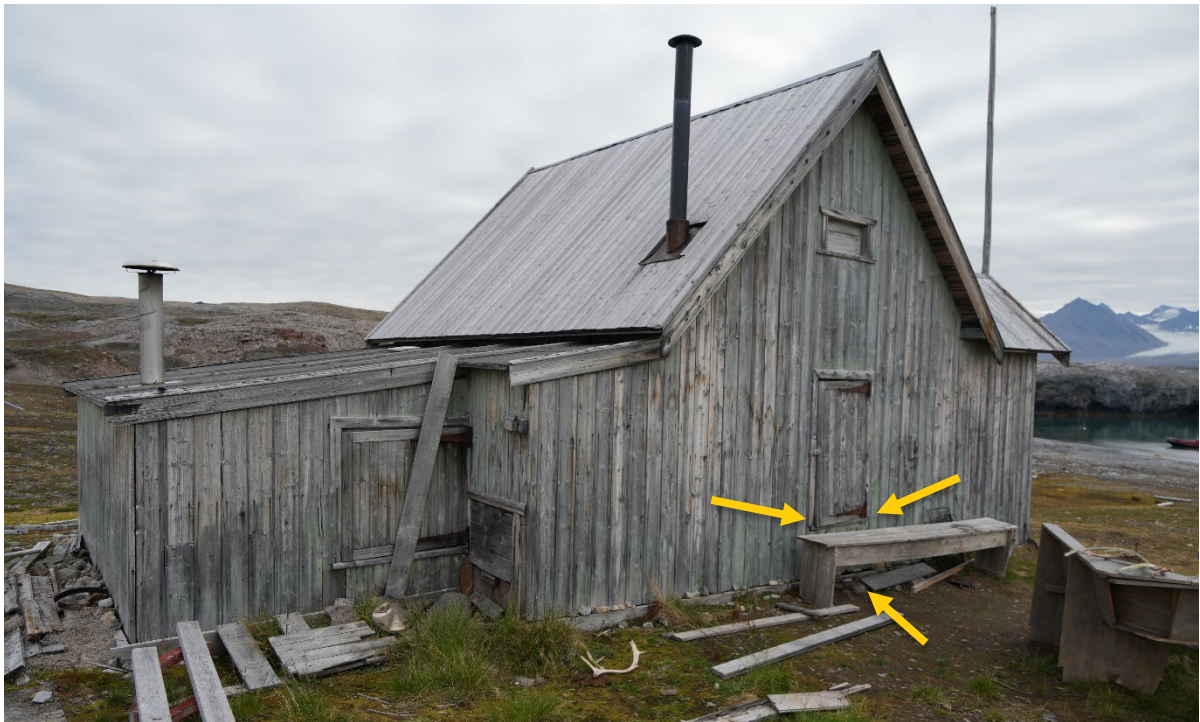
“Velferden”/Camp Lagercrantz, façade facing west. Points of awl probing indicated

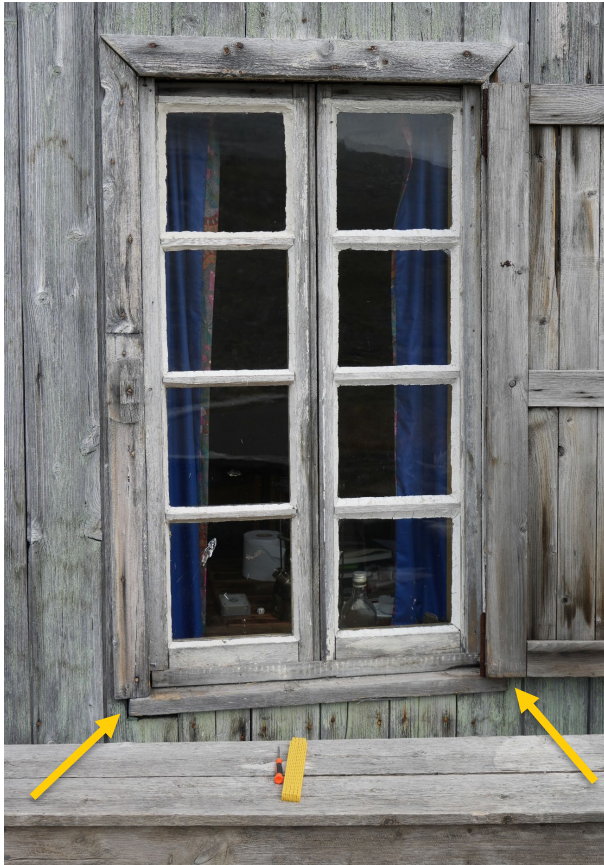
“Velferden”/Camp Lagercrantz, façade facing west. Point of awl probing indicated. Awl probing performed on end grain of weatherboard beneath window

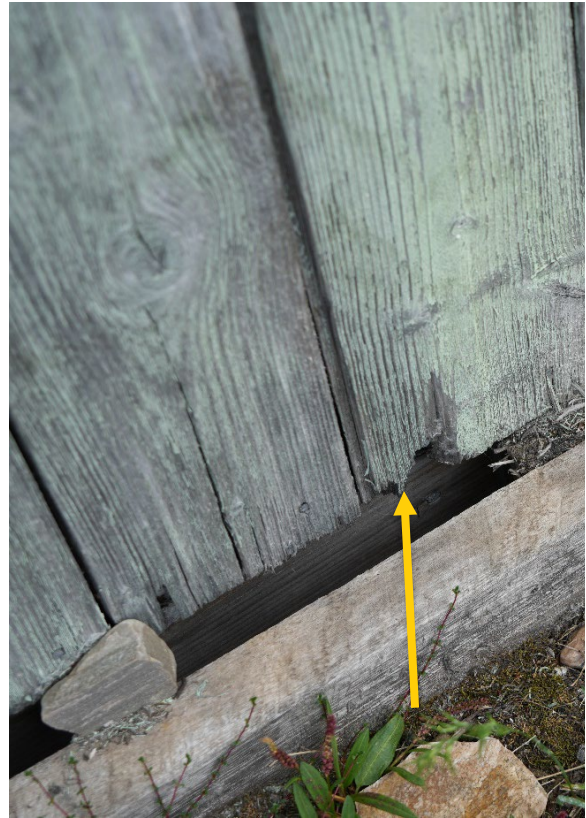
“Velferden”/Camp Lagercrantz, façade facing west. Point of awl probing indicated. Awl probing performed on end grain of panel

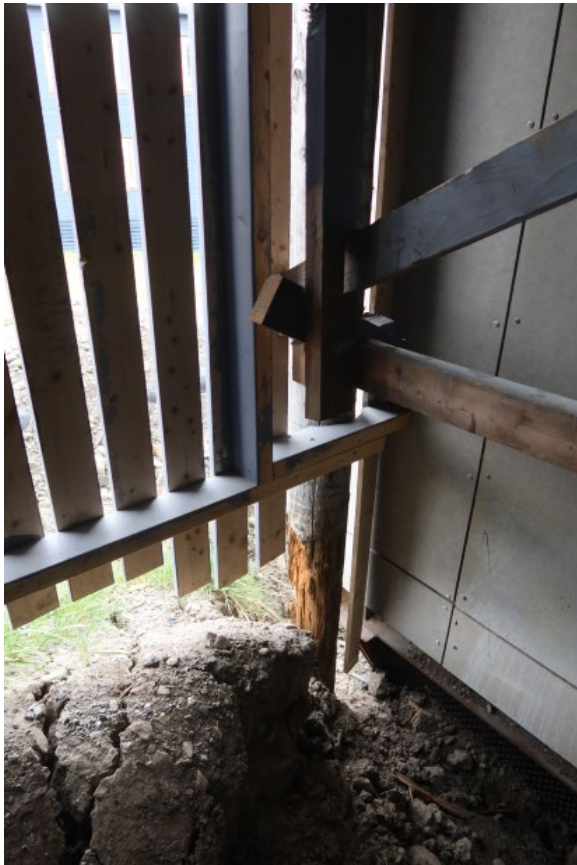
Hotel Radisson Blu, foundation pile SAS1. Overview from the inside

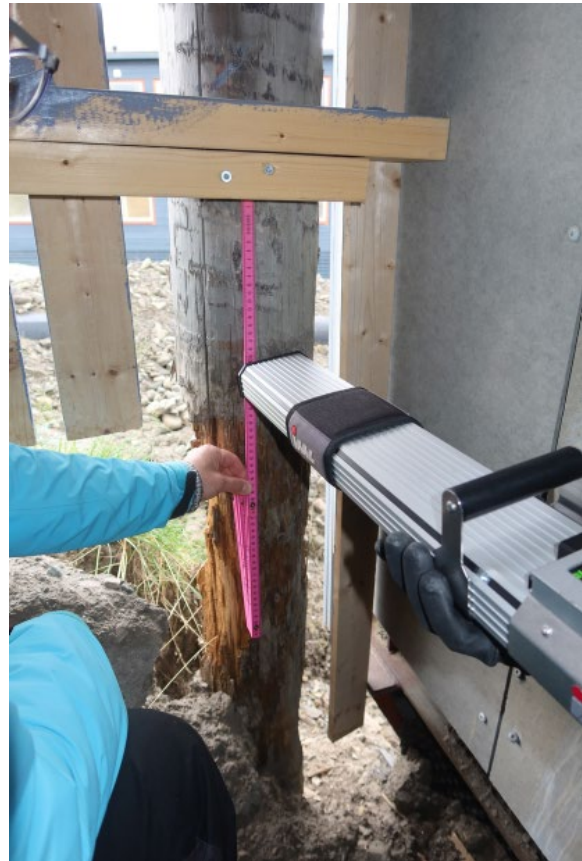
Hotel Radisson Blu, foundation pile SAS1. Decay detection drilling 233, 20 cm from beam

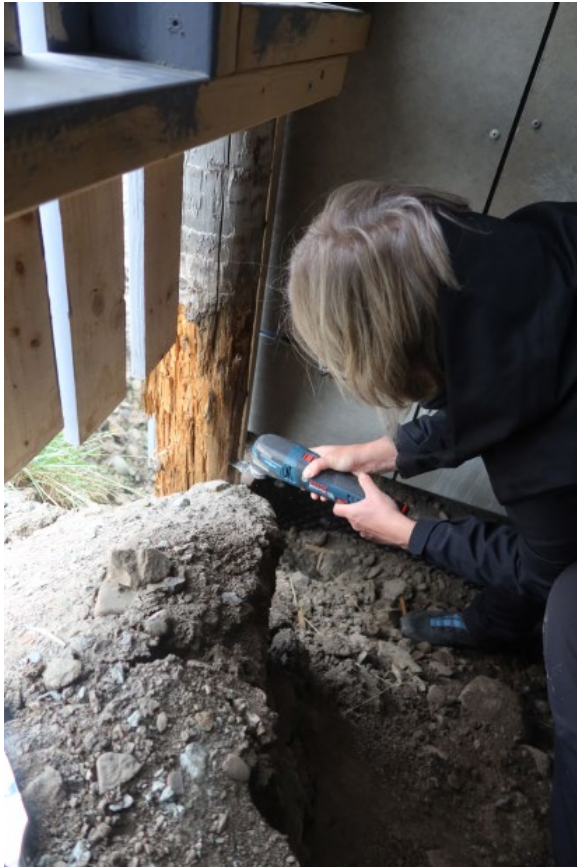
Hotel Radisson Blu, foundation pile SAS1. Cutting sample SAS1-2, 60 cm from beam

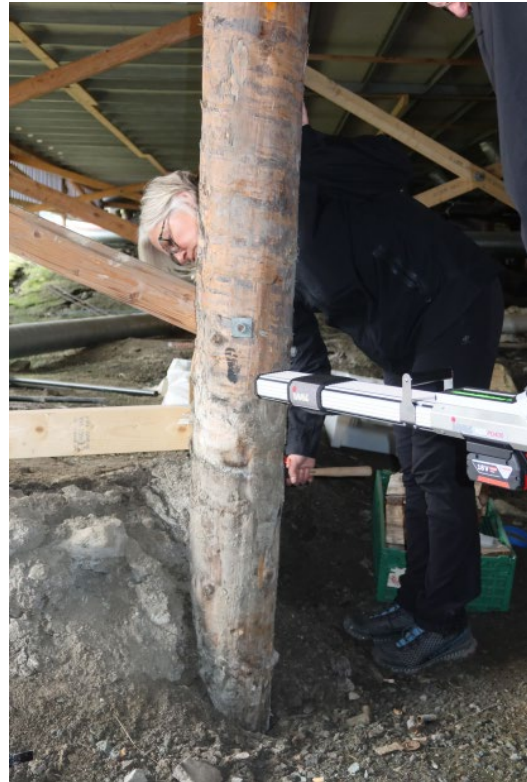
Hotel Radisson Blu, foundation pile SAS2. Decay detection drilling 244, cutting of sample SAS2-2
