Sampling for wood decay analyses of cable car trestles and houses at Svalbard

Field report

NIBIO REPORT | VOL. 9 | NR. 12 | 2023

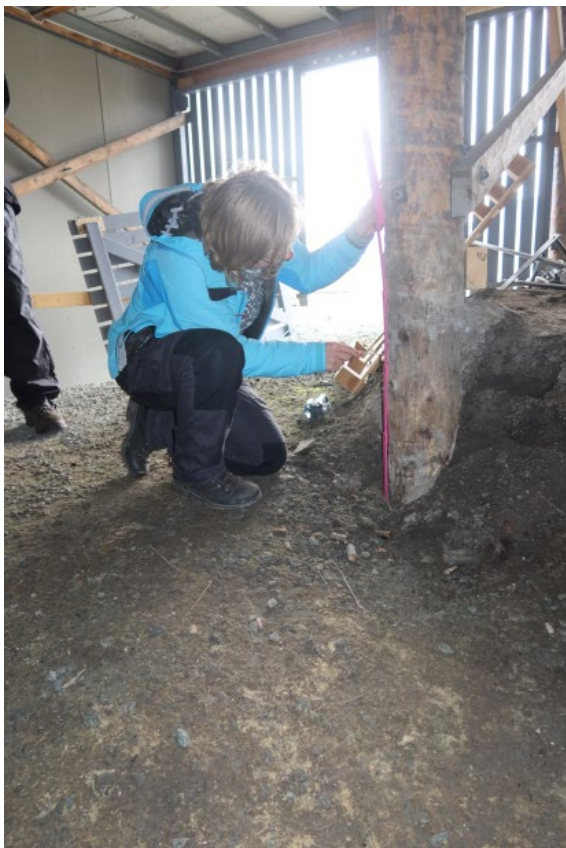
Hotel Radisson Blu, foundation pile SAS2. Probing with awl 40 cm from soil

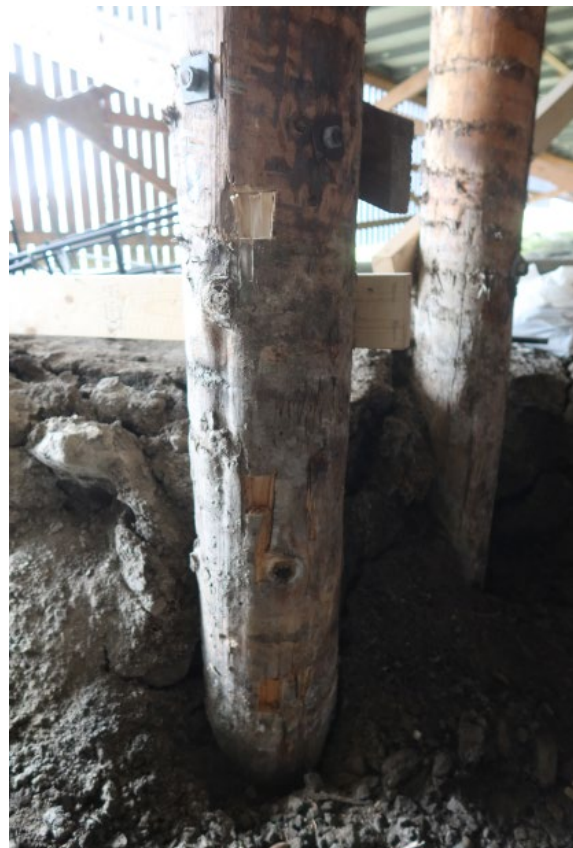
Hotel Radisson Blu, foundation pile SAS2, after sampling

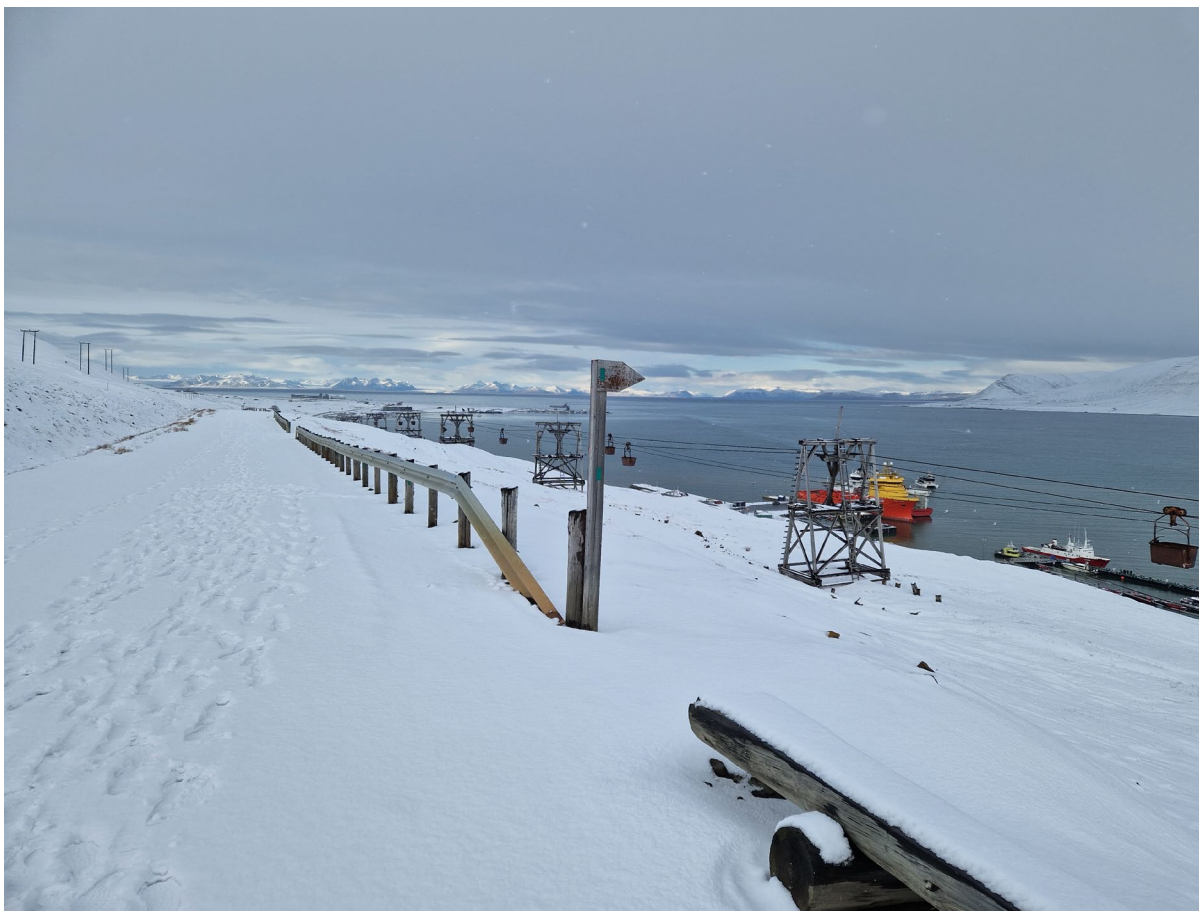
Samples were taken from this pole (no. 16 from the bridge) plus in seven poles further
