# Impermeable plastic covers for better winter survival of golf course putting greens: Ventilation under the covers during the winter 2020-2021

NIBIO REPORT | VOL. 7 | NO. 181 | 2021

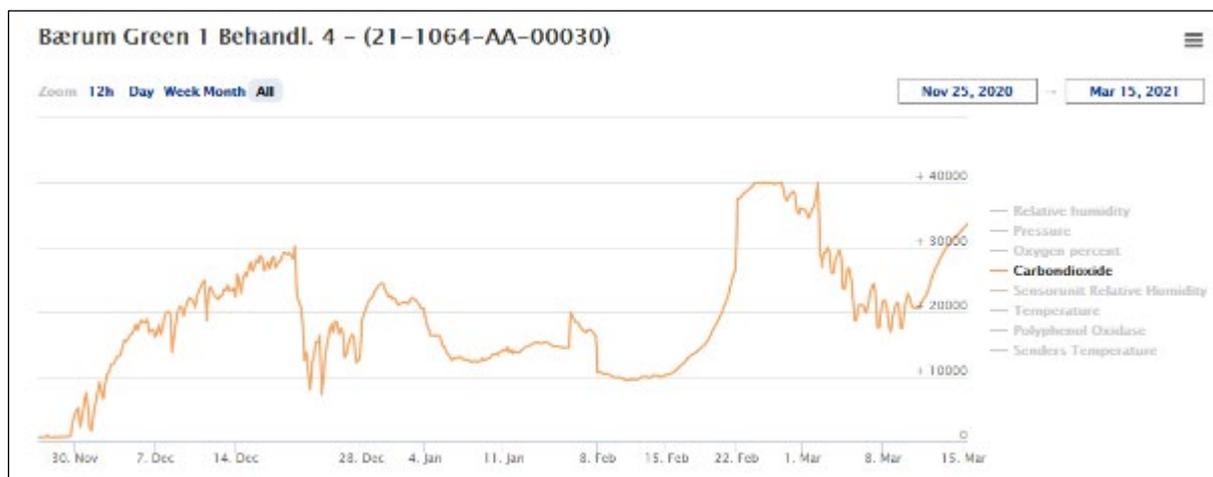
The two other greens in treatment 4 were not ventilated at all. This was a mistake as the CO<sub>2</sub>-level reached 40000 ppm on 23 Feb. on Green 1 (Figure 12) and on 8 Jan. and 24 Feb. on Green 5 (Figure 13a). The O<sub>2</sub> sensor on green 1 did not work, whereas the O<sub>2</sub> concentration on Green 5 never went down to the ventilation threshold of 12 % O<sub>2</sub> (Figure 13b).

Figure 12. CO<sub>2</sub> concentration on green 1 (treatment 4 – drainage pipes) at Bærum GC. By mistake, this green was never ventilated despite CO<sub>2</sub>- concentrations reaching 40000 ppm on 24 February. The O<sub>2</sub> sensor did not report values on this green.

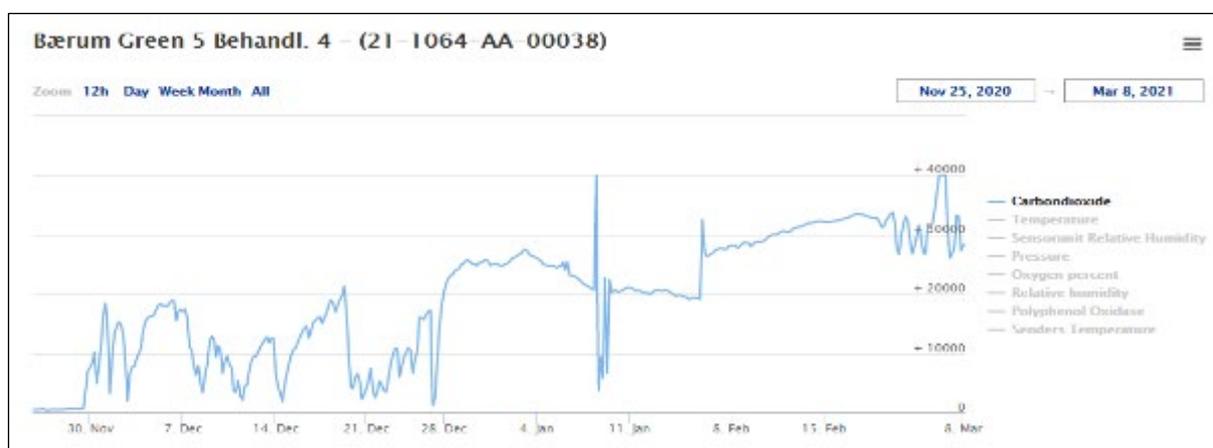
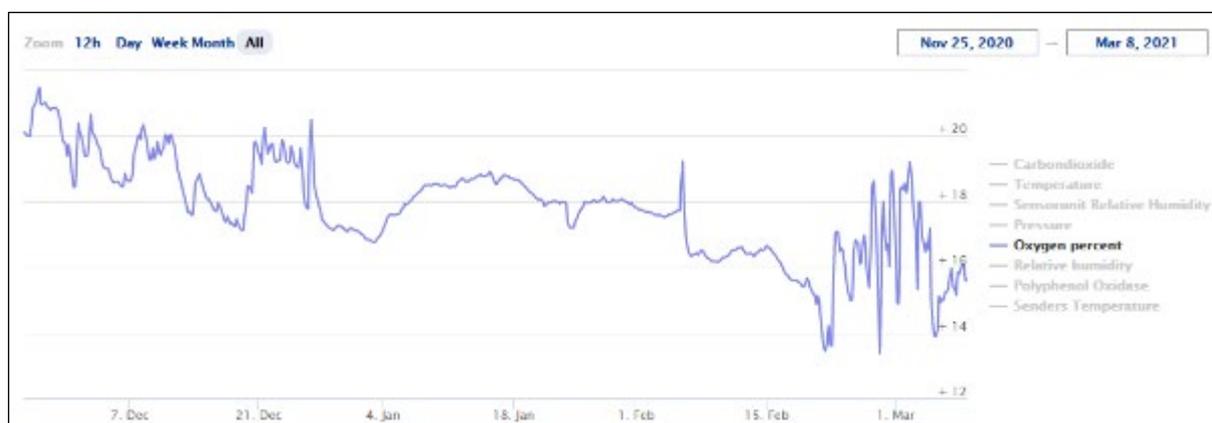
Figure 13a,b. CO<sub>2</sub> and O<sub>2</sub> concentration on green 5 (treatment 4) at Bærum GC. By mistake, this green was never ventilated despite CO<sub>2</sub>- concentrations reaching 40000 ppm on 8 Jan. and 24 Feb.

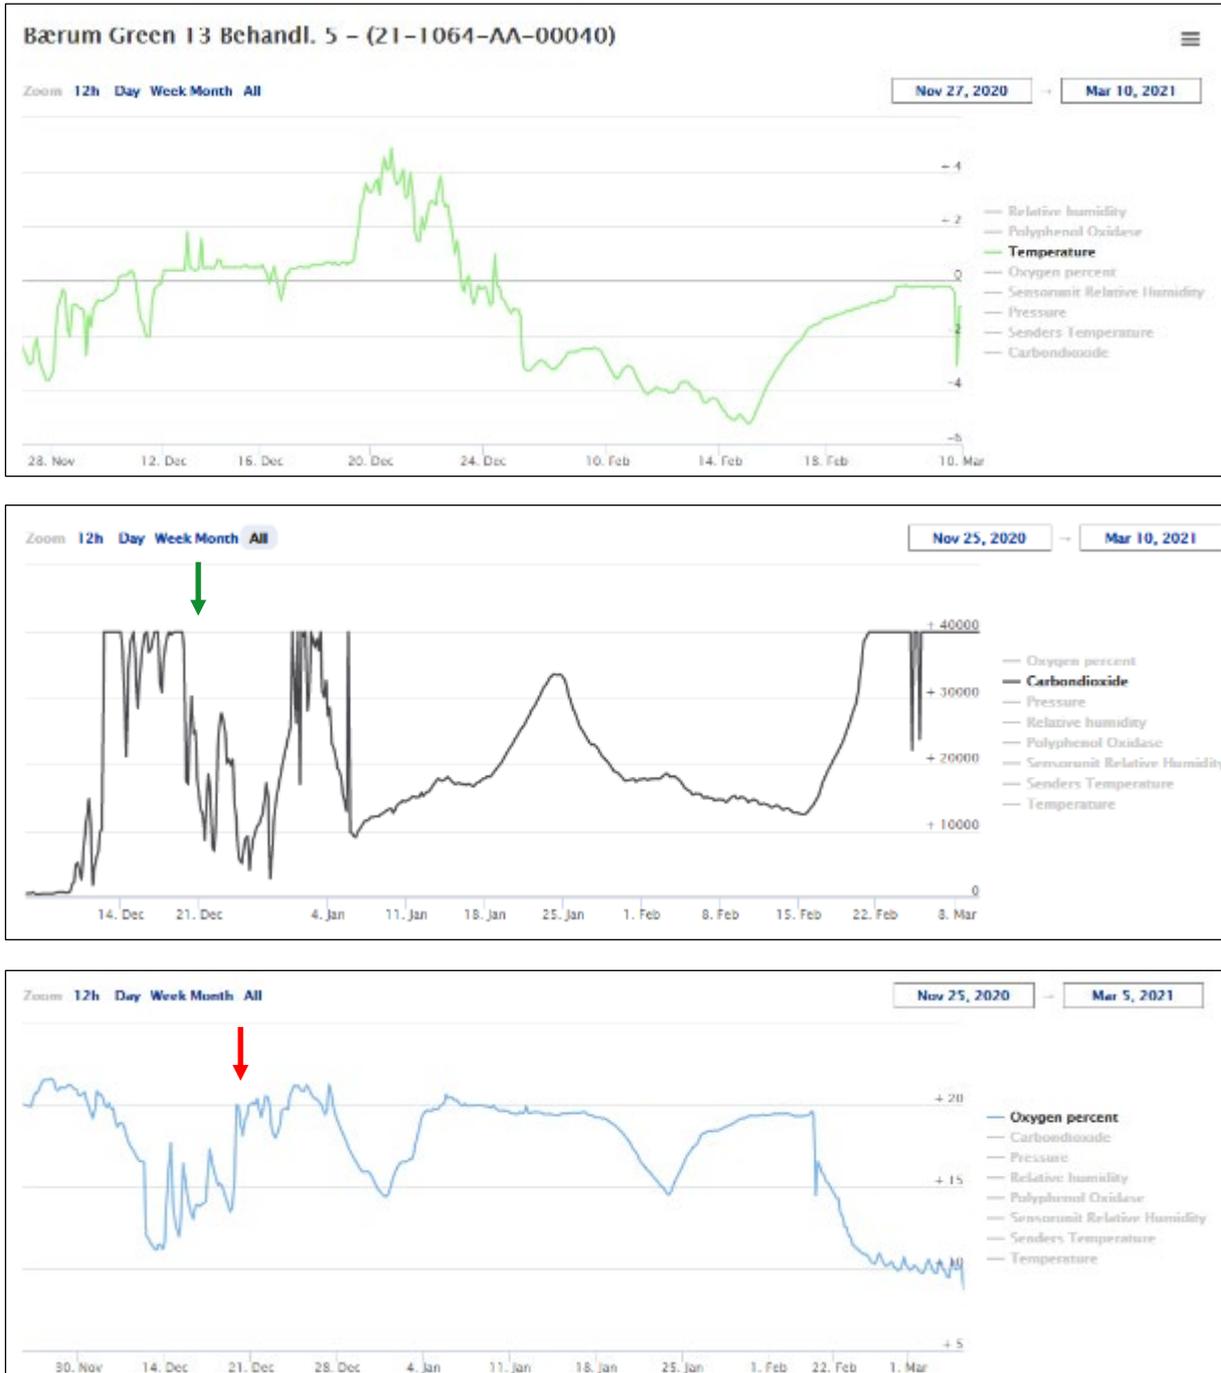
In treatment 5, Greens 13 (Figure 14) and Green 11 (Figure 15) were both ventilated only once. In both cases, the ventilations resulted in lower CO<sub>2</sub>-level, whereas the effect on O<sub>2</sub> concentration was less evident (Figure 14). According to the CO<sub>2</sub> and O<sub>2</sub> concentrations, both greens should have been ventilated for at least one more time, but this was not followed up by the greenkeepers.

Figure 14a-c. Temperature, CO<sub>2</sub> and O<sub>2</sub> concentration on green 13 (treatment 5 – flat tubes) at Bærum GC. This green was only ventilated once but should have received additional ventilations on 30 Dec. and 20 Feb.

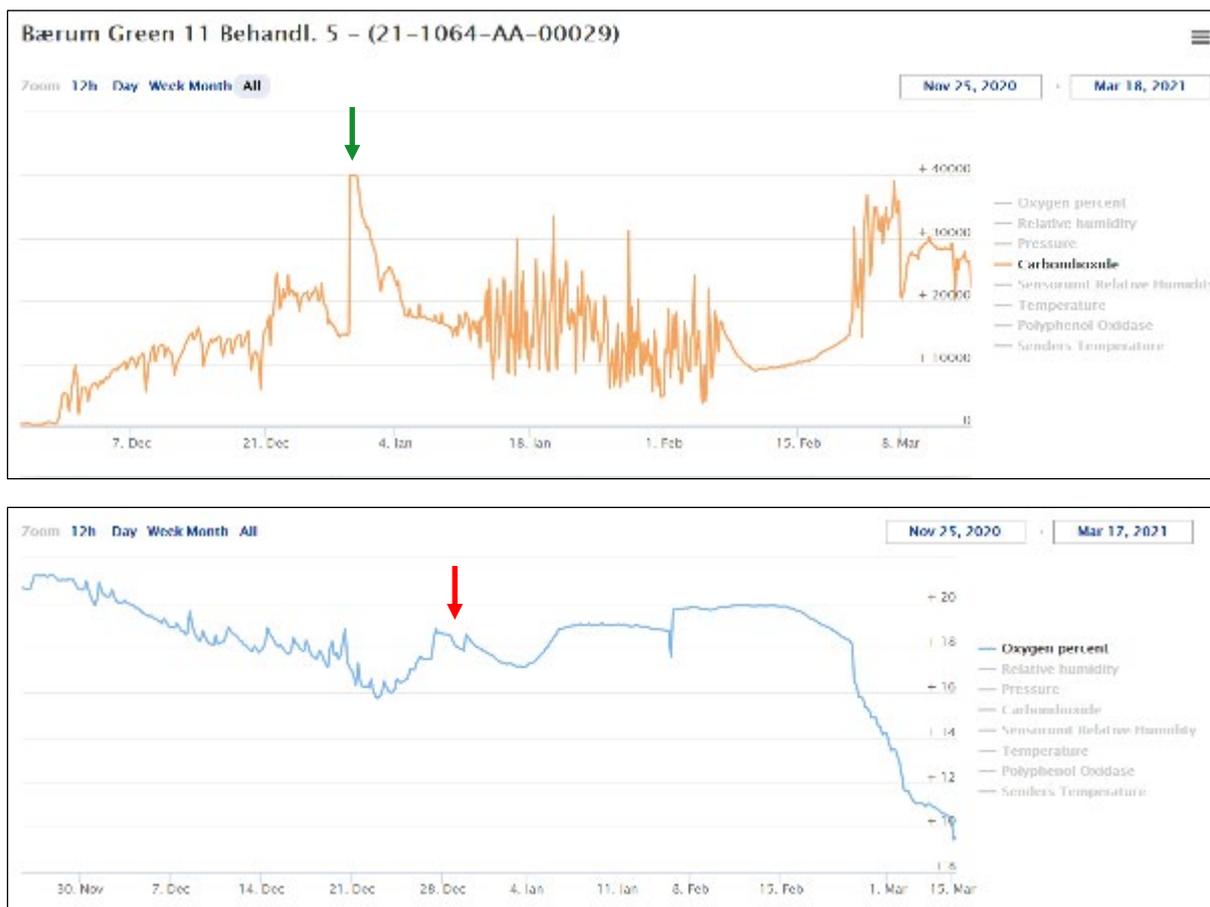
Figure 15a,b. CO<sub>2</sub> and O<sub>2</sub> concentration on green 11 (treatment 5 – flat tubes) at Bærum GC. This green was only ventilated once. Because of falling O<sub>2</sub> concentration, it should have been ventilated also on 6 March.

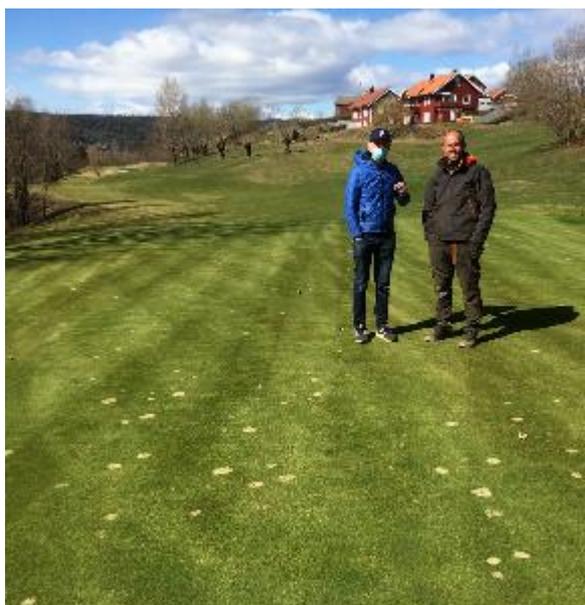
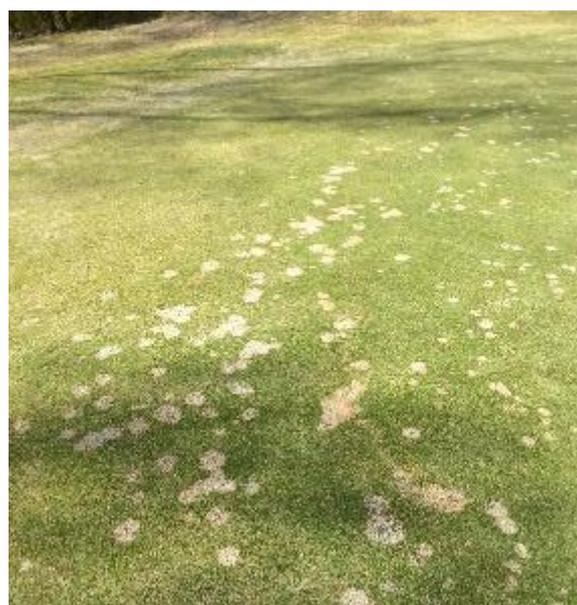
*Photo 19. a) Pål Melbye from Norwegian Golf Federation (left) and Course Manager Guttorm Ray Tuxen (right) on Green 6 (treatment 3). b) Green 7 (treatment 2) with line after drainage pipe. Both photos taken on 22 April by Trygve S. Aamlid.*

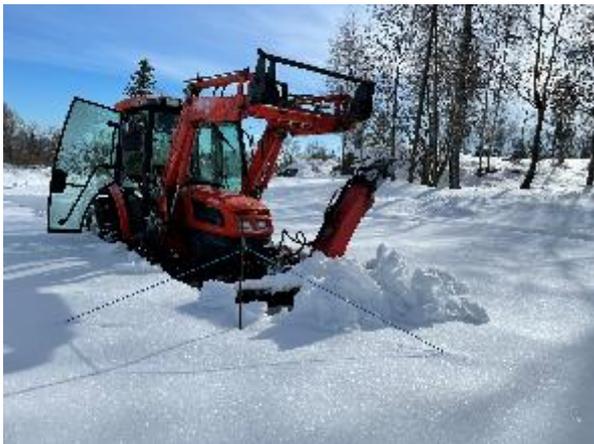
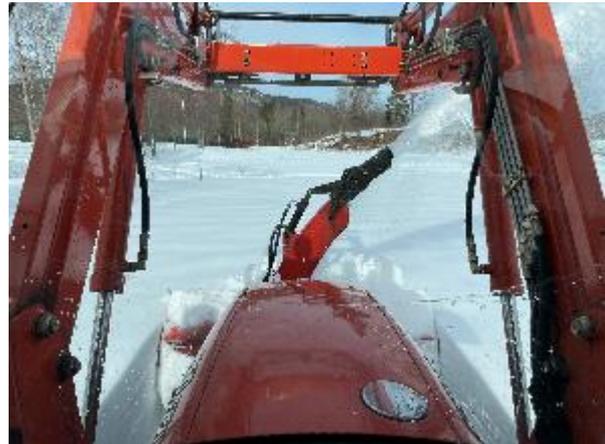
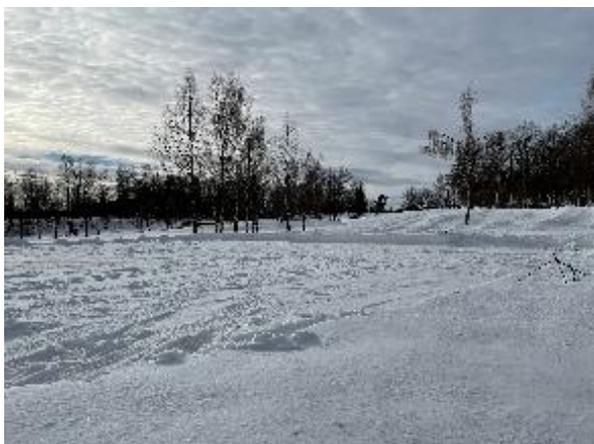
Photo 23a-c. Snow removal on Green 8 (a, b) and Green 6 (c) at Asker on 17 March. The tractor driver intentionally left 8-10 cm of snow in order not to destroy the covers. Photos: James Bentley.

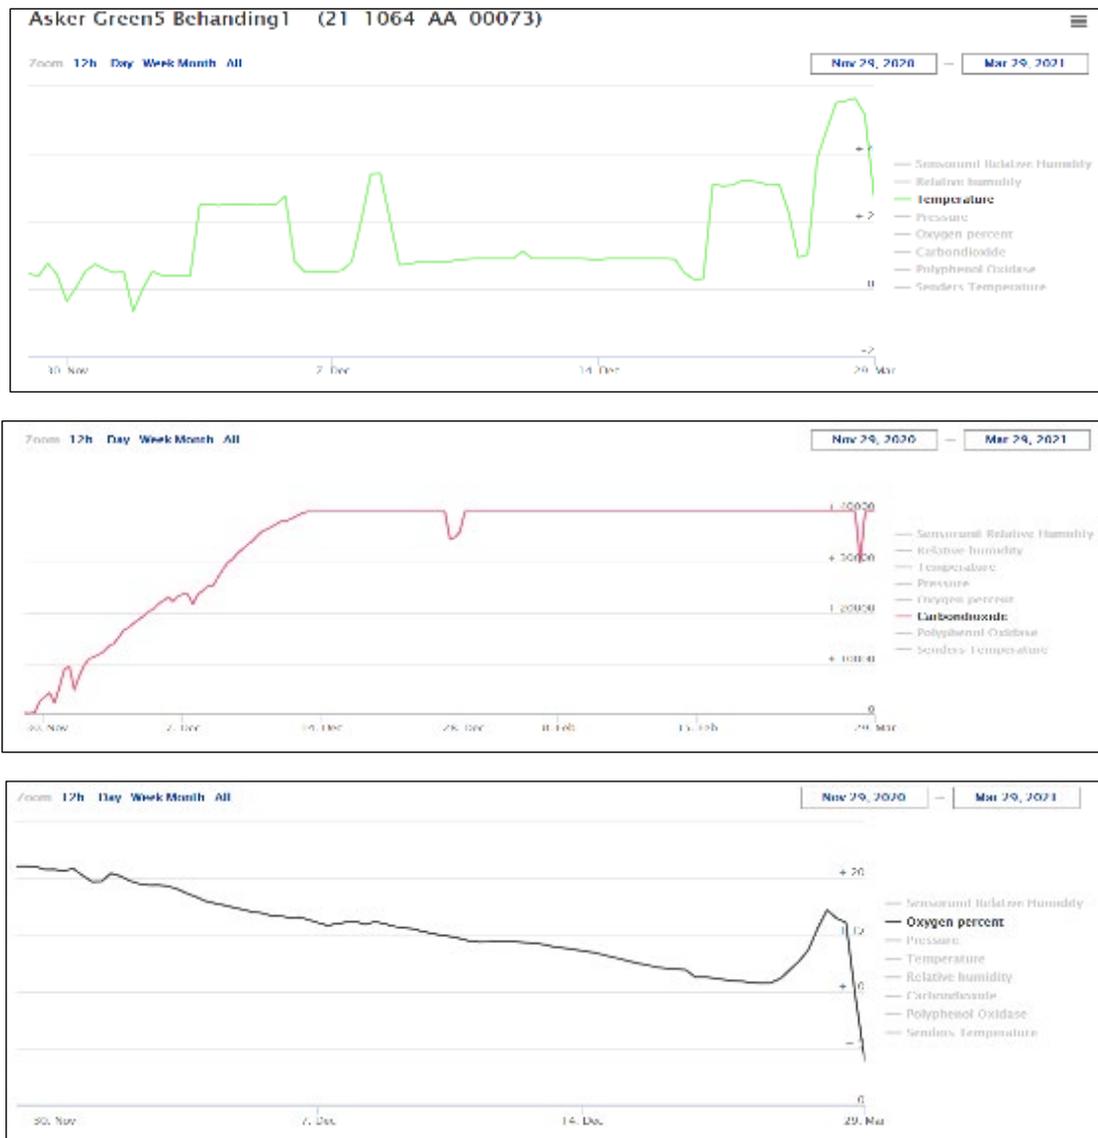
The most reliable data from the sensors at Asker were from December. During this month, the temperatures under the covers were mostly above freezing, with CO<sub>2</sub> levels increased up to 40000 ppm between 12 and 16 December. A couple of days later, the O<sub>2</sub> sensors that were operative showed values down to 11 % on the unventilated greens (treatment 1; Figure 18).

Figure 18a-c. Temperature CO<sub>2</sub>- and O<sub>2</sub> concentration in the hole cup on the unventilated Green 5 at Asker.

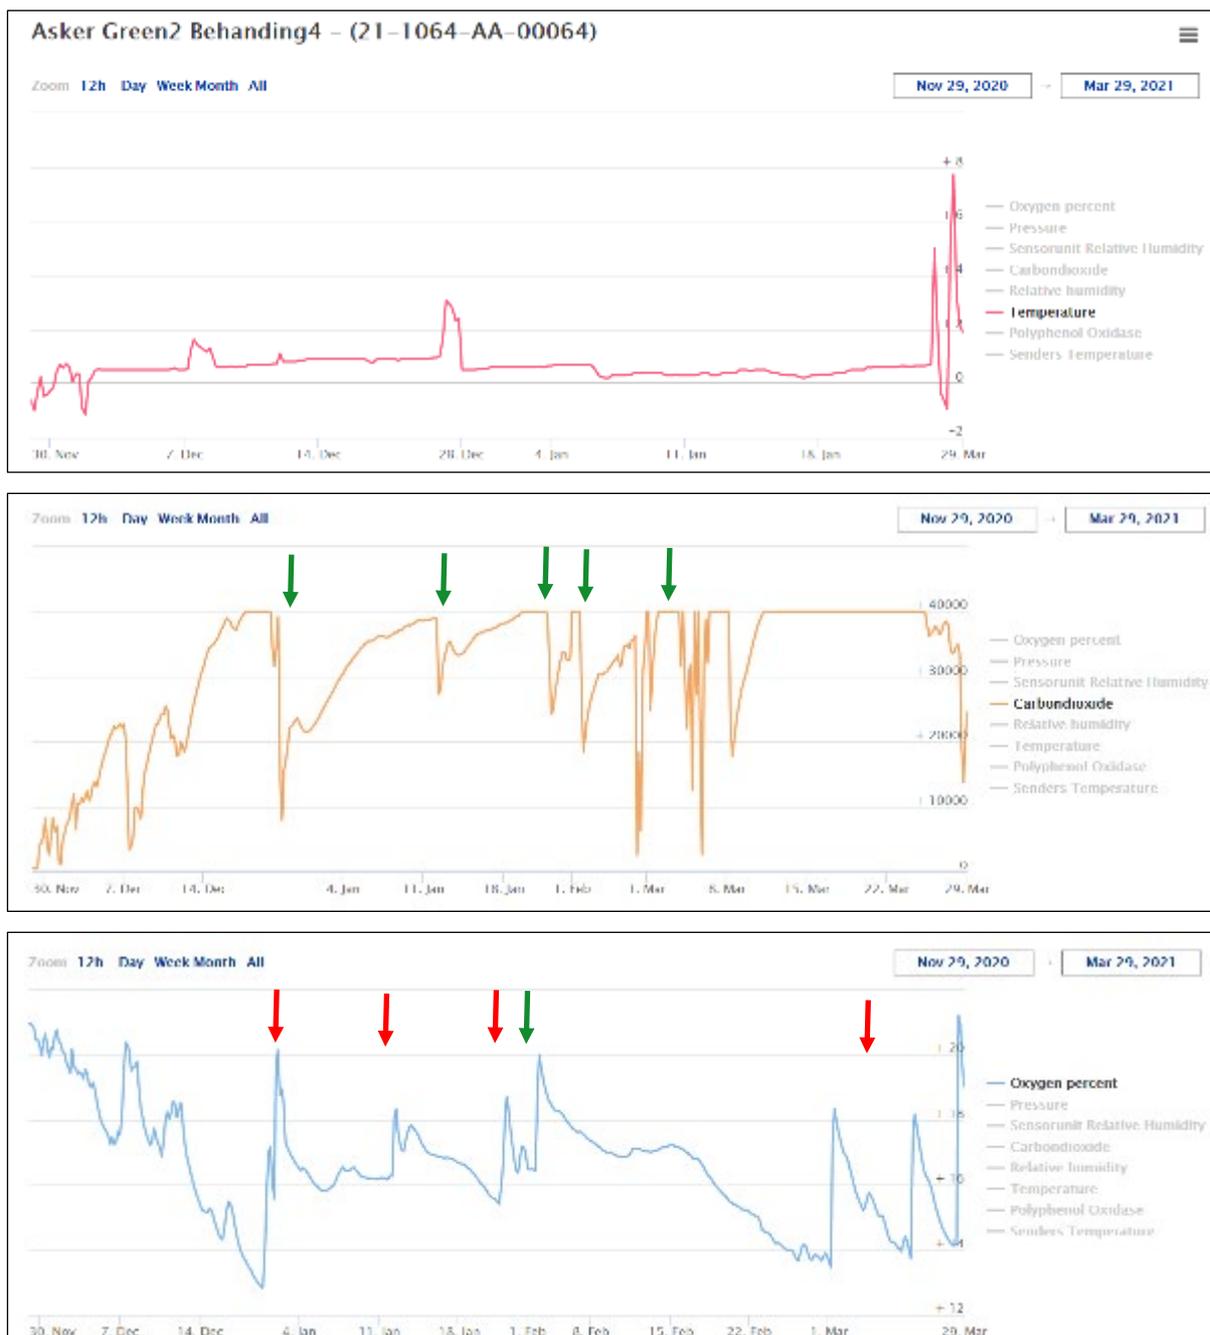
In the sensor-based ventilation treatment 4, it was always the CO<sub>2</sub>-threshold that resulted in ventilation as the O<sub>2</sub> concentration was never below 12 %. Green 2 was ventilated five times from 21 Dec to 2 March but should ideally have been ventilated at least one more time in March (Figure 19). Similarly, Green 4 was ventilated four times but should also have been reventilated in March (Figure 20). Green 13 with the same treatment was only ventilated on 21 Dec. as neither the CO<sub>2</sub> nor the O<sub>2</sub> sensors operative after December (data not shown).

Figure 19a-c. Temperature and CO<sub>2</sub>- and O<sub>2</sub> concentration under the plastic sheets on Green 2 (treatment 4) at Asker GC. The CO<sub>2</sub>-threshold (40000 ppm) resulted in five ventilations from 21 Dec. to 2 March. According to this criterion, the green should have been ventilated at least one more time in March, but that was not carried out. The O<sub>2</sub> concentration never went down to 12 %, but as indicated by the red arrows, the recorded responses to ventilation were far less evident than for CO<sub>2</sub>.

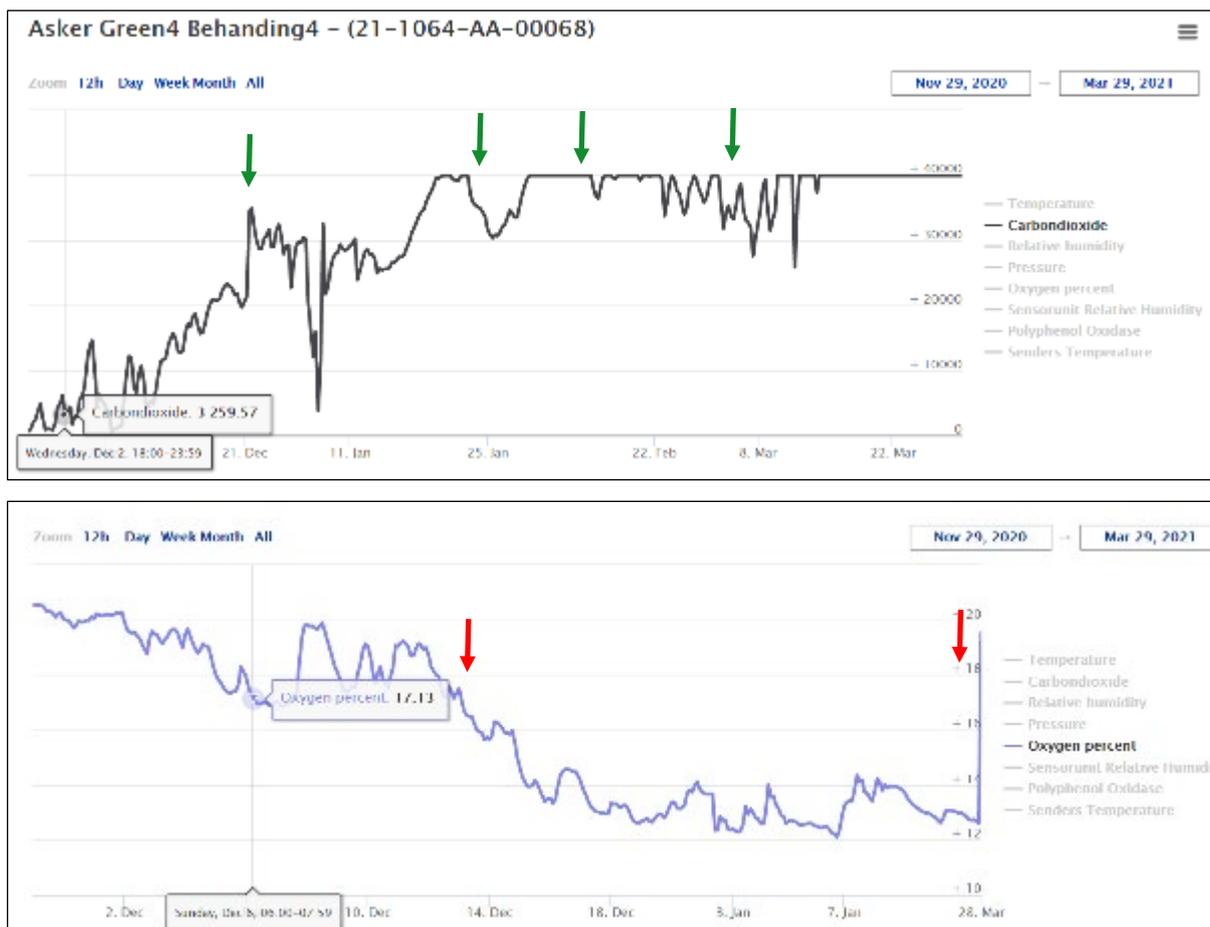
**Figure 20.** CO<sub>2</sub>- and O<sub>2</sub> concentration under the plastic cover on Green 4 (treatment 4) at Asker. The CO<sub>2</sub>-threshold 40000 ppm for ventilation was reached four times from 21 Dec. to 2 March. According to this threshold, the green should also have been ventilated at least one more time in March. The O<sub>2</sub> sensor did not respond positively to ventilations and was not operative after 11 Jan.

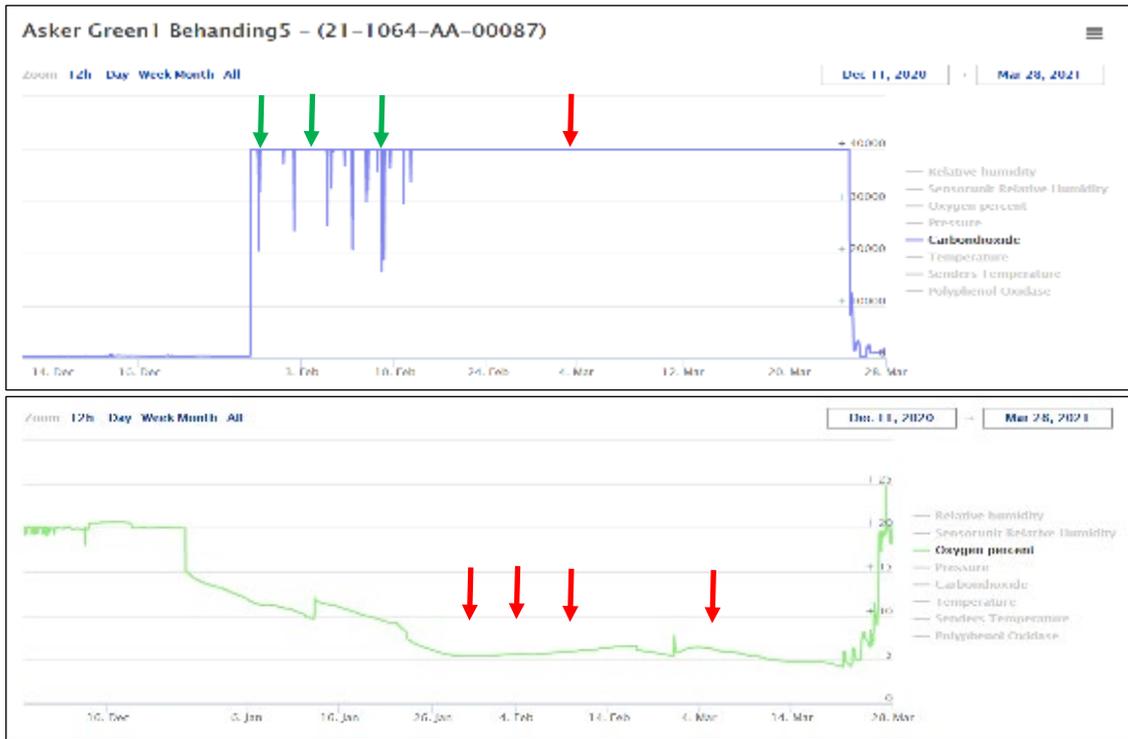
In the sensor-based treatment 5 (flat tubes) no data were available for temperatures on green 1. After the replacement of the sender unit on 30 Dec., the CO<sub>2</sub> and O<sub>2</sub> concentrations were, however almost constantly higher than 40000 ppm and lower the 12 %, respectively (Figure 21). The green was ventilated on 21 Dec. (due not warnings for the other greens with the same treatment) and on 30 Jan., 3 Feb., 8 Feb. and 3 March, but except for 21 Dec., ventilation was difficult because of the heavy snow and ice cover. Small and temporary drops in CO<sub>2</sub> concentration could be seen after some of the ventilations, but the O<sub>2</sub>-sensor did not react to the ventilations at all (Figure 21).

Figure 21. CO<sub>2</sub>- and O<sub>2</sub> concentration on Green 1 (treatment 5) at Asker GC. The CO<sub>2</sub>-threshold 40000 ppm was exceeded and the O<sub>2</sub>-concentration went below 10 % a period for more than 60 days. Responses in gas concentration to ventilations were absent for O<sub>2</sub> (red arrows) and, at the very best, transient for CO<sub>2</sub> (green arrows). This green was also ventilated on 21 Dec., but then there was no sensor in operation.

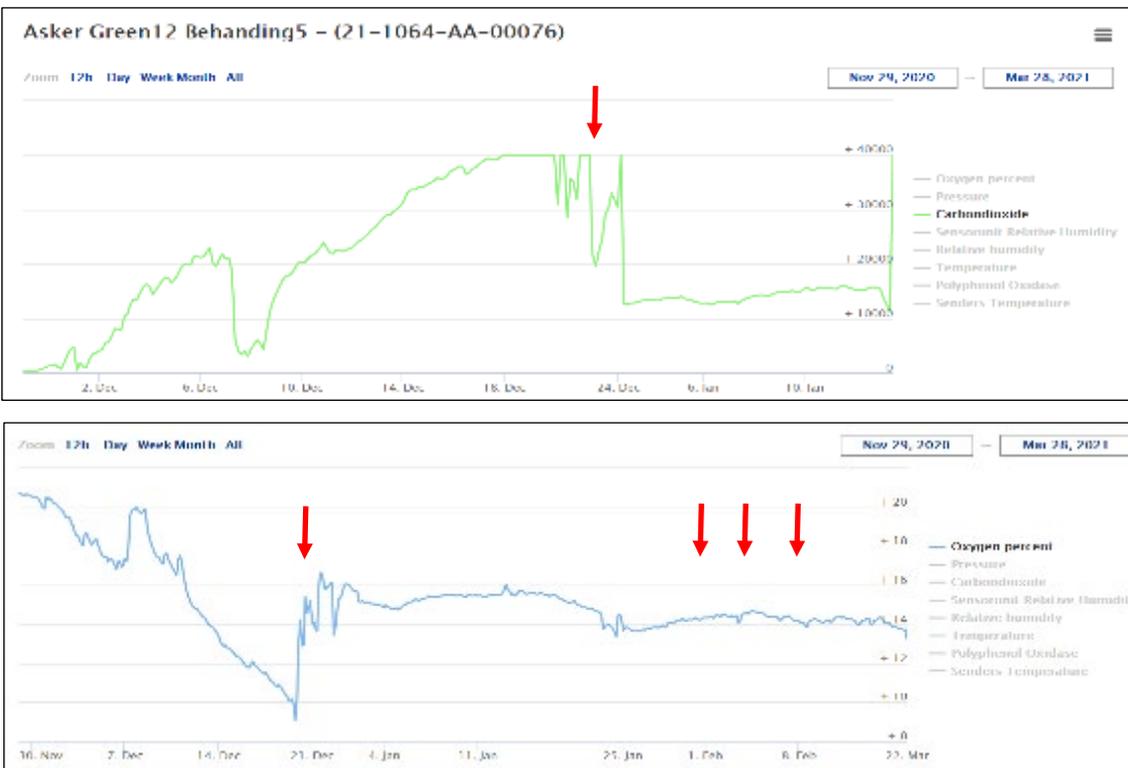
On Green 12, also treatment 5, the CO<sub>2</sub> levels exceeded 40000 ppm and O<sub>2</sub> levels were down to less than 10 % around 20 Dec. (Figure 22). The resulting ventilation on 21 Dec. was detected by the CO<sub>2</sub> sensor but hardly by the O<sub>2</sub>-sensor. For the rest of the winter, this green and Green 3 (also treatment 5) were ventilated according to the gas concentration in the same treatment on green 1. The CO<sub>2</sub>-sensors did not work, and ventilations were not detected by the O<sub>2</sub>-sensors.

Figure 22. CO<sub>2</sub>- and O<sub>2</sub> concentration under plastic sheets on green 12 (treatment 5) at Asker GC. The green was ventilated on 21 Dec. in response to the high CO<sub>2</sub>-concentrations and low O<sub>2</sub>-concentrations, but a change in concentrations was detected only by the CO<sub>2</sub>-sensor.

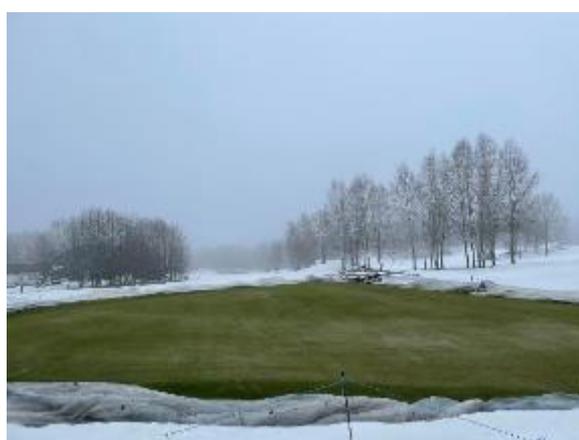
Turfgrass samples taken inside from Green 2 (treatment 4) on 2 Feb. (i.e. approximately half way through the winter) showed healthy turf with no damage thus far (Photo 25). This was also confirmed when the plastic sheets and undercovers were taken off on 29 March (Photo 26). Except on Green 3 which had a small area where where ice and melting water had been trapped partly on the green and partly just outside (Photo 27), there was no ice or water damage at all. The most damage from microdochium patch was seen on parts of Green 6 (treatment 3) where the plastic had blown off due to the blizzard between Christmas and New Year (Photo 28).

*Photo 26. Green 13 (treatment 4) shortly after cover removal on 29 March. Photo: James Bentley.*

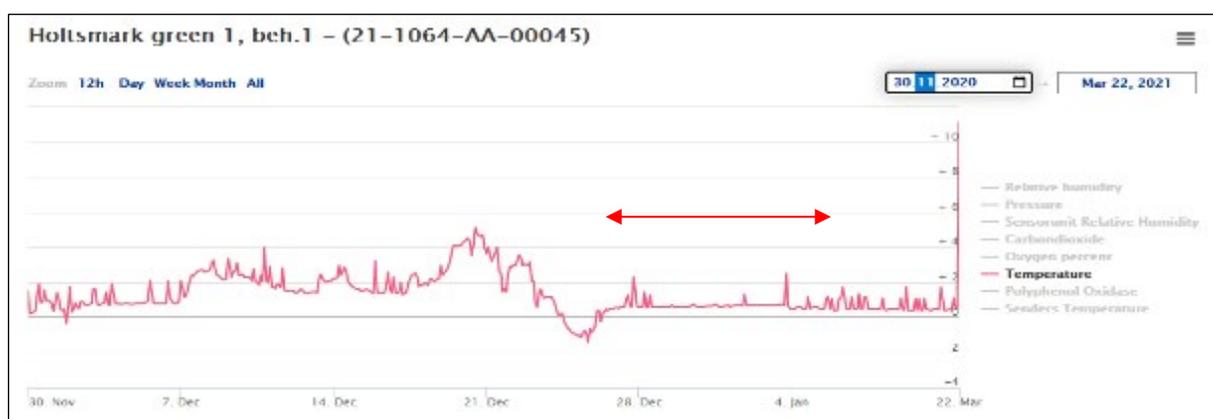
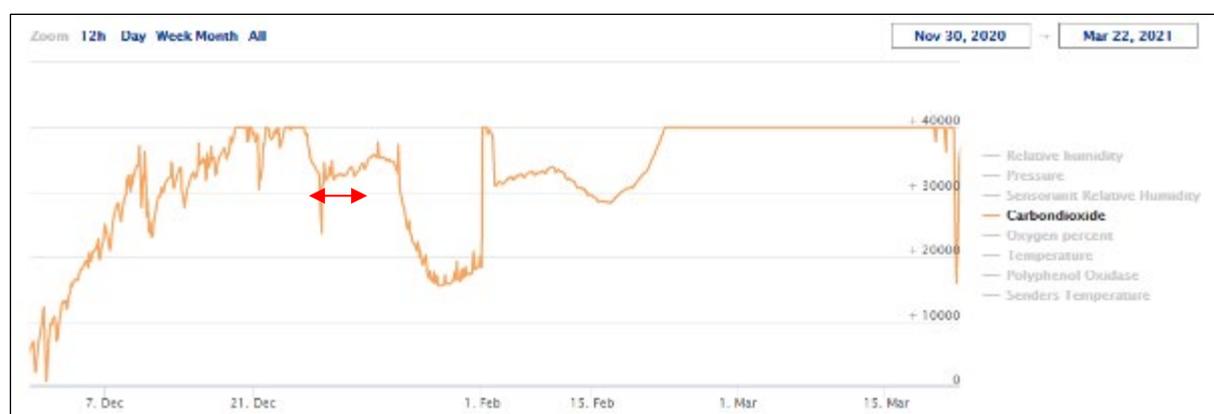
CO<sub>2</sub> concentrations varied between the two unventilated greens that kept the covers in place during most of the winter. On Green 1 the concentration exceeded 40000 ppm from about 20 Feb. (Figure 25), but on Green 9 the concentration was always less than 20000 ppm (Figure 26). The O<sub>2</sub> sensors did not report reliable data on Green 1, but showed values that were always higher than 14 % on Green 9.

Figure 25a,b. CO<sub>2</sub> and O<sub>2</sub> concentrations under the plastic sheets on the unventilated Green 1 at Holtsmark GC. Red arrows indicate the period when parts of the green were uncovered after the storm around Christmas has been indicated. The O<sub>2</sub> sensor did not work on this green.

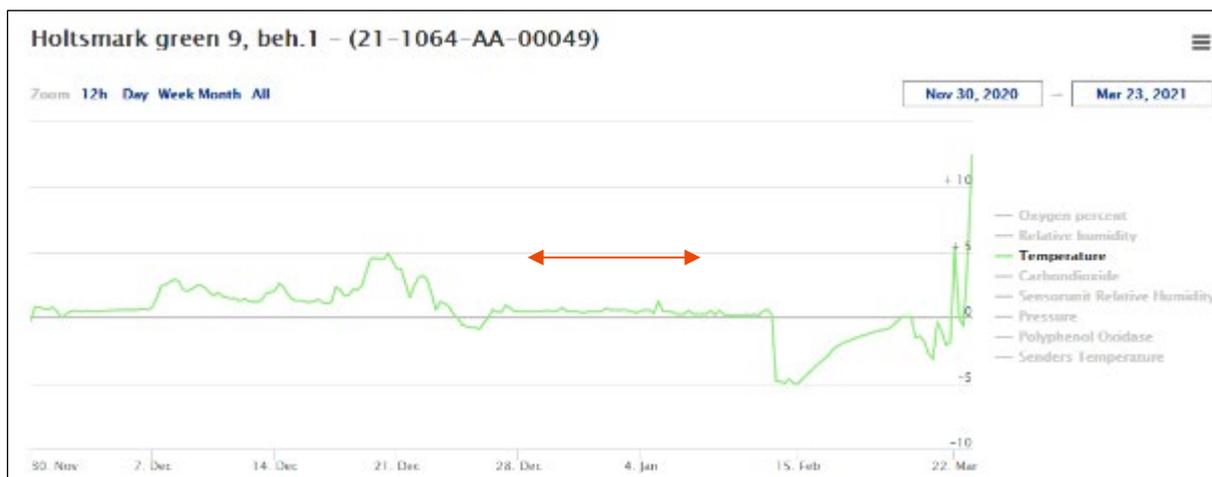
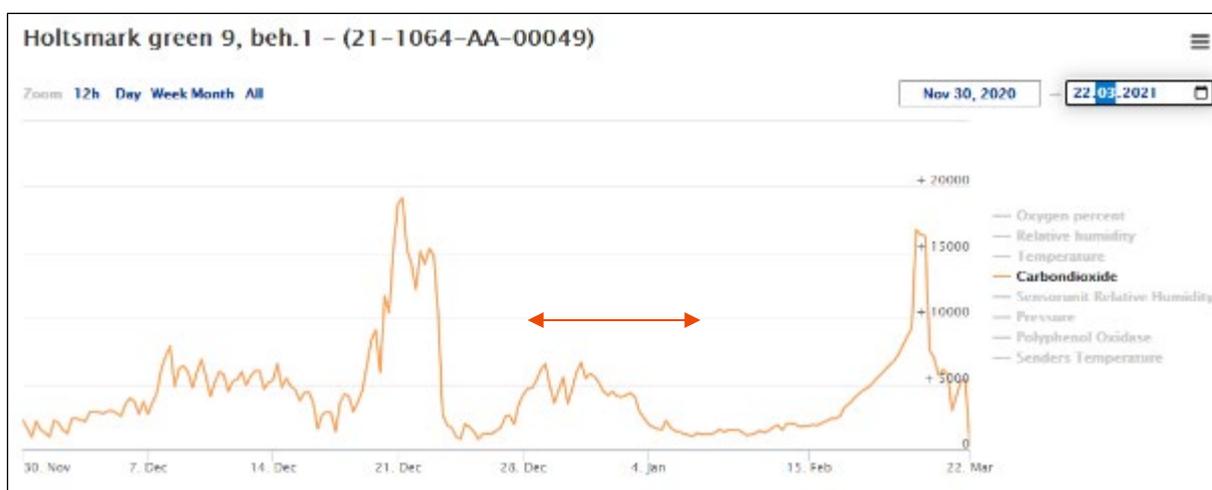
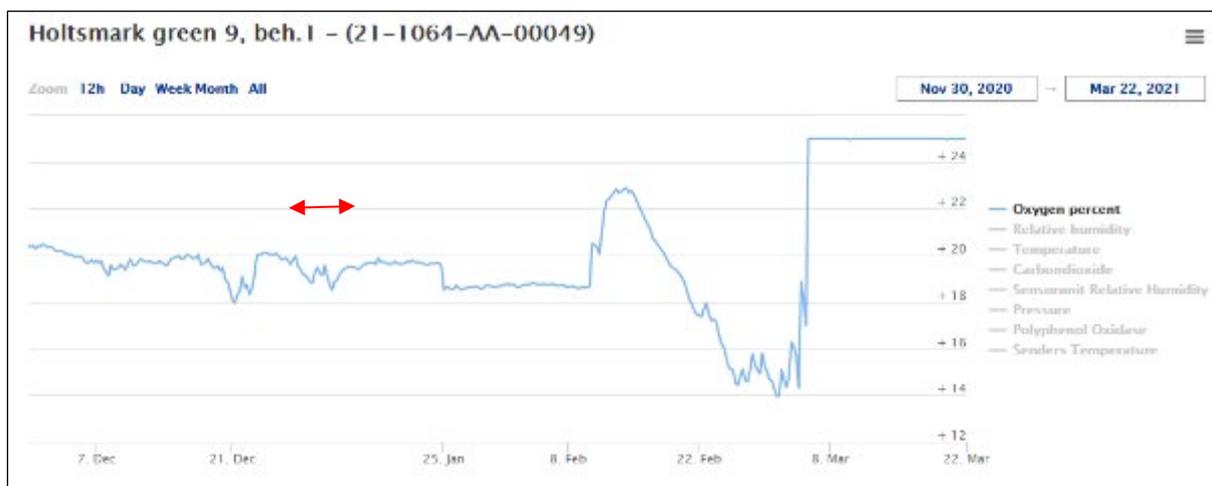
Figure 26a-c. Temperature, CO<sub>2</sub> and O<sub>2</sub> concentrations under the plastic sheets on the unventilated green 9 at Holtmark GC. The period 28 Dec.-11 Jan. when the green was partly uncovered after storm around Christmas has been indicated.

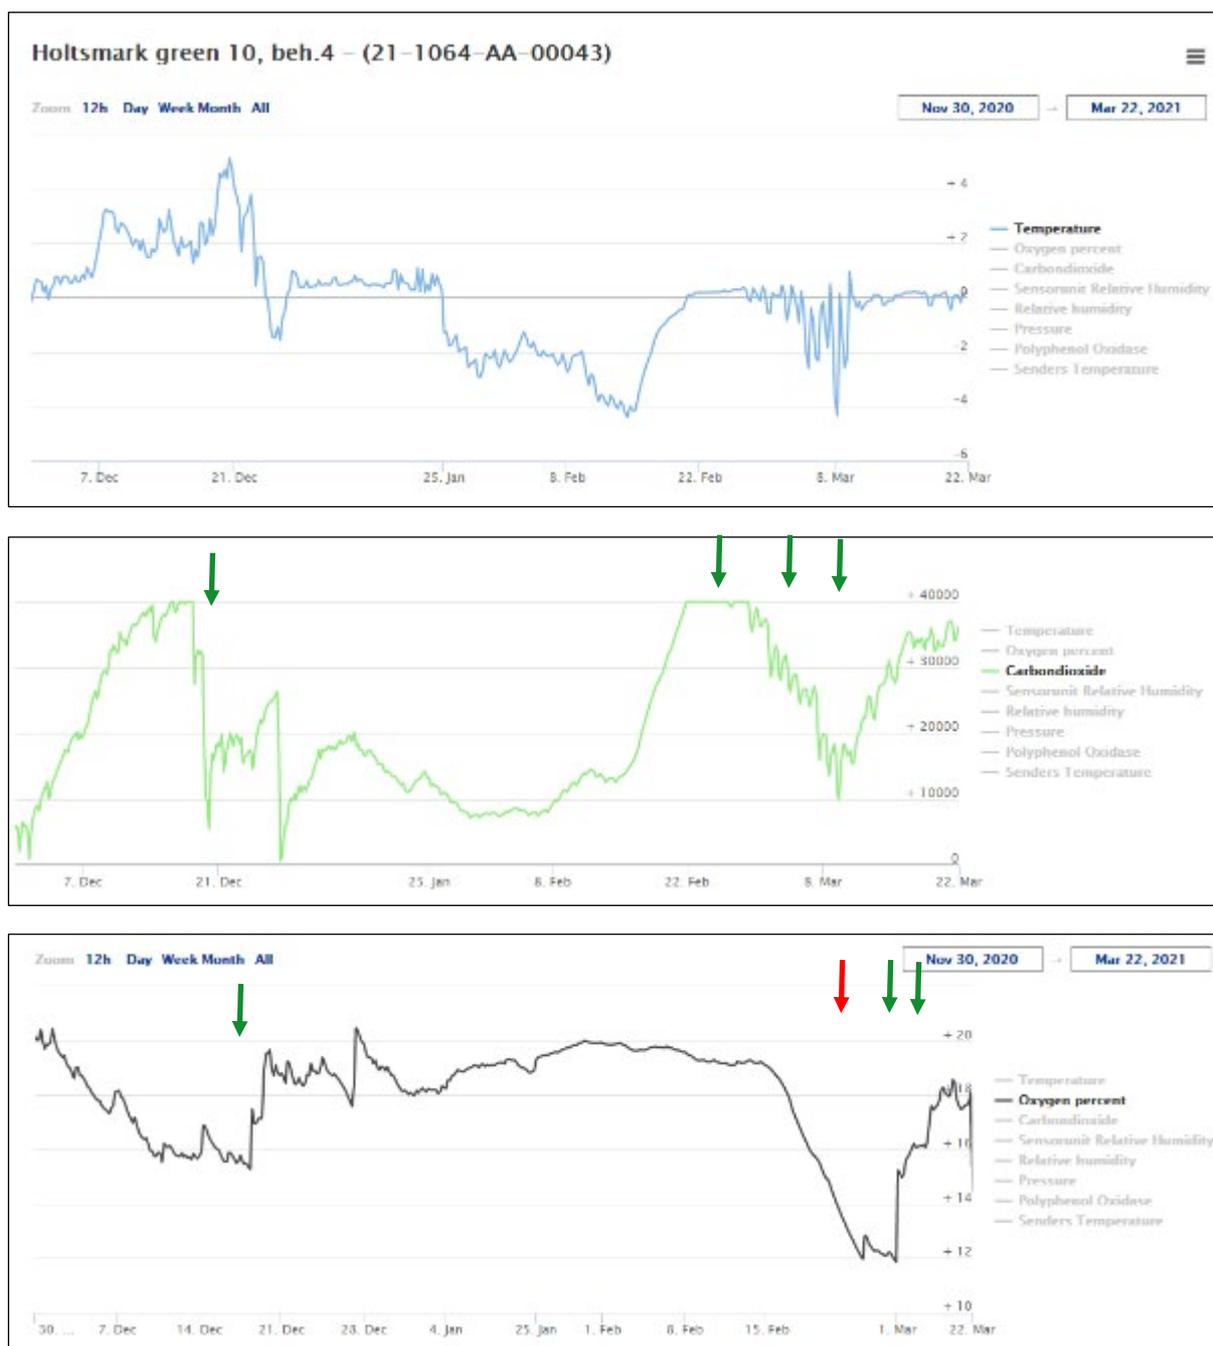
In treatment 4 with sensor-based ventilation through drainage pipes, on Green 10 there was a good response in both CO<sub>2</sub> and O<sub>2</sub>-levels to the first ventilation triggered by the CO<sub>2</sub> concentration on 18 Dec. (Figure 27). The next ventilation on the same green was on 23 Feb., also in response to high CO<sub>2</sub> levels, while the last two ventilations on 2 March and 9 March were in response to O<sub>2</sub>-concentrations

approaching 12 %. In large, these ventilations produced detectable changes in the gas concentrations under the covers, although less precise and in some cases with couple of days' delay in response.

Figure 27a-c. Temperature, CO<sub>2</sub> and O<sub>2</sub> concentrations under the plastic sheets on green 10 ventilated through drainage pipes at Holtsmark. Green arrows indicate ventilations followed by a detectable change in CO<sub>2</sub> or O<sub>2</sub> concentration, while red arrows indicate apparently unsuccessful ventilations.

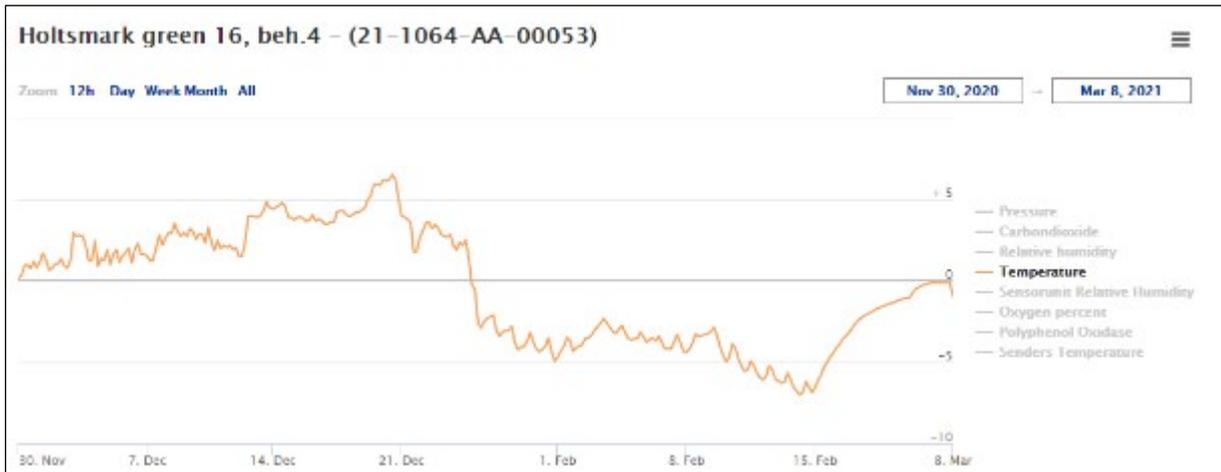
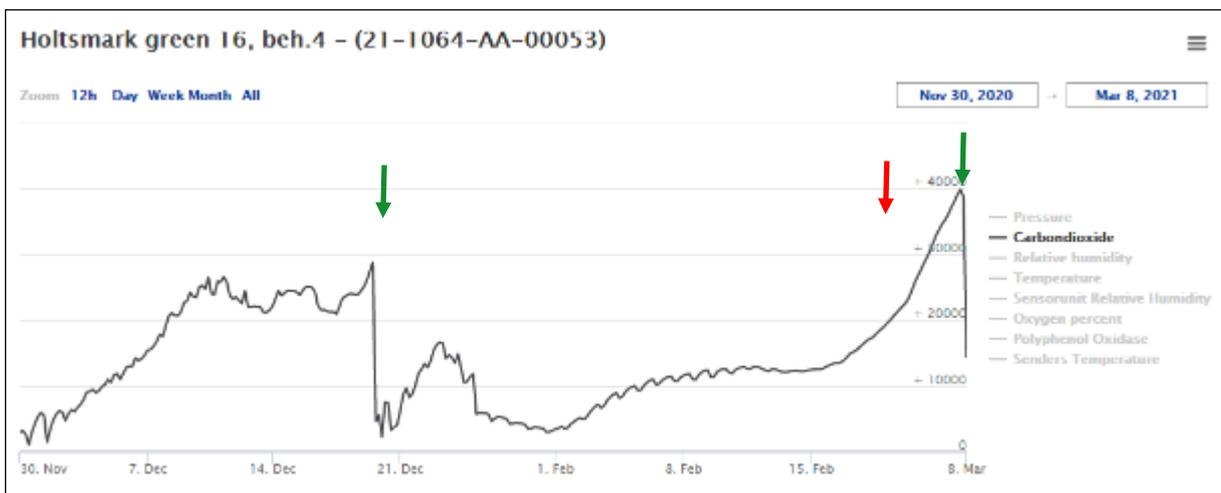
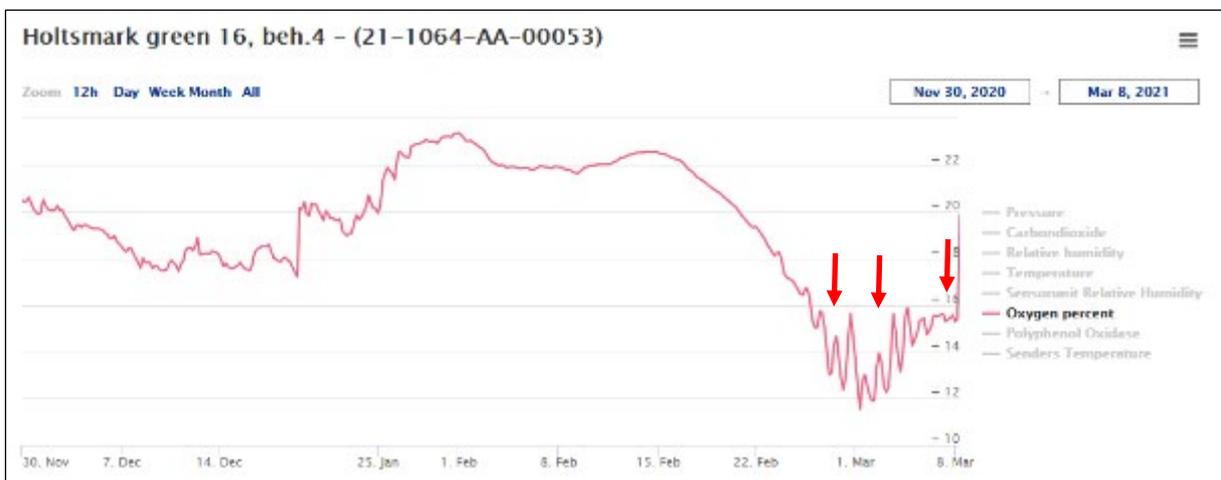
Also in treatment 4, Green 4 was never ventilated as the sensors were operative in December only and then never reached the threshold values (data not shown). Green 16 was, in contrast, ventilated on 18 Dec. and on 23 Feb. in response to the CO<sub>2</sub> threshold, and on 2 March according to the O<sub>2</sub> threshold as the CO<sub>2</sub> sensor was not in operation any more (Figure 28).

Figure 28a-c. Temperature, CO<sub>2</sub> and O<sub>2</sub> concentrations under the plastic sheets on green 16 ventilated through drainage pipes at Holtsmark. Green arrows indicate ventilations followed by a detectable change in CO<sub>2</sub> or O<sub>2</sub> concentration, while red arrows indicate apparently unsuccessful ventilations.

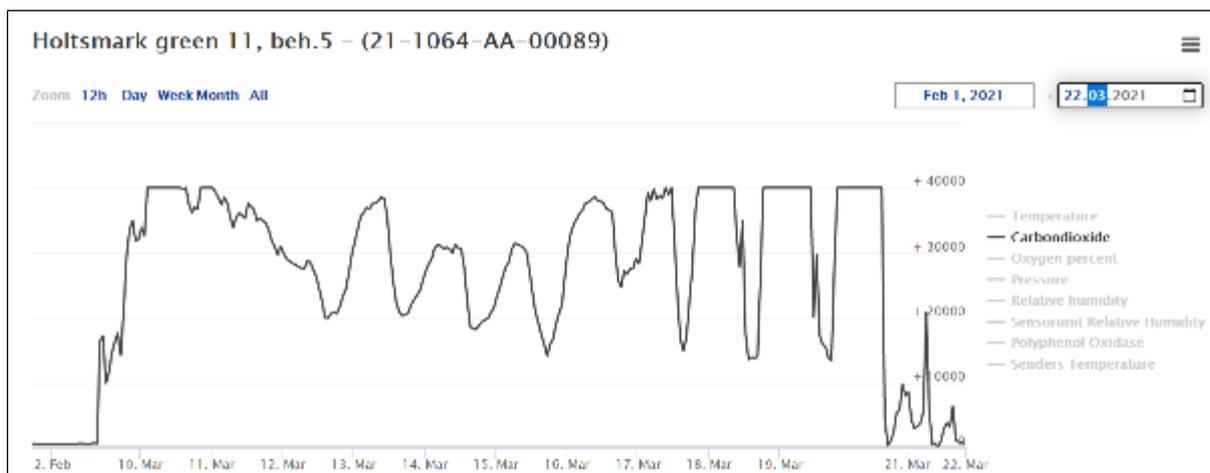
In treatment 5 (flat tubes), Green 11 was never ventilated despite CO<sub>2</sub>-concentrations reaching 40000 ppm on several occasions after the sensor had been replaced on 2 Feb. (Fig 29). Green 12 was ventilated on 18 Dec. because CO<sub>2</sub> had reached 40000 ppm., and this ventilation showed a temporary increase also in O<sub>2</sub>-values (Figure 30). Late ventilations were not carried out on this green as the CO<sub>2</sub> sensor went out of work while the O<sub>2</sub> sensor showed values above 12% O<sub>2</sub>.

Figure 29. CO<sub>2</sub>-concentration under the plastic sheets on green 11 (treatment 5) at Holtmark GC. This green was not ventilated despite CO<sub>2</sub> concentrations reaching 40000 ppm in March.

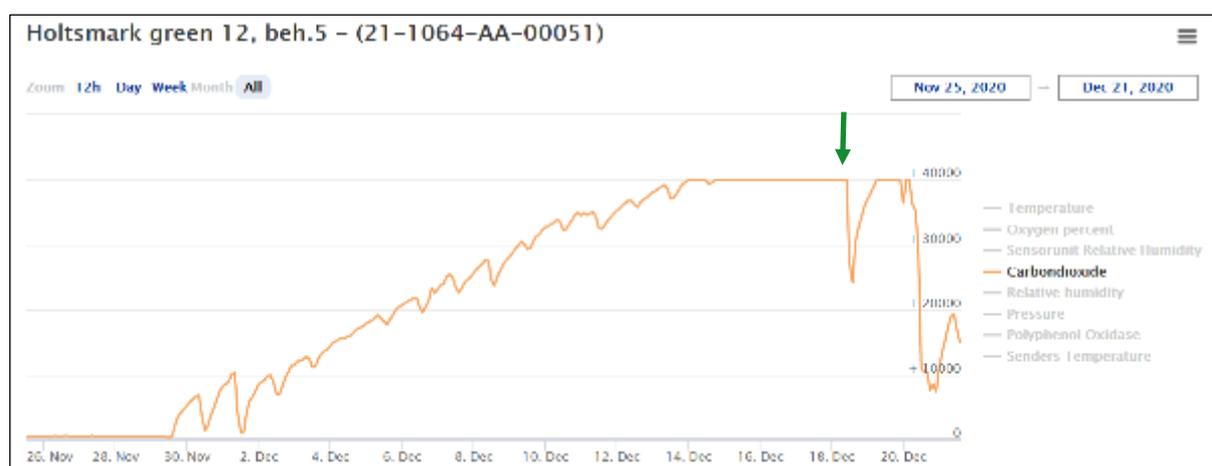
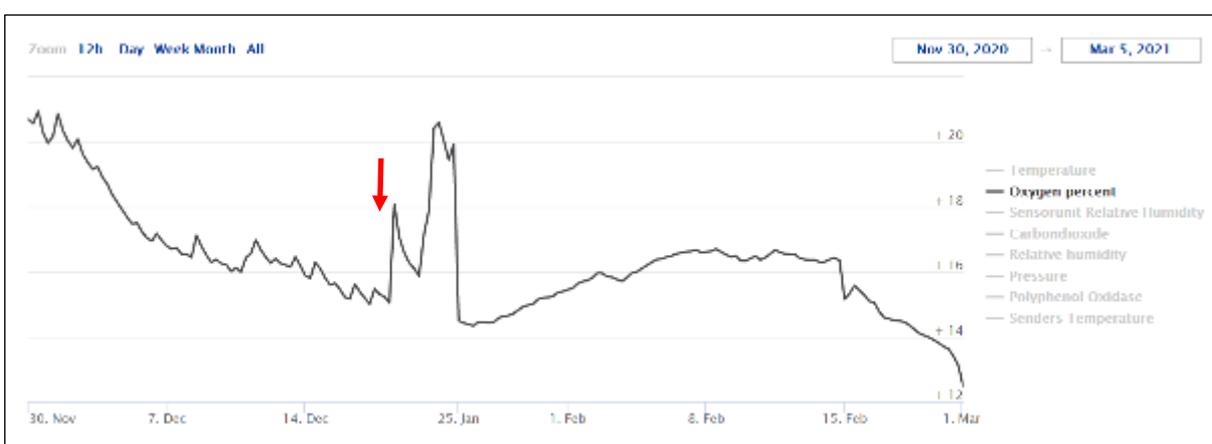
Figure 30a,b. CO<sub>2</sub> and O<sub>2</sub> concentrations under the plastic sheets on green 12 ventilated through flat tubes at Holtmark. This green was ventilated only on 18 Dec. because the CO<sub>2</sub> sensor failed after 21 Dec. whilst the O<sub>2</sub> sensor never showed concentrations below 12 %.
