# Impermeable plastic covers for better winter survival of golf course putting greens: Ventilation under the covers during the winter 2020-2021

NIBIO REPORT | VOL. 7 | NO. 181 | 2021

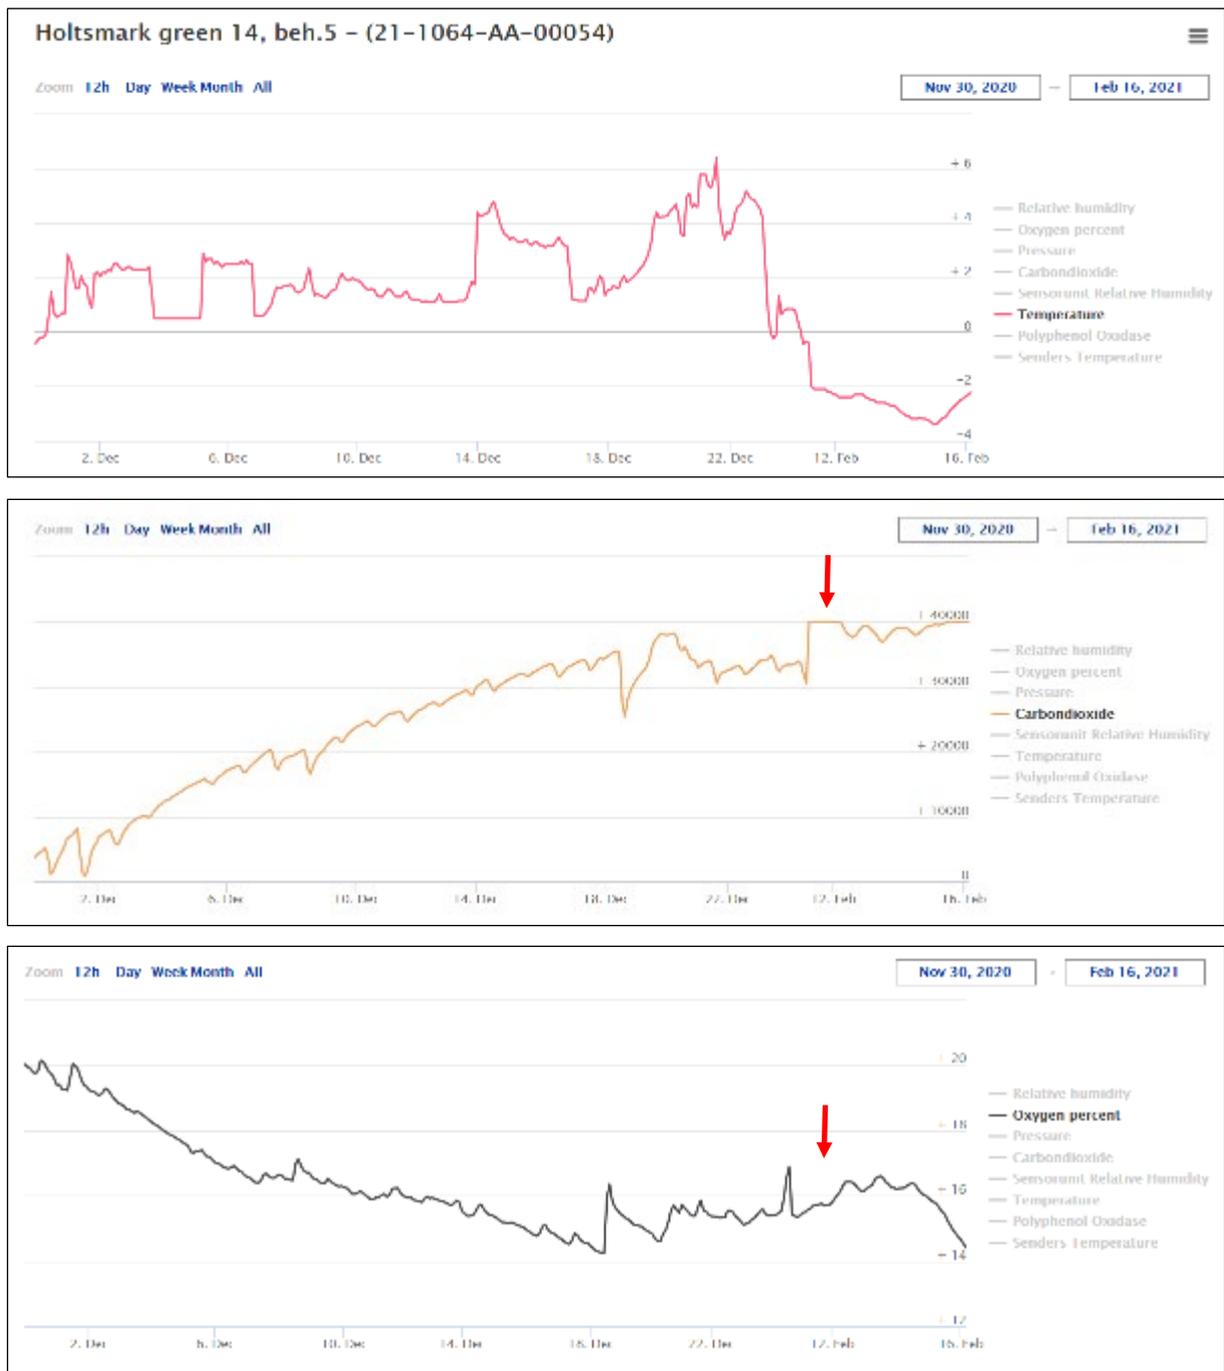
Green 14, also representing treatment 5, was ventilated on 11 Feb. in response CO<sub>2</sub> reaching 40000 ppm., but at this point there was hardly any detectable response in either CO<sub>2</sub> or O<sub>2</sub> concentration (Figure 31). Ventilation was repeated also on 18 Feb., 23 Feb., 2 March and 9 March although none of the sensors were working on these dates.

Figure 31 a-c. CO<sub>2</sub> and O<sub>2</sub> concentrations under the plastic sheets on green 14 ventilated through flat tubes at Holtmark GC. CO<sub>2</sub> and O<sub>2</sub> concentrations responded to ventilation on 18 Dec. but not on 11 Feb. The green was ventilated also on 18 Feb. 23 Feb., 2 March and 9 March despite sensors did not work after 16 Feb.

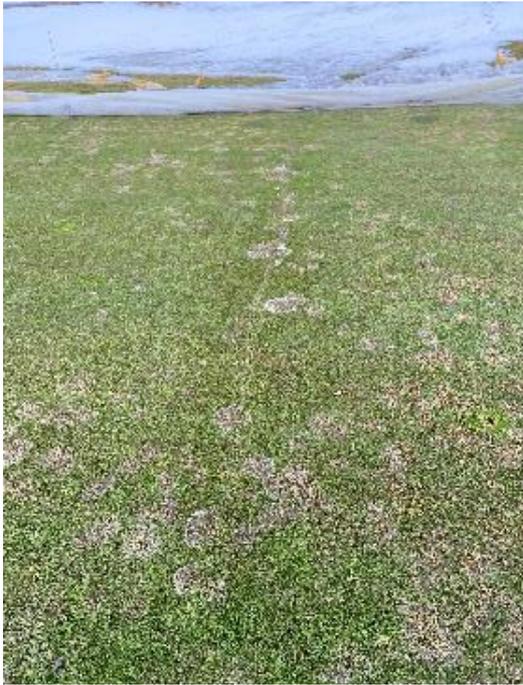
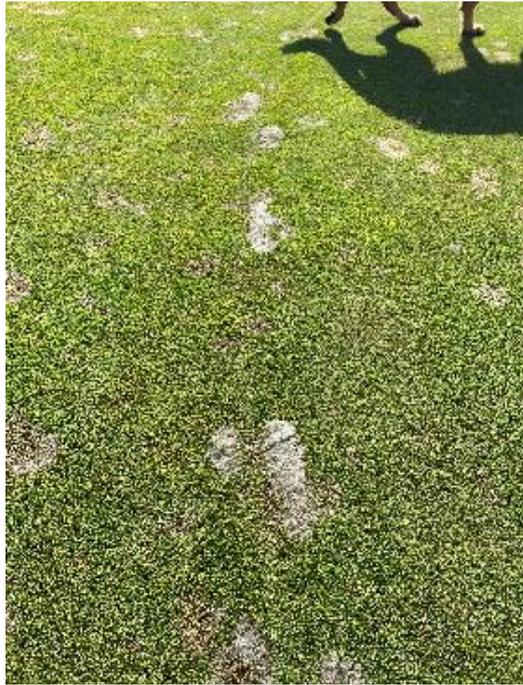
*Photo 32a,b. Close up from Greens 18 and 15 on 24-25 March. There were patches of micordochium patch all over these greens, but the disease appeared to be most active (new mycelium) close to the drainage pipes. Photos: Mads Thers.*

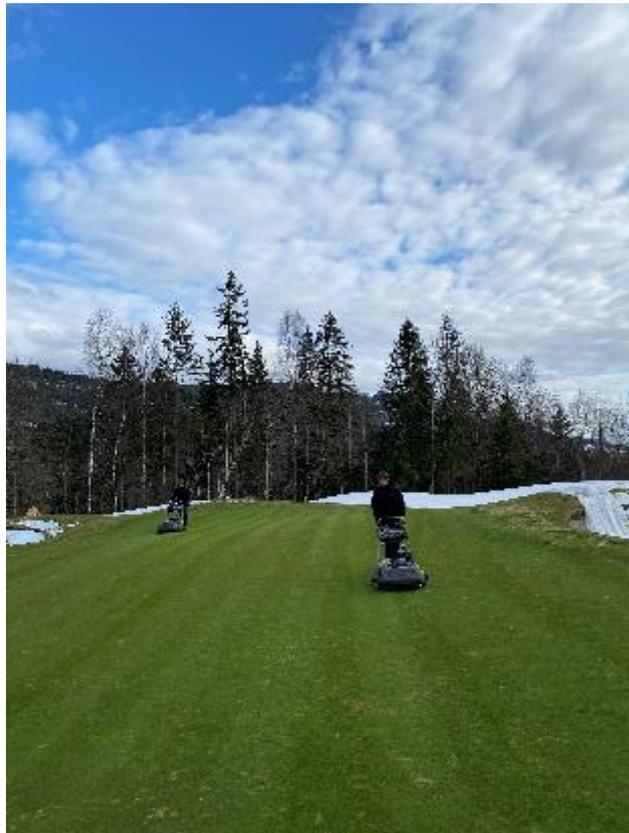
*Photo 33. First mowing using walk-behind mowers on Green 12, 14 April. Photo Mats Thers.*
