Environmental monitoring of the archaeological deposits at Øvregaten 19, Bergen

Concluding report 2013-2017

NIBIO RAPPORT | VOL. 3 | NR. 101 | 2017

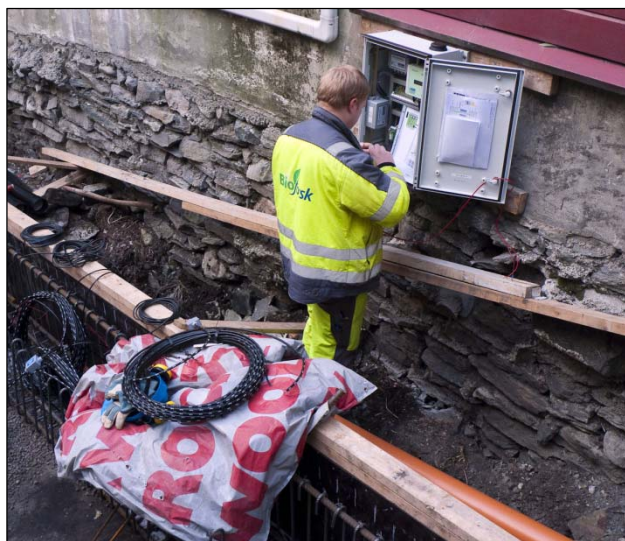
The sensors that have been installed are TRIME-PICO 32 from IMKO Modultechnik GmbH. These sensors can be installed in a heterogeneous and sandy stone-rich type of soil that is often found at archaeological sites. The sensors have universal calibration for mineral soils as standard. All sensors were connected to an automatic standard logger from SEBA Hydrometrie GmbH (<http://www.seba-hydrometrie.de/en/applications.html>). The data is made accessible on a website via mobile modem technology. The logger and battery were placed in a waterproof cabinet close to the site (Figure 2).

Figure 2. A waterproof cabinet for the automatic logger from SEBA Hydrometrie GmbH was installed on the wall close to the site.

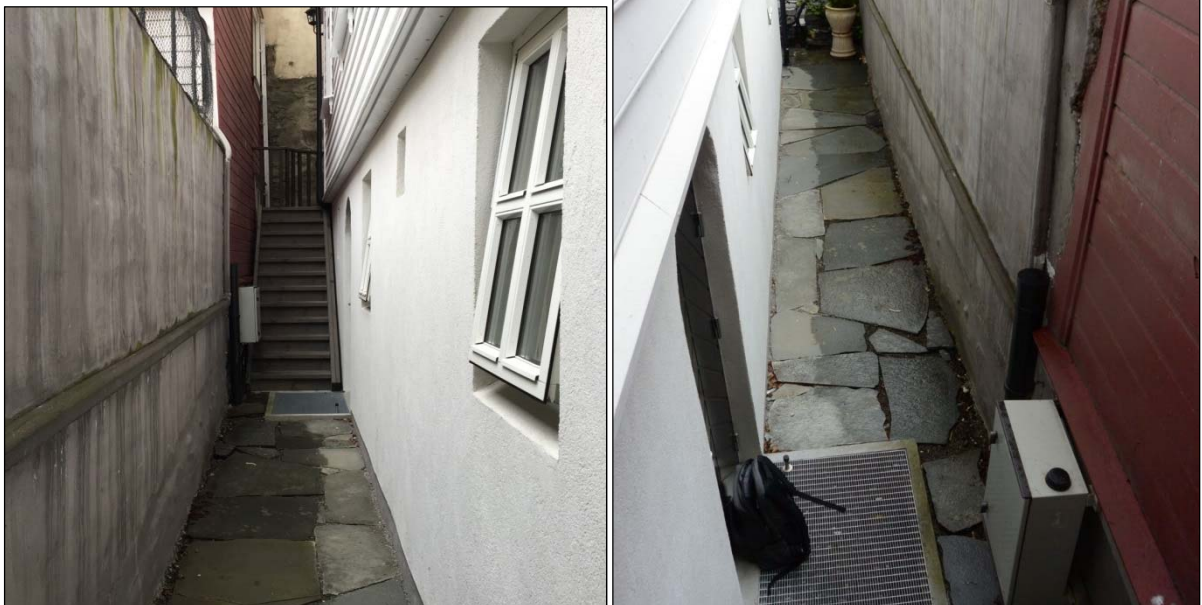
Location of Cabinet with the logger at Øvregaten 19 (June 2016)

The logger battery was recharged in late June 2015.

The battery capacity for the monitoring equipment is still satisfactory and is expected to work well for the rest of the monitoring period.
