Sampling for wood decay analyses of cable car trestles and houses at Svalbard

Field report

NIBIO REPORT | VOL. 9 | NR. 12 | 2023

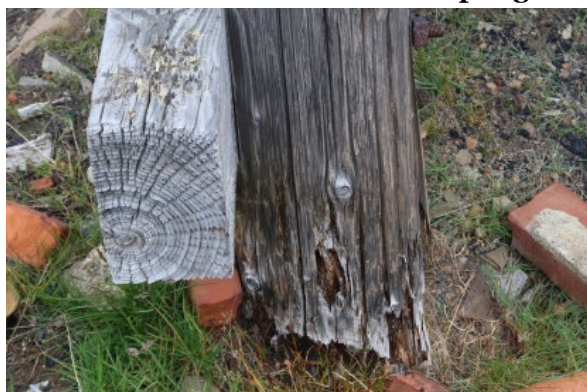
This cable car trestle has clear signs of fungal decay in all the foundation legs. It is low and stands away from traffic, so it does not pose a great danger to the surroundings. Nevertheless, reindeer often graze in the vicinity.

Leg SW, soil contact, before sampling

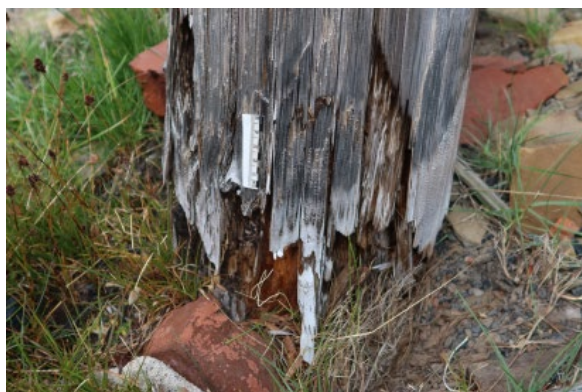
Leg SW, soil contact, after sampling

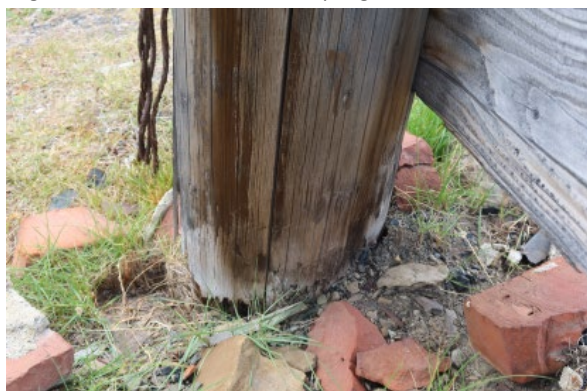
Leg SW, above ground, before sampling

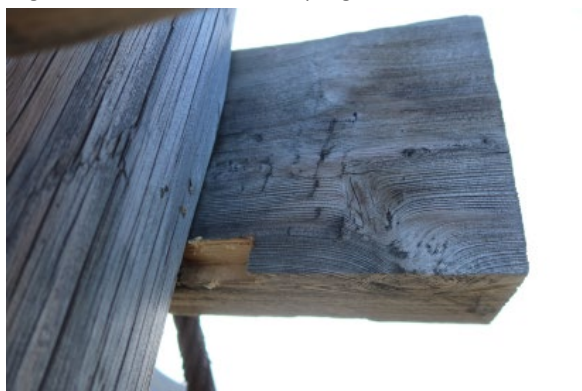
Leg SW, above ground, after sampling

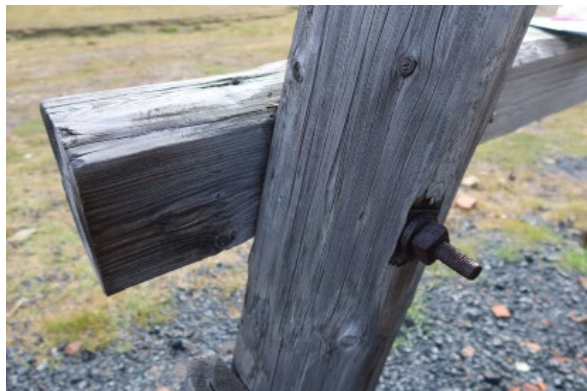
Leg NE, above ground, before sampling

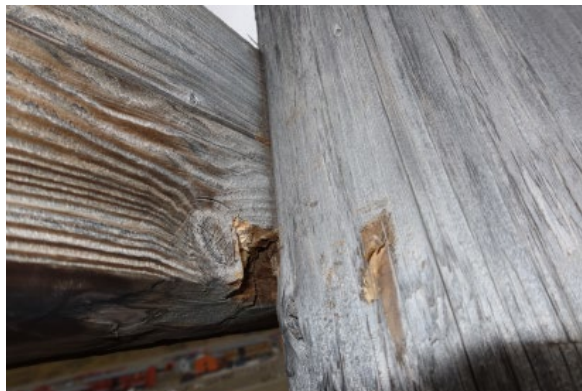
Leg NE, above ground, after sampling

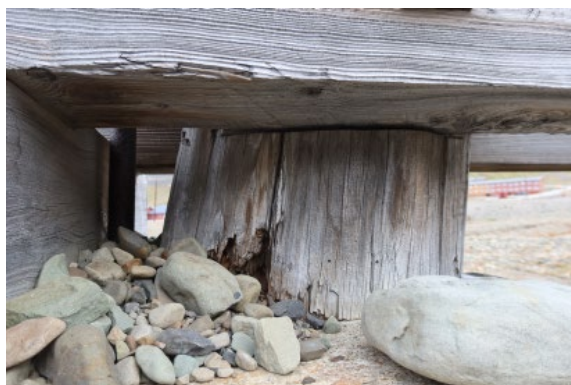
Leg NE, soil contact, after sampling

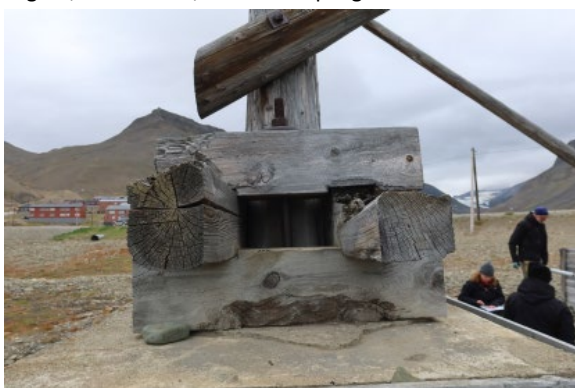
Leg NE, above ground, before sampling

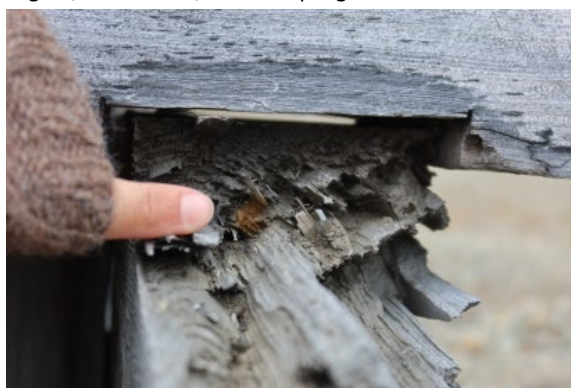
Leg NE, above ground, after sampling

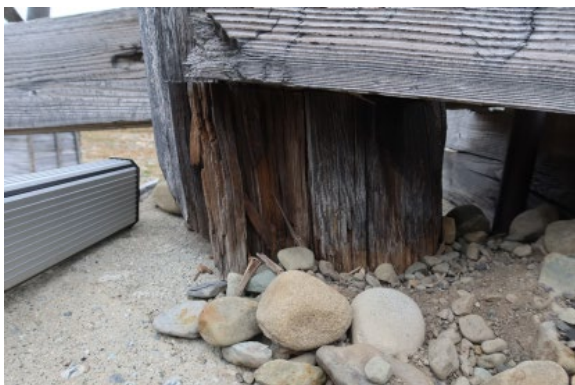
Leg SW, soil contact, before sampling

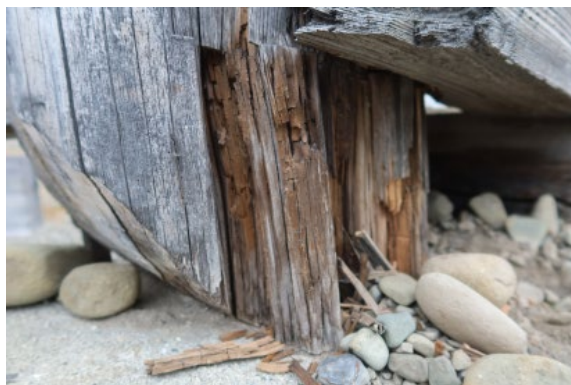
Leg SW, soil contact, after sampling

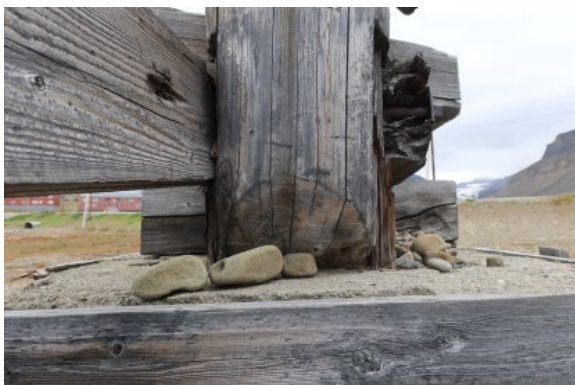
Leg SW, above ground, before sampling

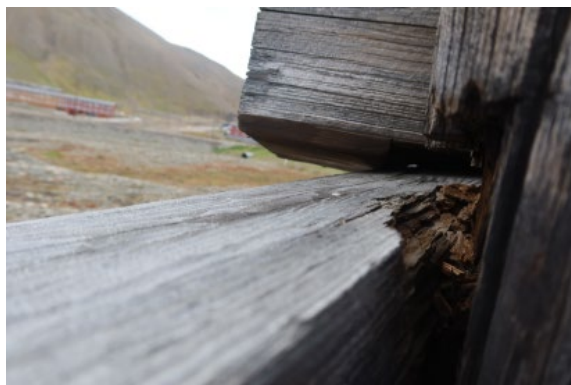
Leg SW, above ground, after sampling

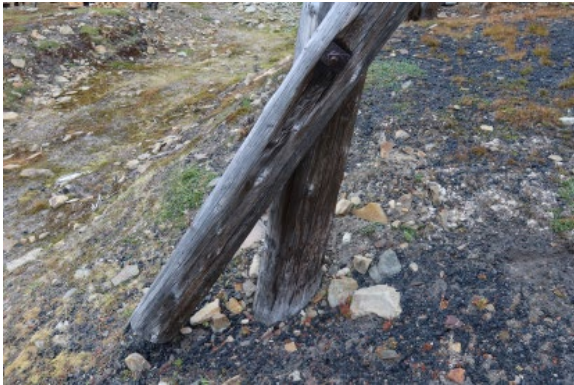
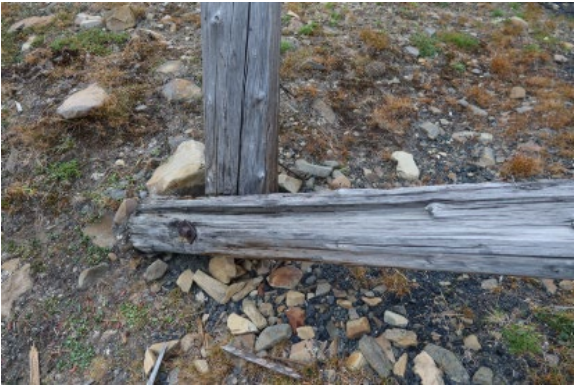
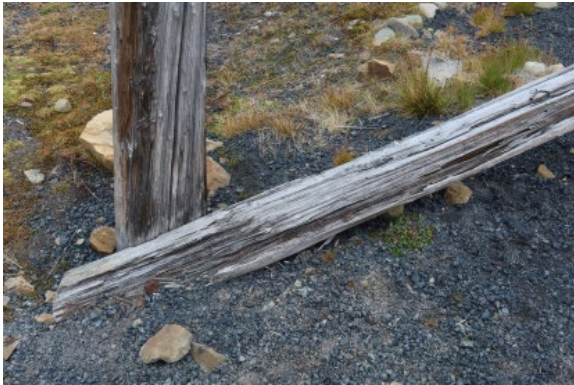
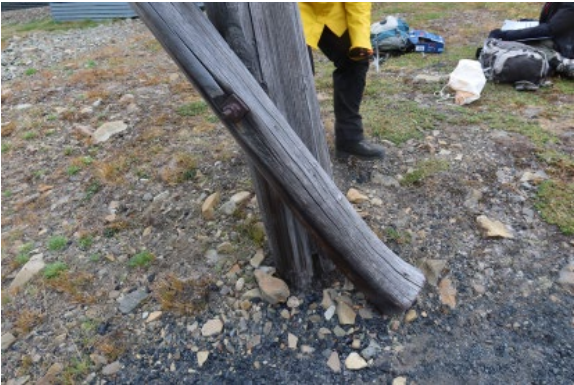
Apparently in good condition and all structural elements in place. Fungal decay in inclined braces. The cable car trestle has not been restored and stands with original materials. Two of the foundation legs may appear to be weakened by fungal decay. The trestle is of medium height, but stands close to residential buildings, and can potentially cause major damage to the buildings.

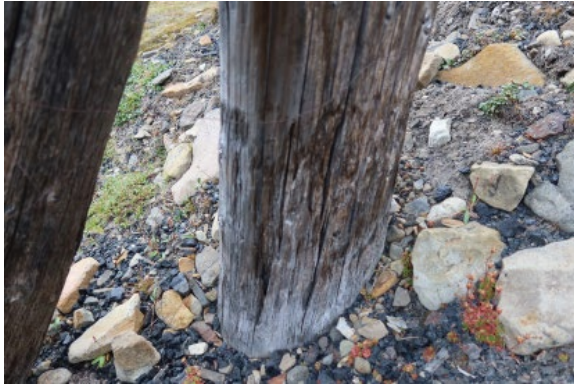
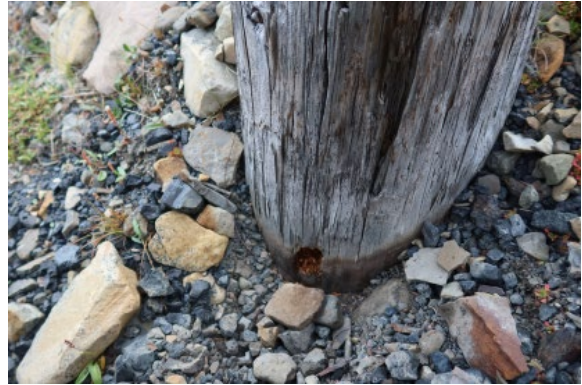
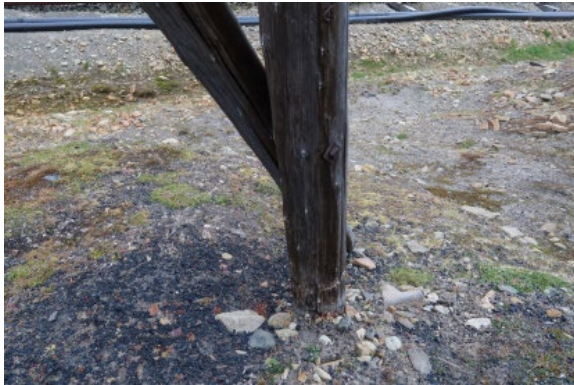
Leg NW, soil contact, before sampling

Leg NW, soil contact, after sampling

Leg NW, above ground, before sampling

Leg NW, above ground, after sampling

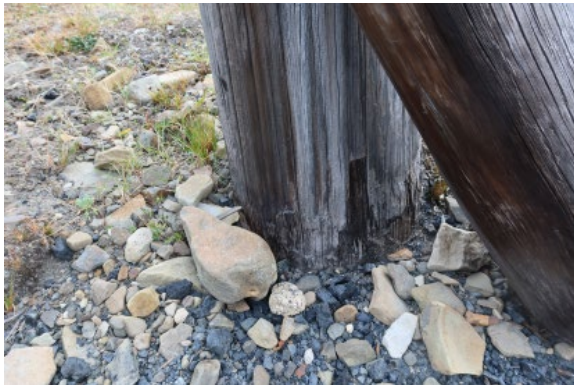
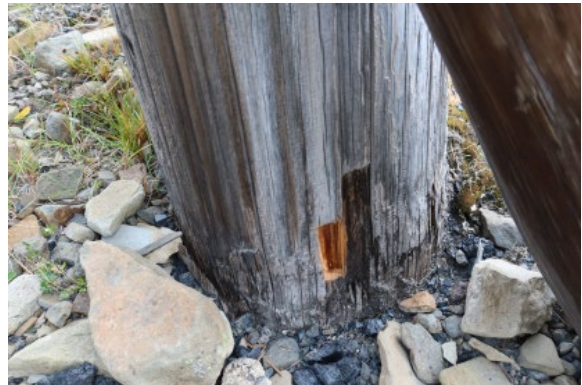
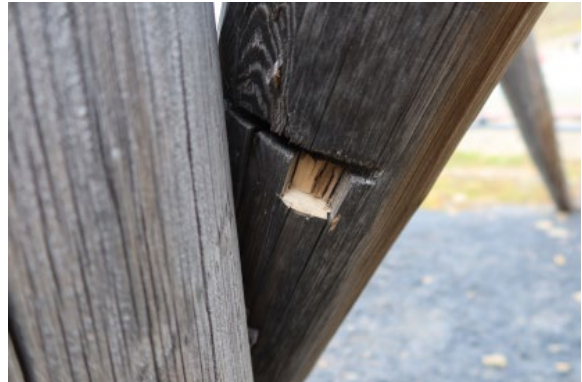
Leg SE, soil contact, before sampling

Leg SE, soil contact, after sampling

Leg SE, above ground, before sampling

Leg SE, above ground, after sampling

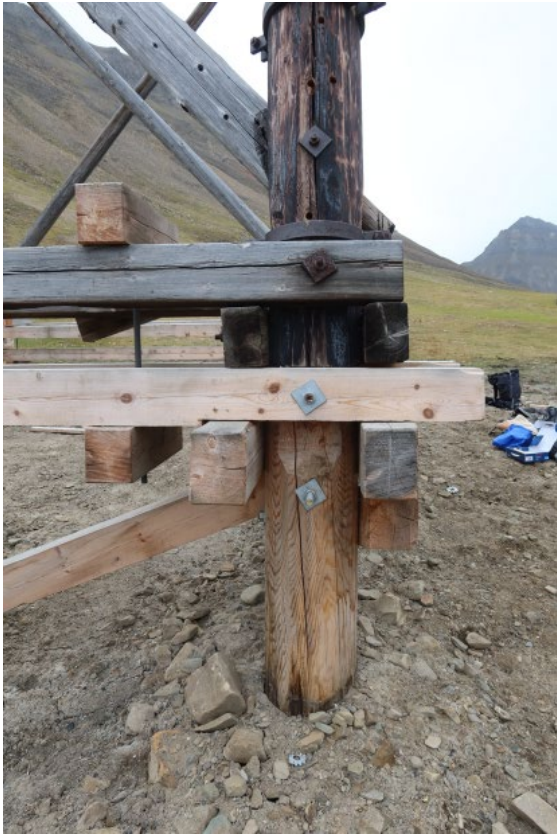
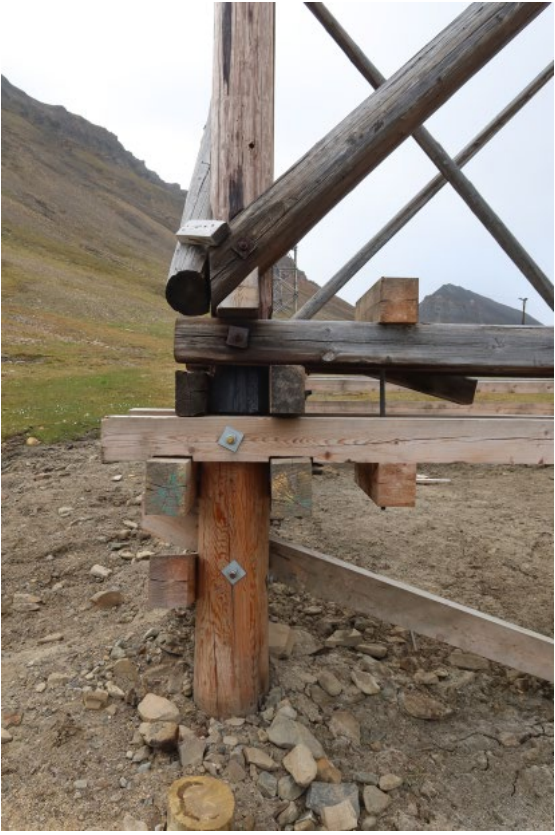
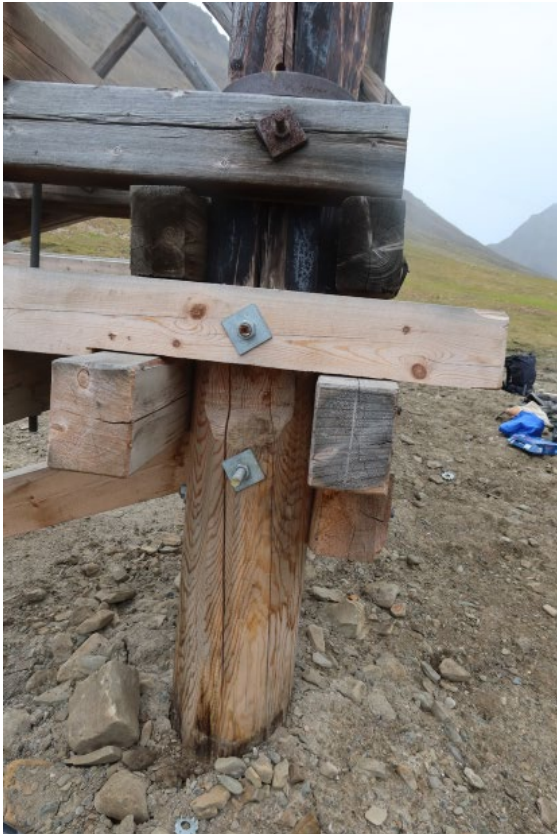
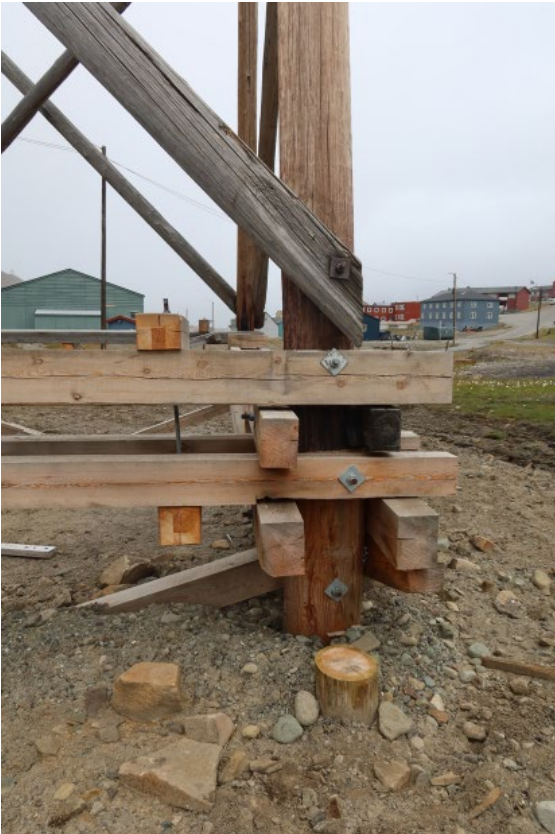
Extensive improvement/replacement in the lower part and foundations in the near future. Creosote in vertical main posts. Apparently in good condition higher up in the construction, however, extensive fungal decay on the upper side of the inclined braces to the north. Should have been replaced. The cable car trestle stands in a flat lojn, but is very tall, and are situated close to a trafficked road.

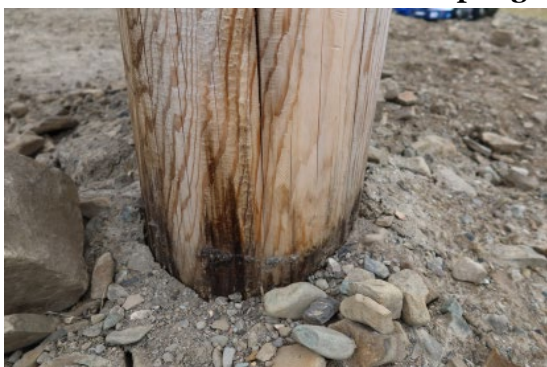
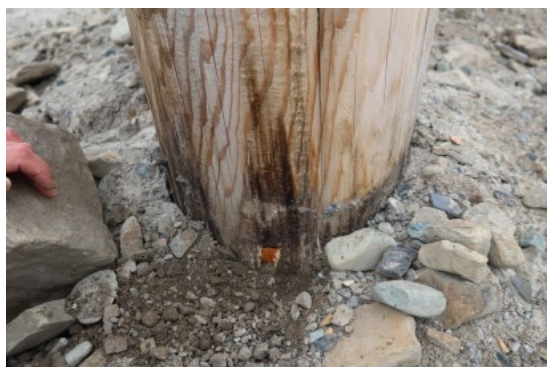
Leg NW, soil contact, before sampling

Leg NW, soil contact, after sampling

Leg NW, above ground, before sampling

Leg NW, above ground, after sampling

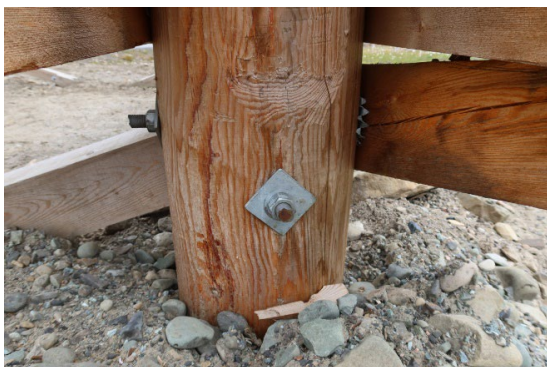
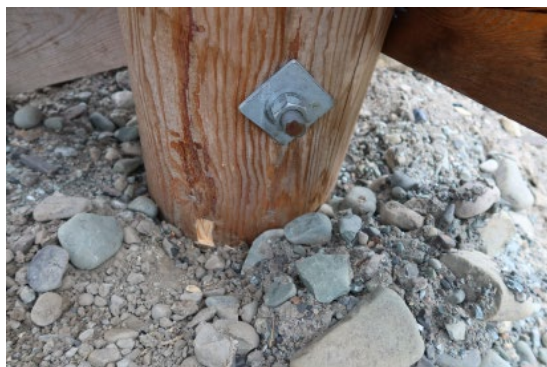
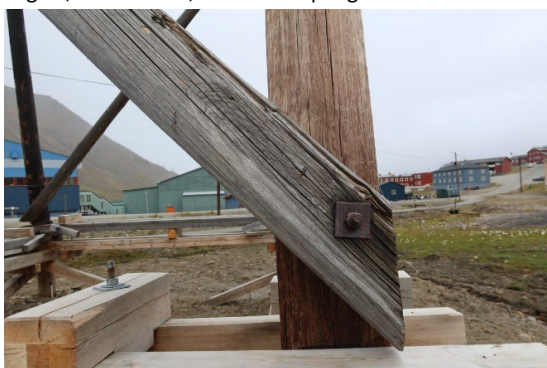
Leg SE, soil contact, before sampling

Leg SE, soil contact, after sampling

Leg SE, above ground, before sampling

Leg SE, above ground, after sampling

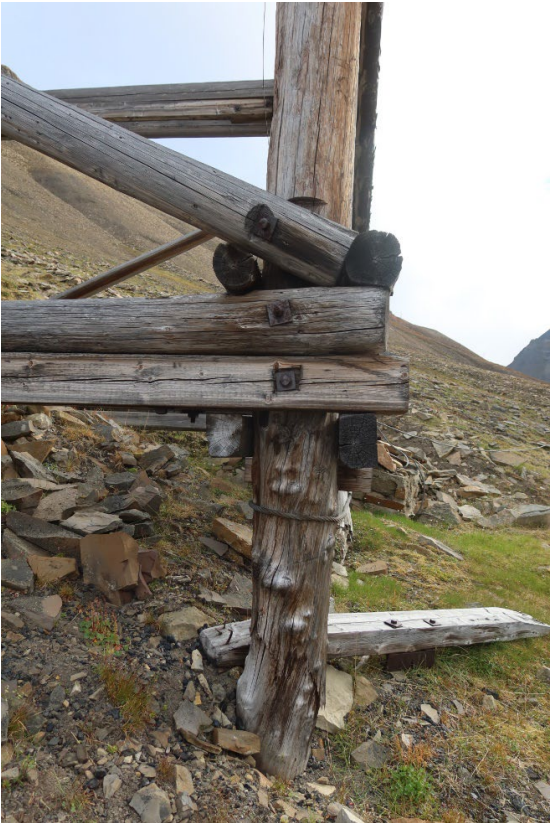
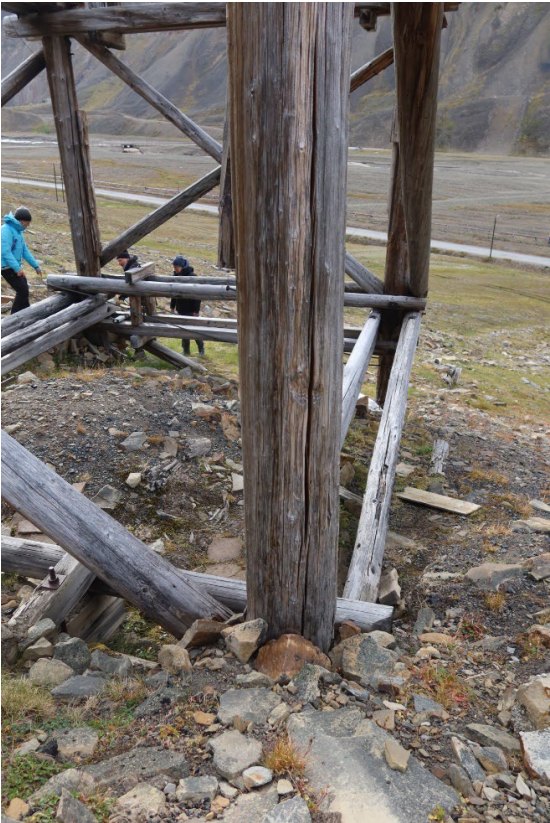
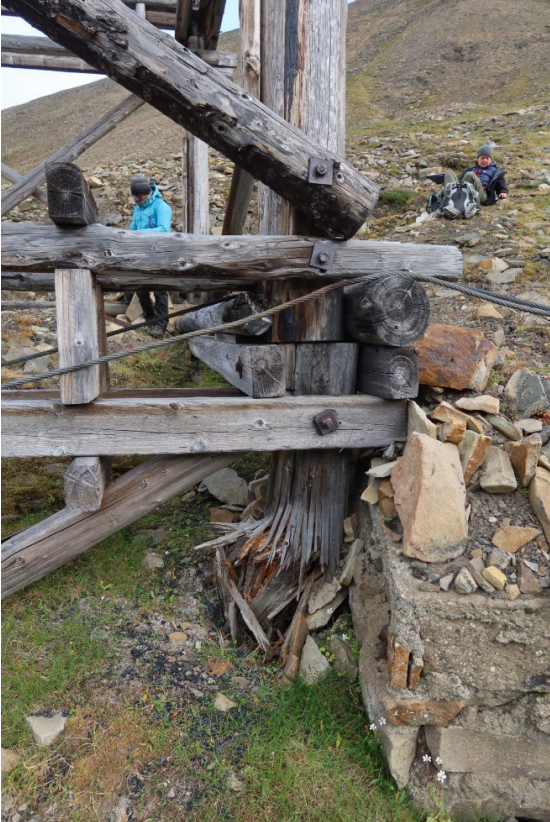
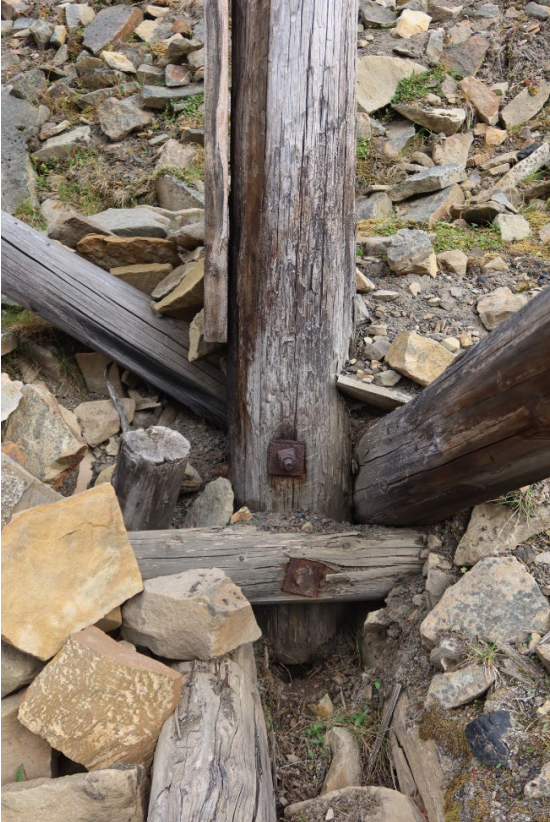
Both foundation legs to the west are completely off due to fungal decay. The rest of the construction looks relatively intact/in good condition. Due to the decayed foundation legs the hole trestle is slightly twisted. The cable car trestle is very high and stands on a steep slope, next to the path leading up to the mine, and visitors get up close. At present, however, the mining facility and the surrounding area are closed to visitors due to a very unsafe and presumably poor condition.

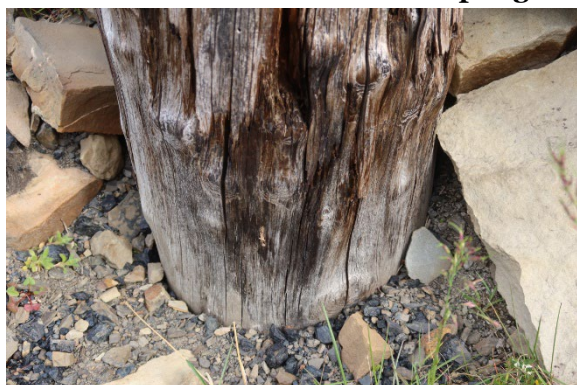
Leg NW, soil contact, before sampling

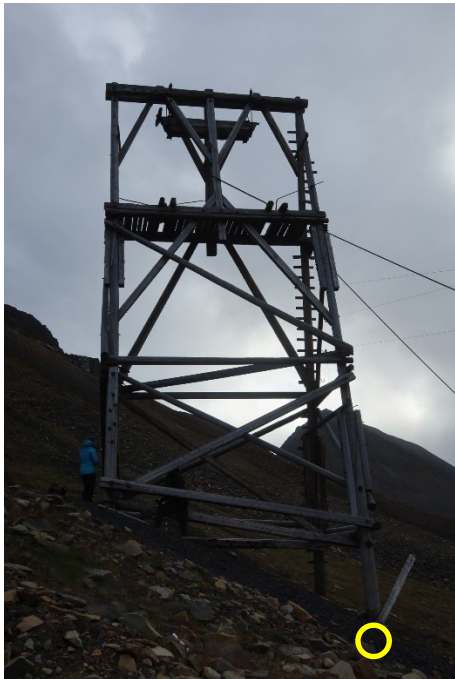
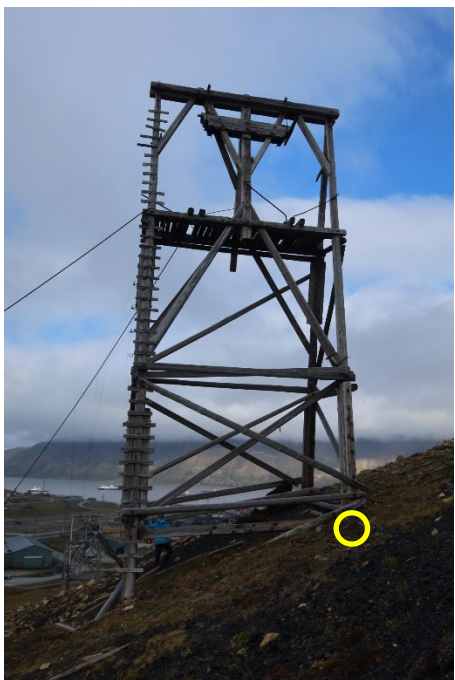
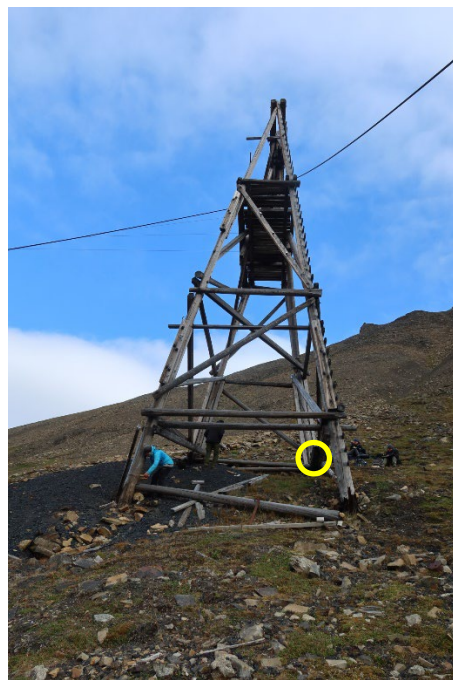
Several of the lower horizontal crossbeams to the south/southeast have broken and/or are missing. Otherwise, the rest of the construction looks relatively intact. Foundation legs to the southwest are broken and completely decomposed by fungal decay. The foundation legs show signs of rot damage. The cable car trestle is very high and stands on a steep slope, next to the path up to the mine, and visitors get up close. At present, however, the mining facility and the surrounding area are closed to visitors due to a very unsafe and presumably poor condition.

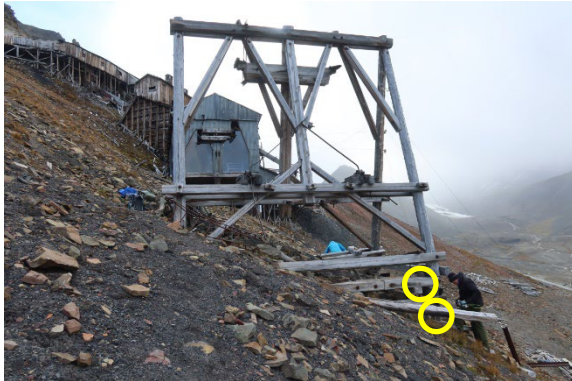
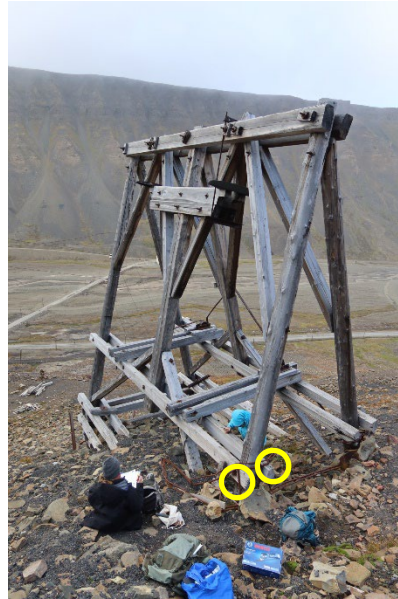
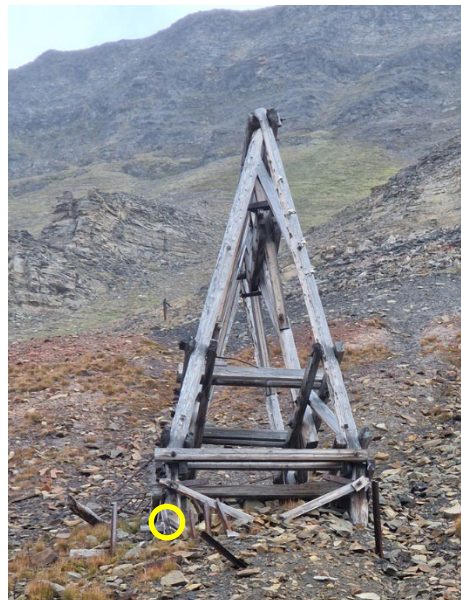
The cable car trestle stands right up next to the mine's day plant. It is partially covered by landslide material. The trestle is low but stands on a steep slope. The foundation legs show signs of rot damage. As it stands in the path up to the mine, visitors get up close. At present, however, the mining facility and the surrounding area are closed to visitors due to a very unsafe and presumably poor condition.

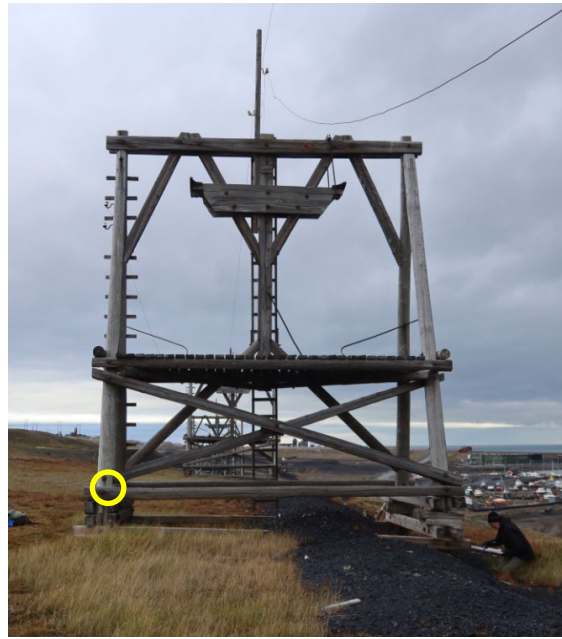
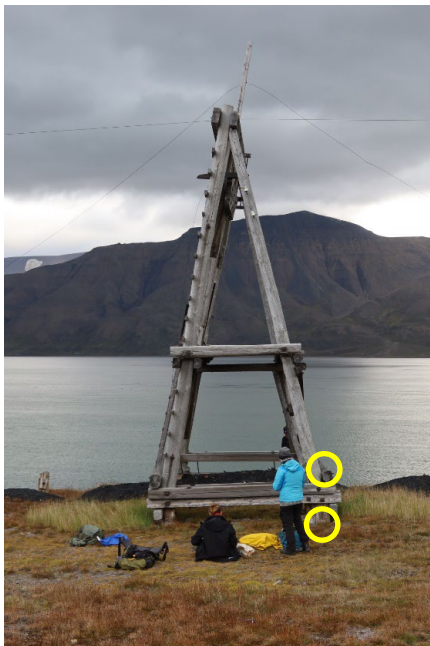
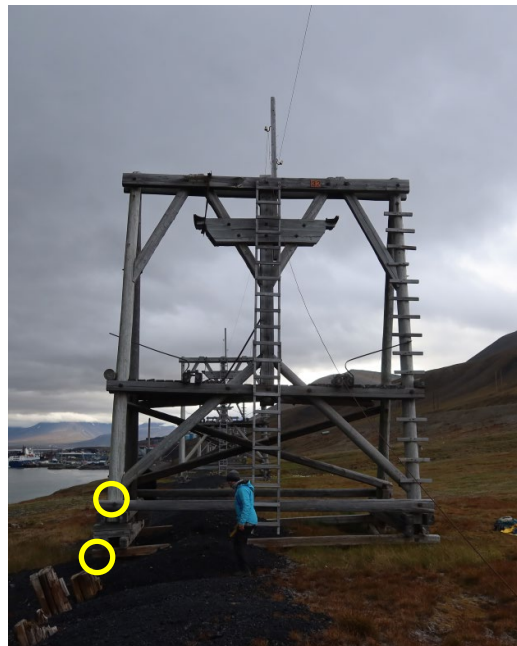
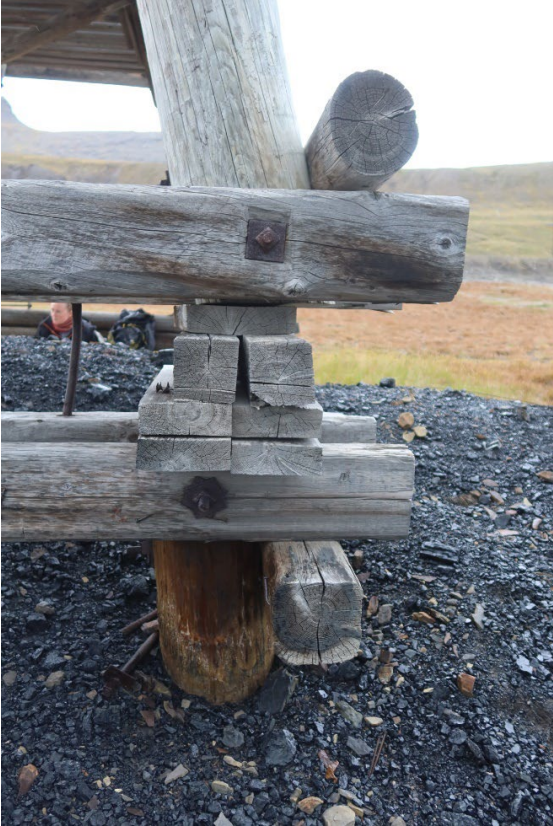
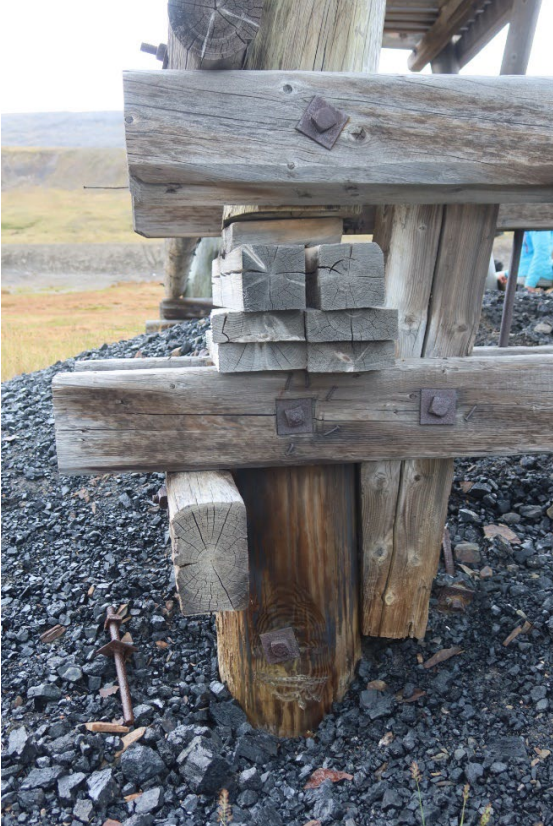
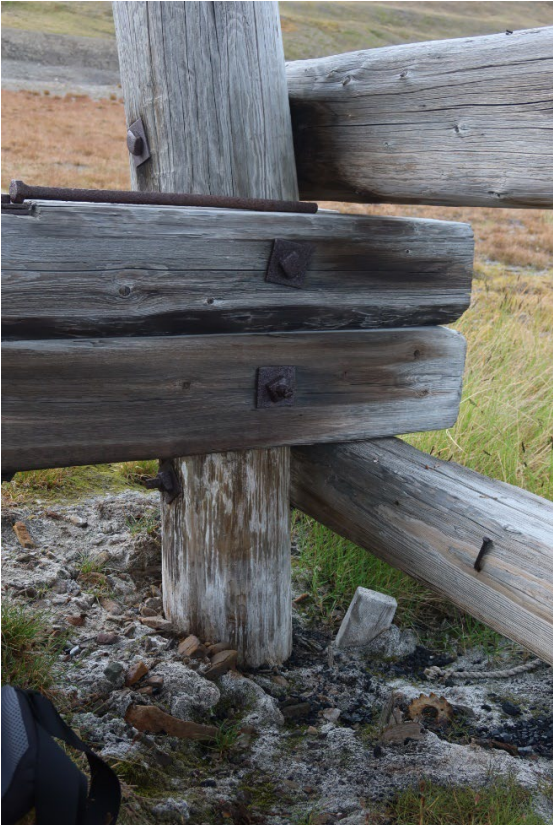
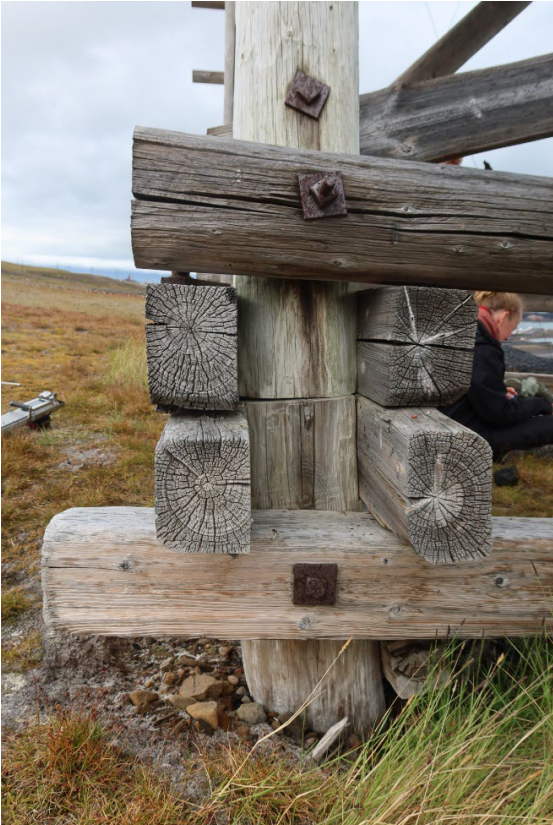
Overview photos – overview of each leg. Taken from different directions depending on structure

This cable car trestle is in surprisingly good condition. Visible salt impact from the ground on foundation legs in the south. Weathering, no rot on beams inspected above ground. This cable car trestle has not been repaired but is in original materials. All the trestles (except from two) in this line were completely replaced while the facility was still in operation. However, we have not been able to find information about when this happened.

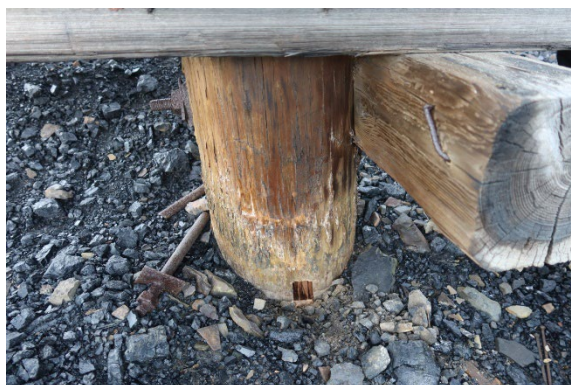
Leg NW, soil contact, before sampling

Leg NW, soil contact, after sampling

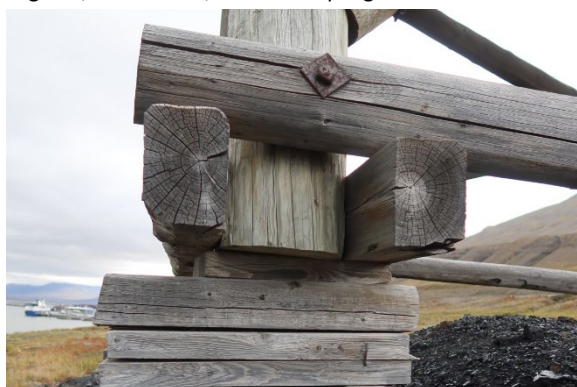
Leg NW, above ground, before sampling

Leg NW, above ground, after sampling

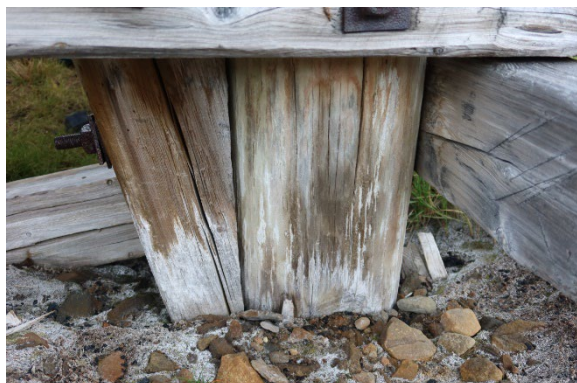
Leg SE, soil contact, before sampling

Leg SE, soil contact, after sampling

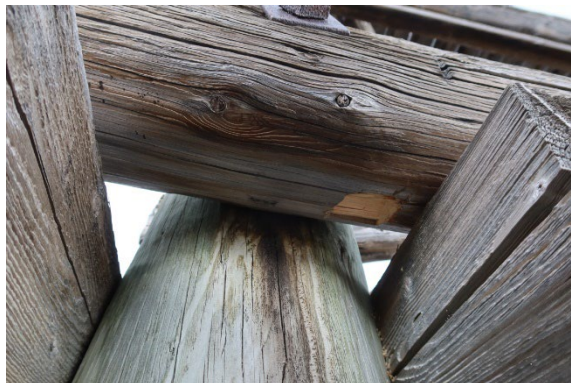
Leg SE, above ground, before sampling

Leg SE, above ground, after sampling

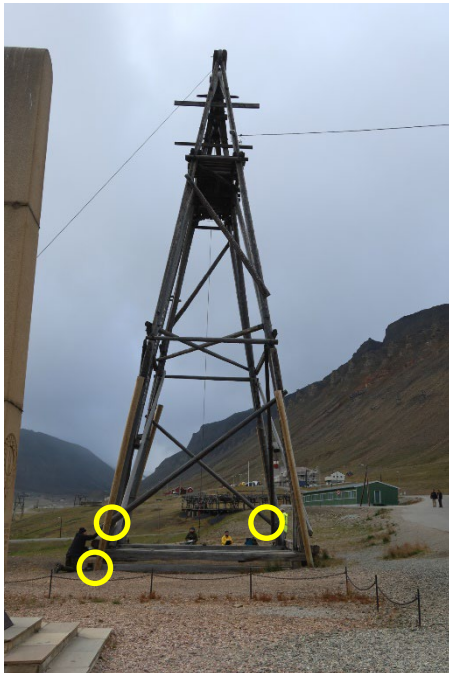
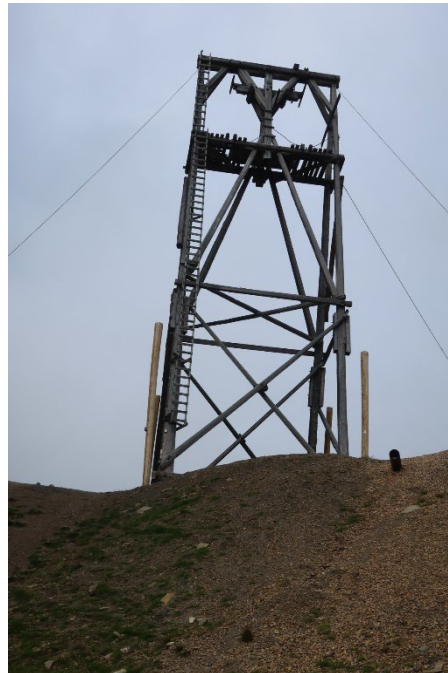
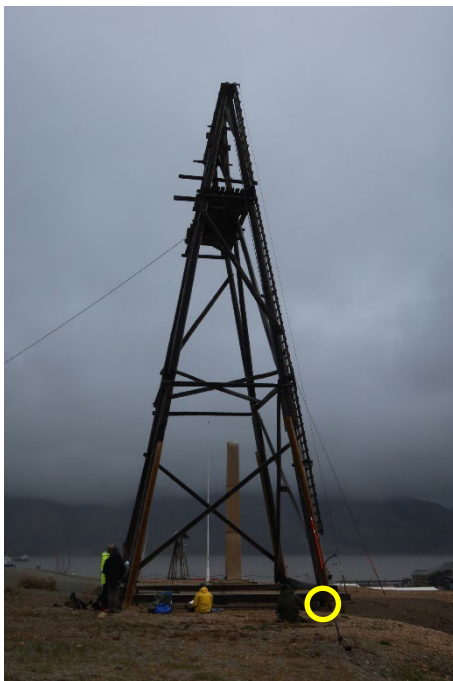
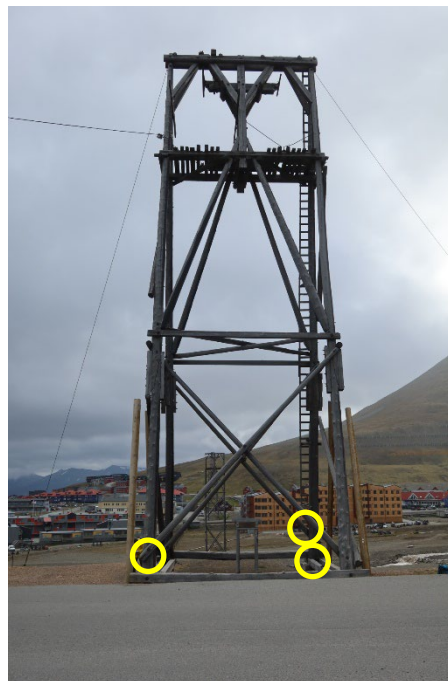
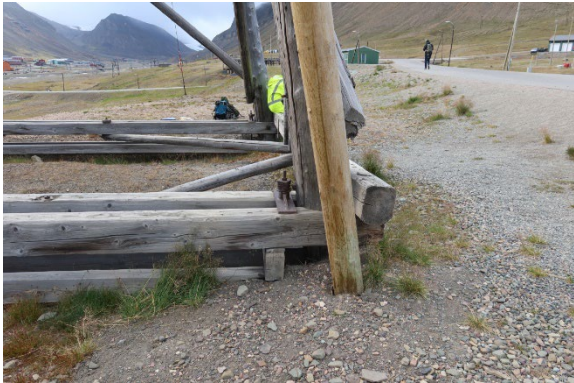
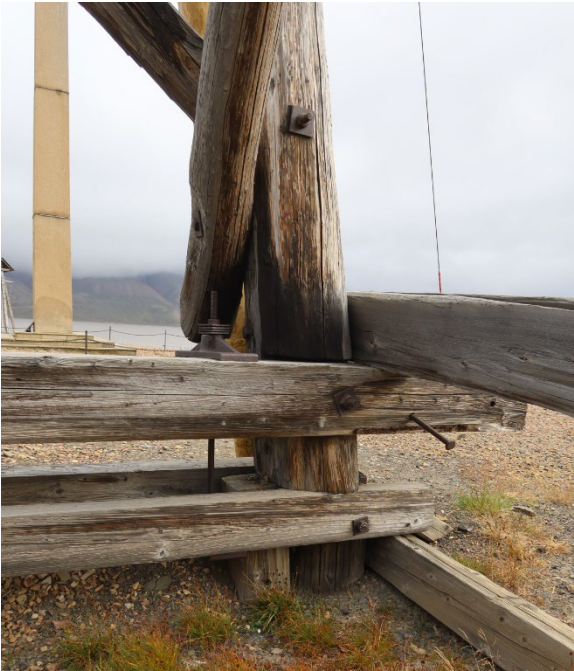
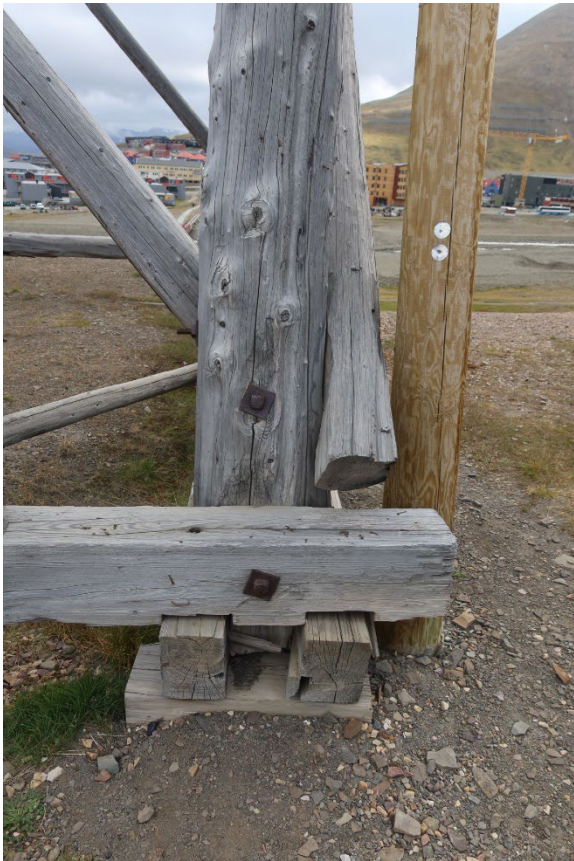
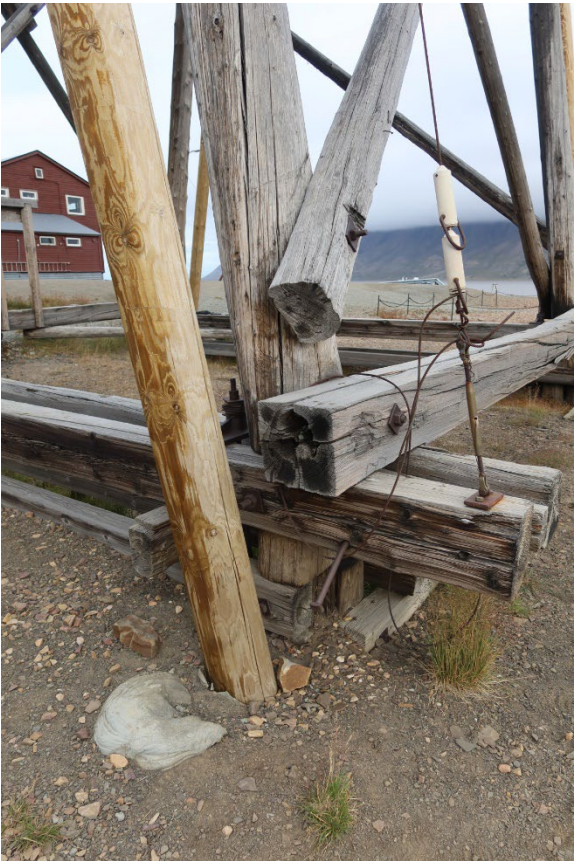
Overview photos – cardinal directions, overview of whole trestle

On this cable car trestle, restoration work has started, but has apparently stopped without being completed. There is no visible damage and apparently the trestle is in good condition. The trestle is very tall and stands right next to the road. It can therefore potentially pose a major danger to passers-by.

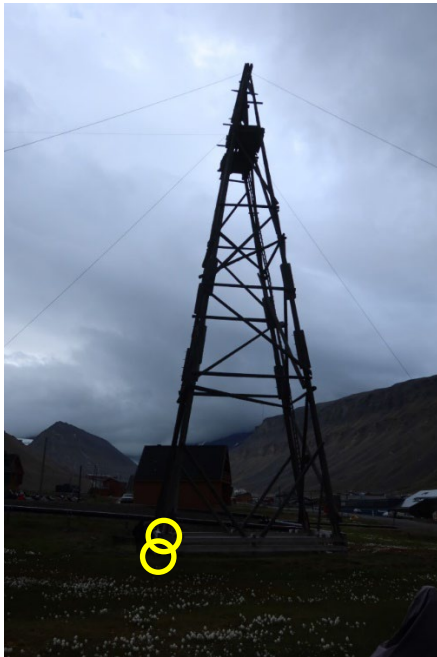
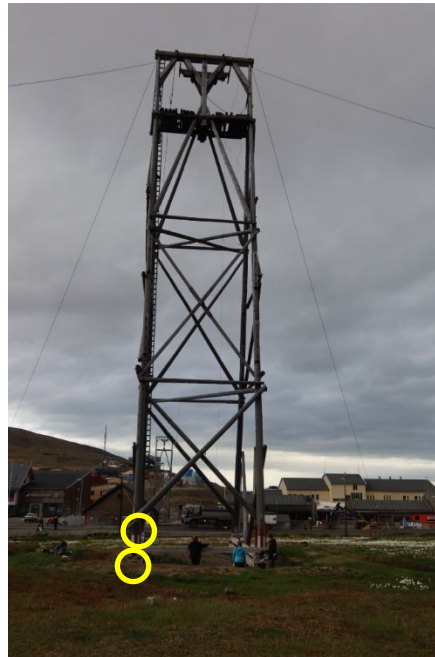
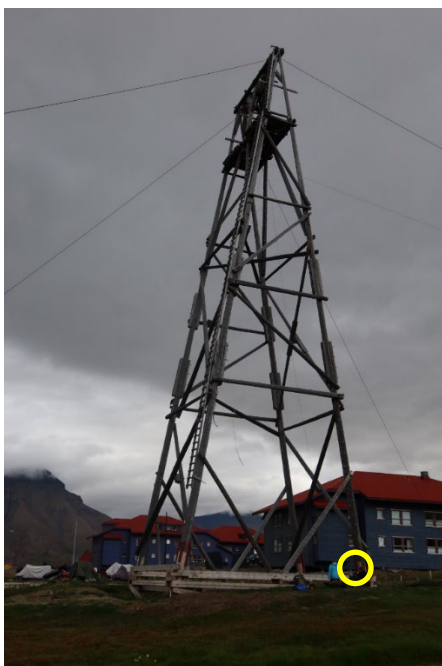
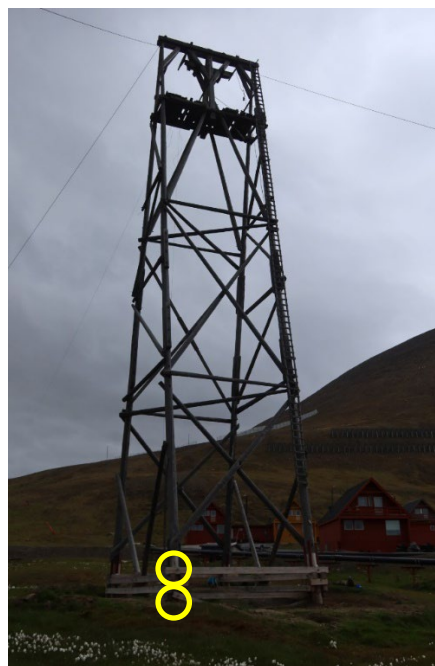
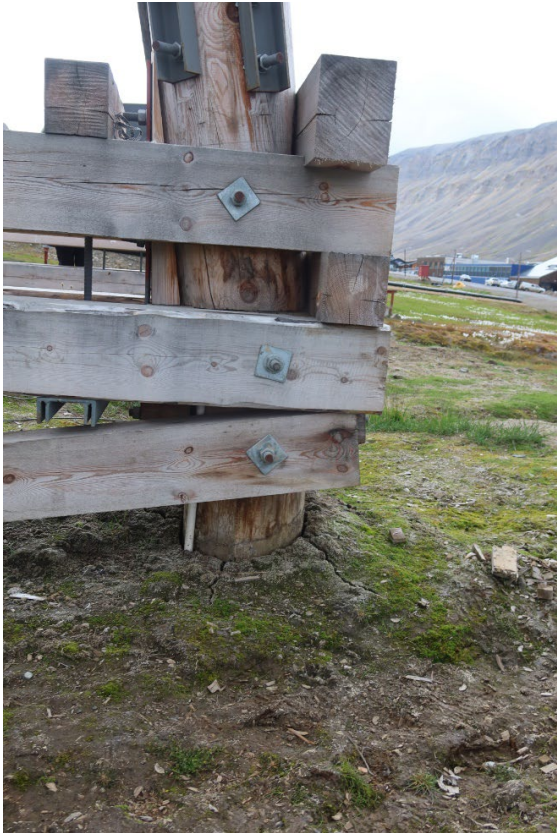
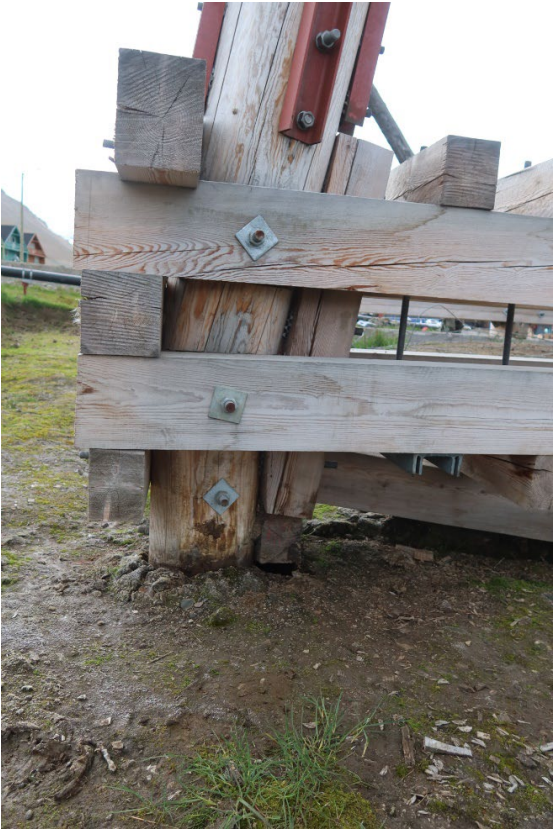
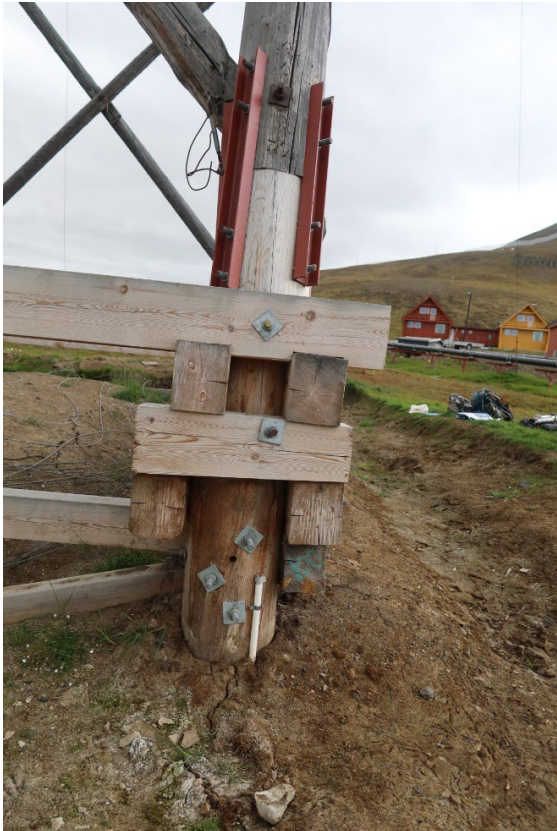
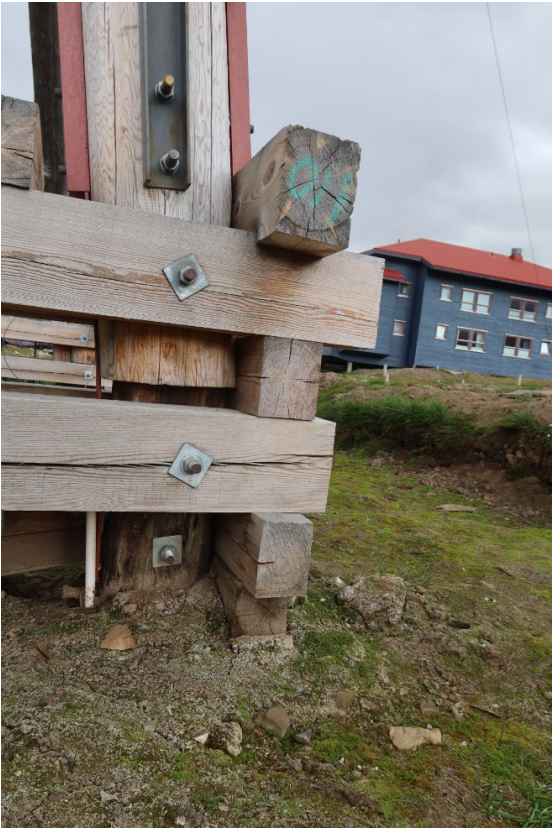
Overview photos – cardinal directions, overview of whole trestle

This cable car trestle has recently been restored and the lower parts have been completely replaced. The trestle is therefore in good condition. It is situated close to where people pass, with snowmobile parking and houses close by, and is very tall. It is therefore important that it is restored.

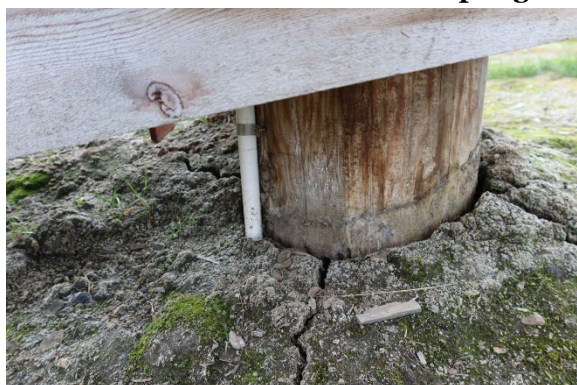
Leg NW, soil contact, before sampling
