Sampling for wood decay analyses of cable car trestles and houses at Svalbard

Field report

NIBIO REPORT | VOL. 9 | NR. 12 | 2023

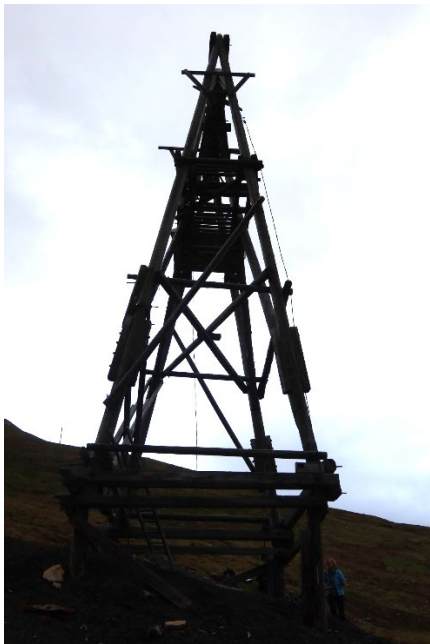
N

This cable car trestle has not been restored but hold original materials/timber. Several of the foundations/legs have extensive rot damage in the transition between ground and air, and the foundation has slipped partly due to solifluction, and partly due to rot. The trestle is therefore in poor condition. It is situated in a slope and will therefore continue sliding. The trestle is close to the ski lift and close to people.

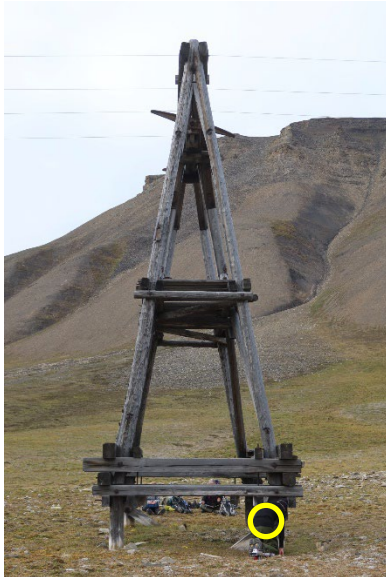
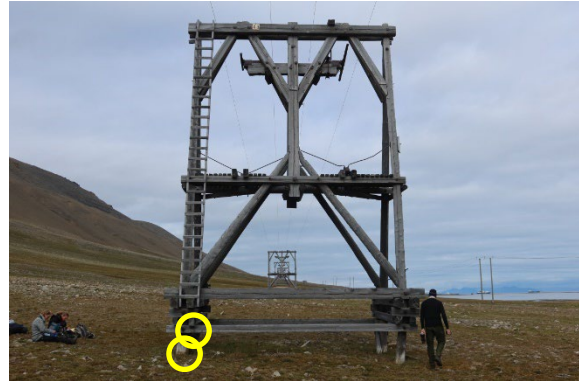
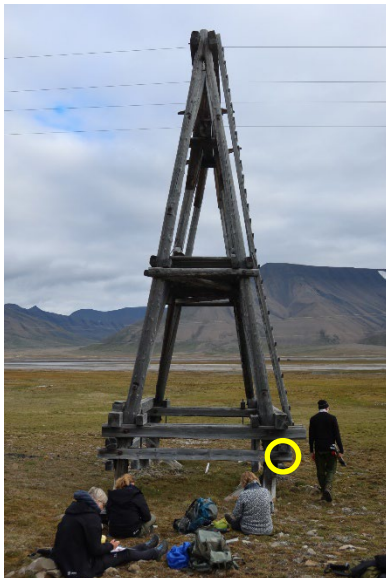
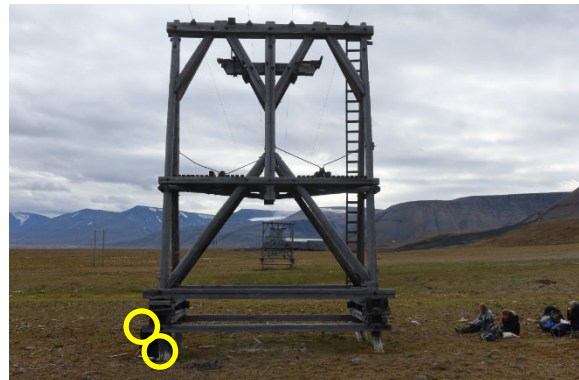
This cable car trestle is apparently in good condition in main structure/foundations and horizontal cross beams. The trestle is low and stands on flat terrain. This cable car trestle has not been restored but hold original materials/timber. There are traces that may indicate rot damage in the foundations in the transition between ground and air. The trestle stands far from human traffic and poses little risk of damage to people and property.

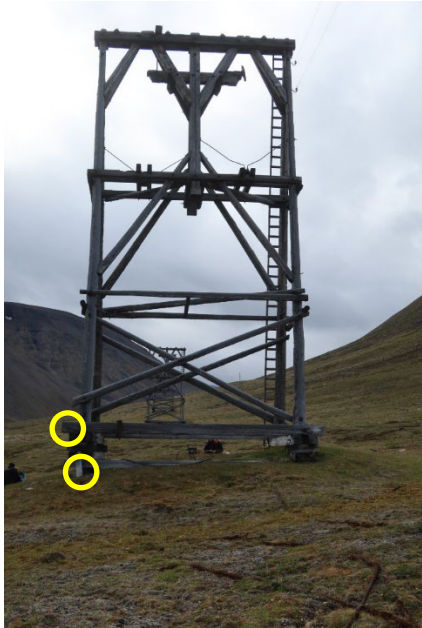
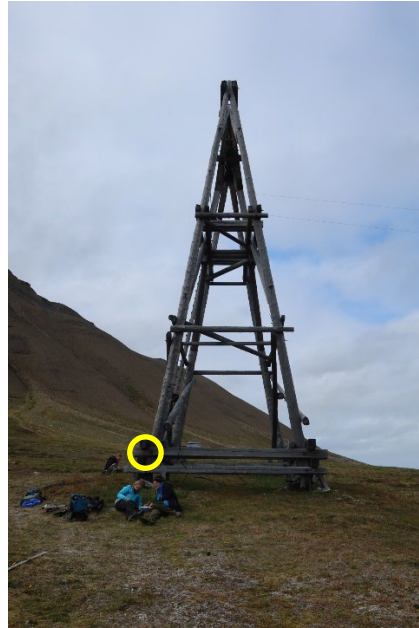
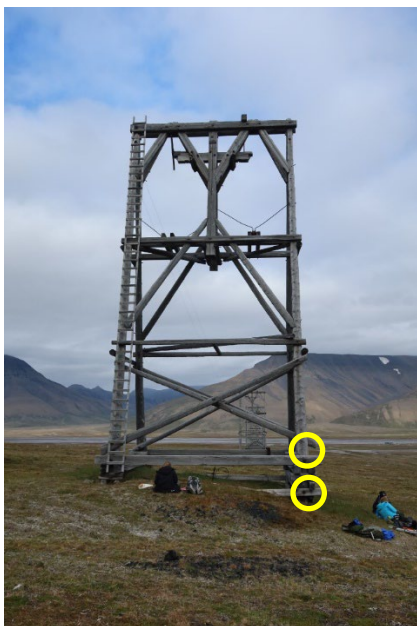
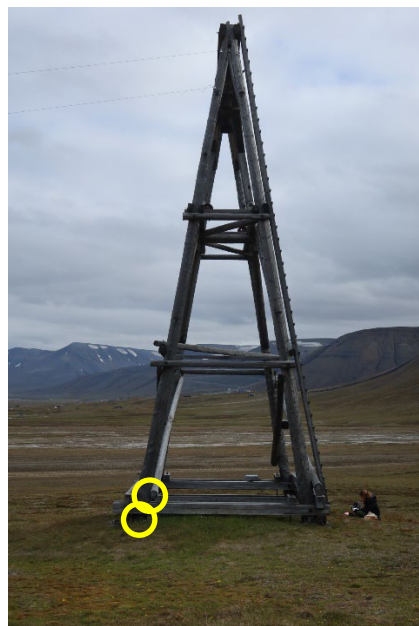
Fungal decay in all foundations/legs, but only critical condition in north-eastern leg. Horizontal beams in good condition. Good condition upwards in the construction. This cable car trestle has not been restored but hold original materials/timber. It is high, however the trestle stands far from human traffic and poses little risk of damage to people and property.

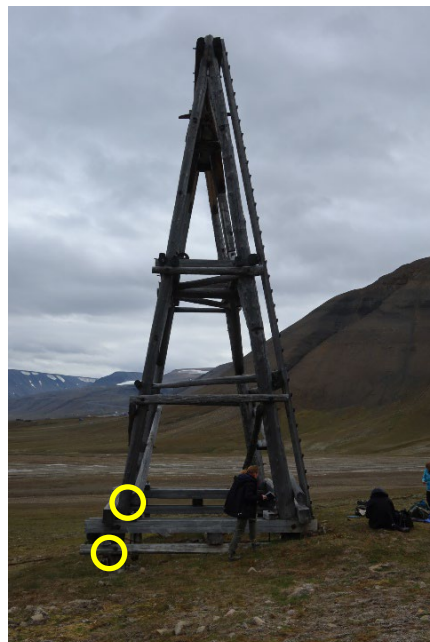
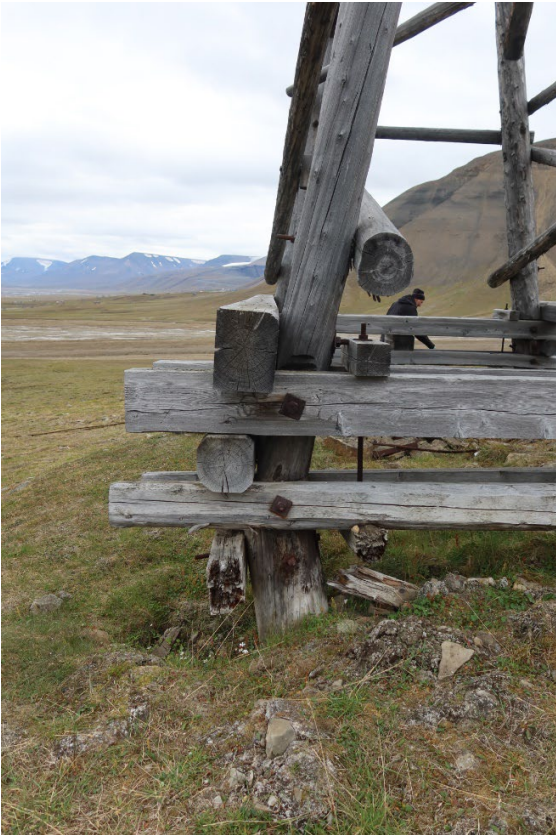
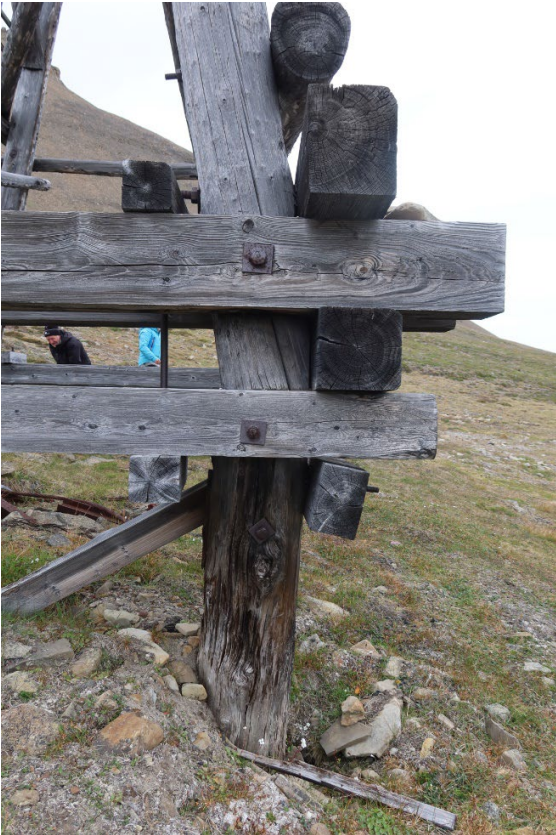
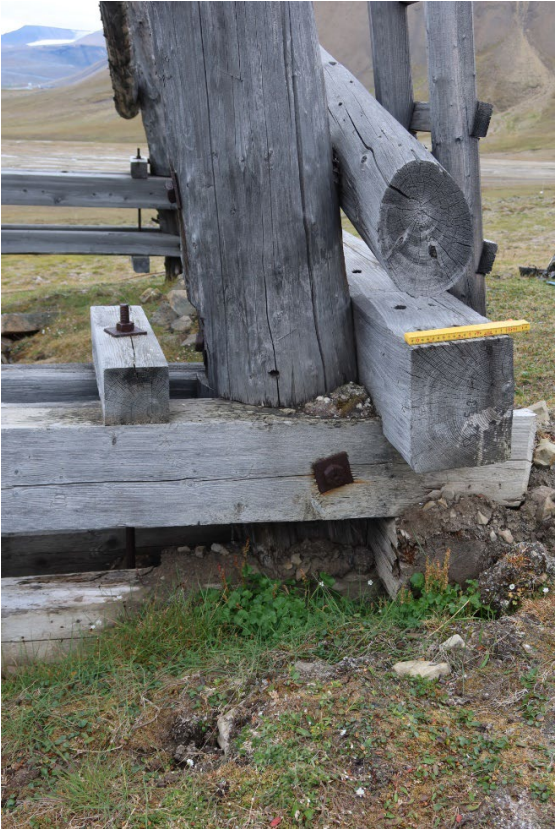
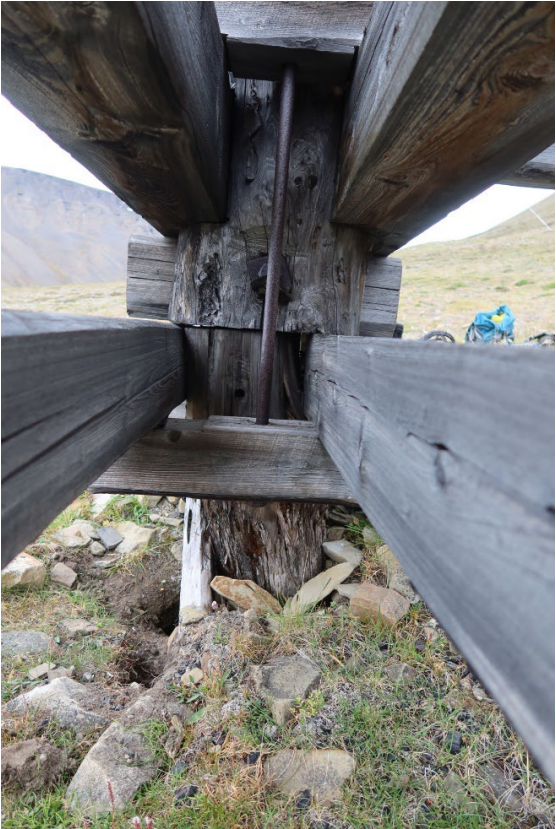
Fungal decay in all foundation logs/legs. Some fungal decay in horizontal beams in the lower arrangement. Apparently good condition higher up in the structure. This cable car trestle has not been restored but hold original materials/timber. It stands far from human traffic and poses little risk of damage to people and property.

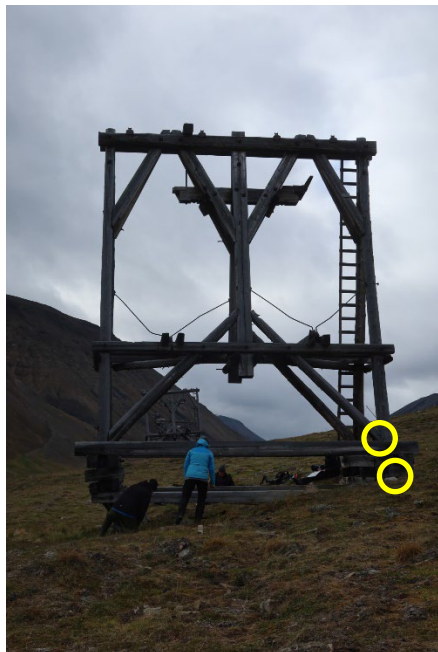
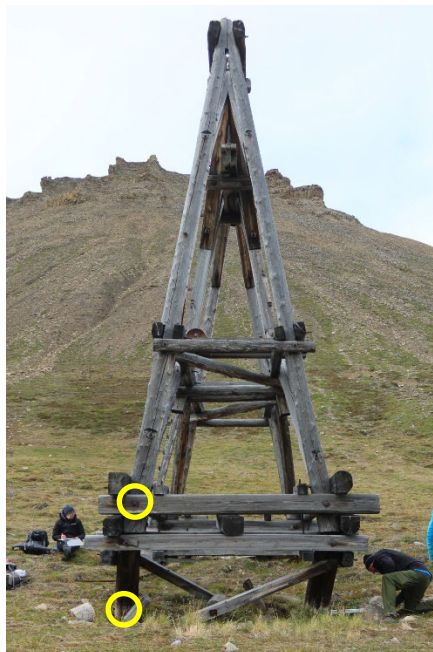
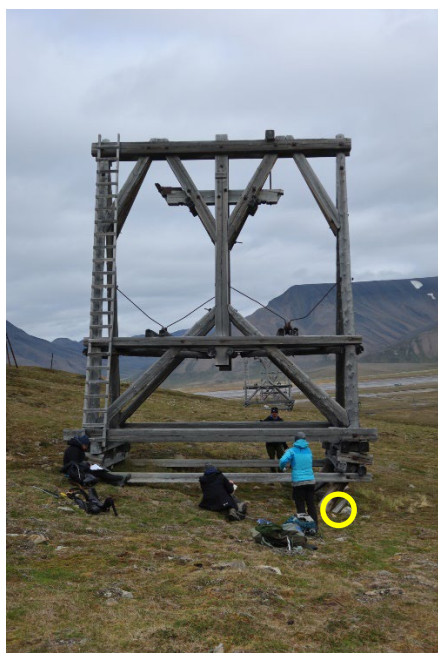
Displacement in the foundation to the east. some fungal decay in the foundations/legs. Apparently good condition higher up in the structure. This cable car trestle has not been restored but hold original materials/timber. It stands far from human traffic and poses little risk of damage to people and property.

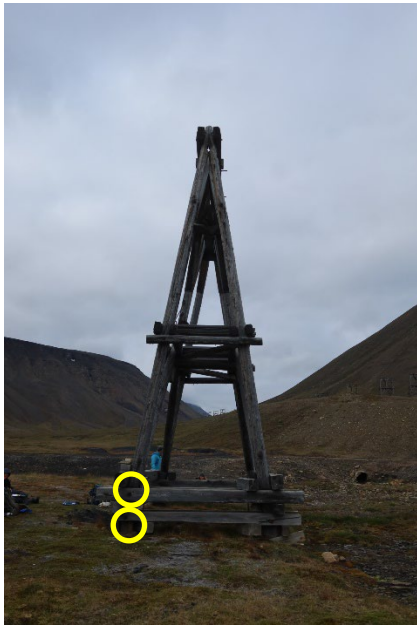
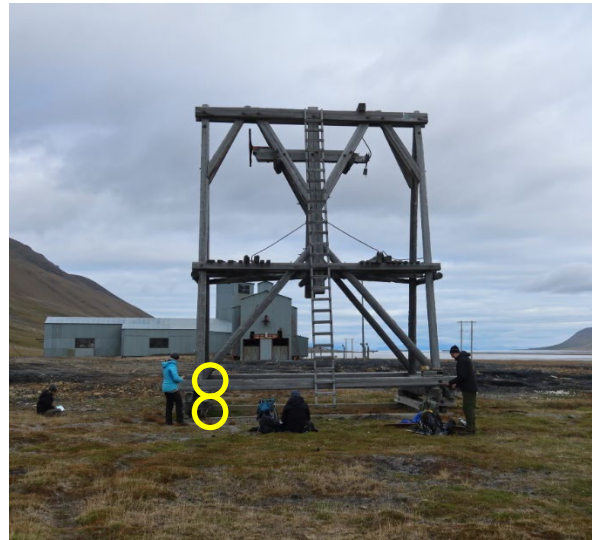
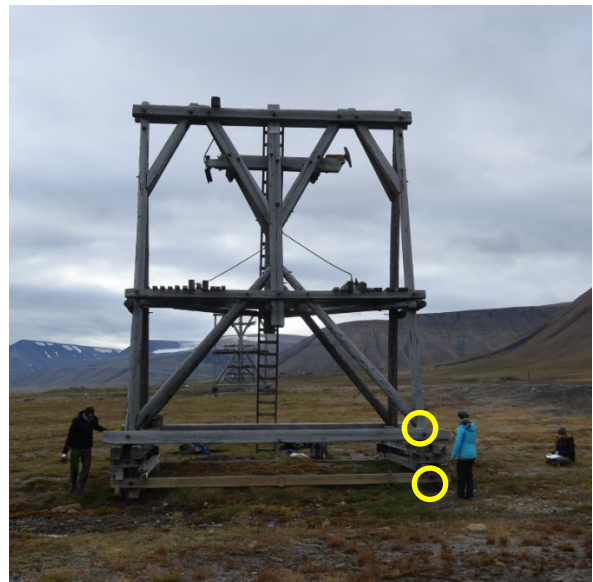
Apparently good condition higher up in the structure. Mechanical damage in the lower horizontal beams to the north-west at the foundation/legs. Fungal decay at the ends of inclined braces against the foundation in contact with the ground. The trestle is low and stands on flat terrain. This cable car trestle has not been restored but hold original materials/timber. The foundations hold signs of fungal decay in the transition between ground and air. It is situated far from human traffic and poses little risk of damage to people and property.

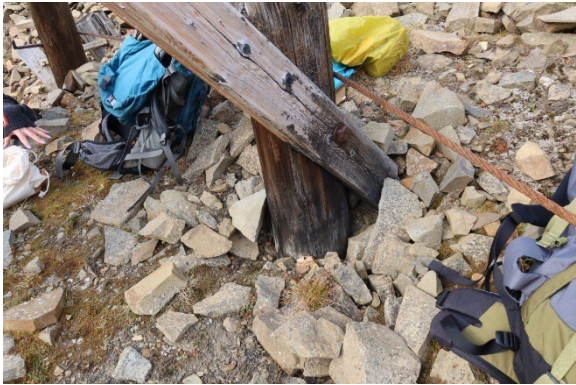
NW

The cable car trestle is located in very steep terrain and is not a threat for tourists and other visitors. Signs of possible decay in two of the legs (NW and SE). Structures further up seems to be in good conditions.

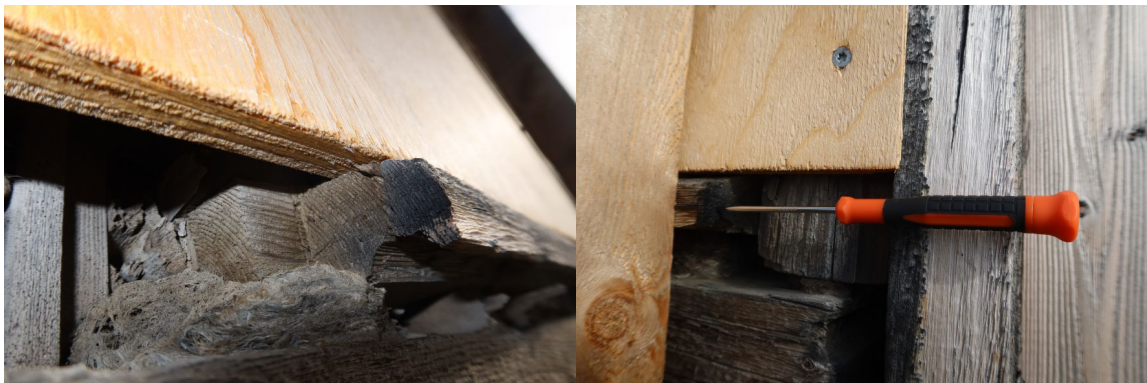
“Telegrafen”, west side. Awl probing in endgrain of weatherboard below window

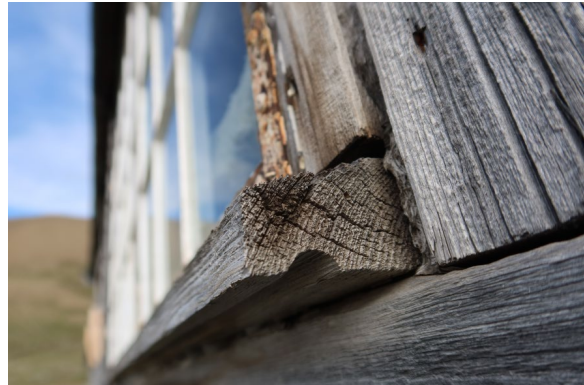
“Direktørboligen”, western facing side. Awl probing performed on end grain of weatherboard beneath main window

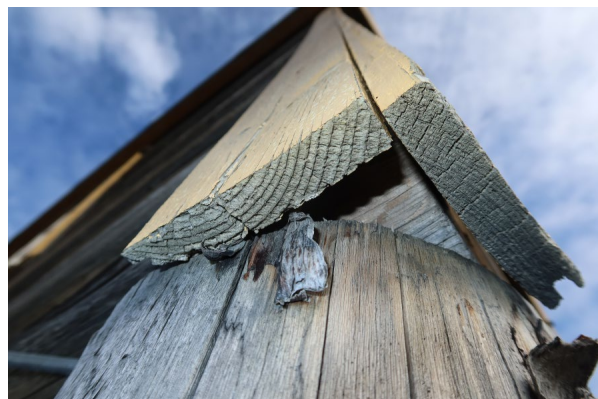
“Direktørboligen”, southwest corner. Awl probing performed on end grain of boards covering the corner

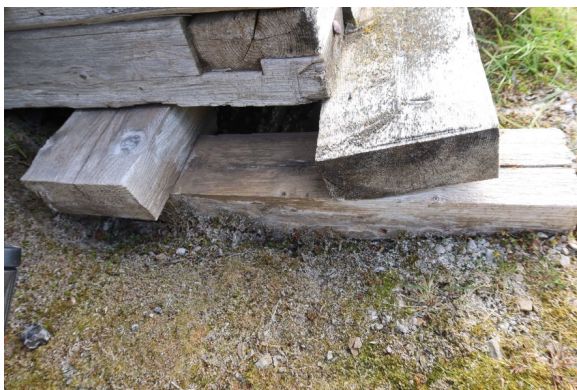
“Boligbrakke”, northwestern corner, north, before sampling

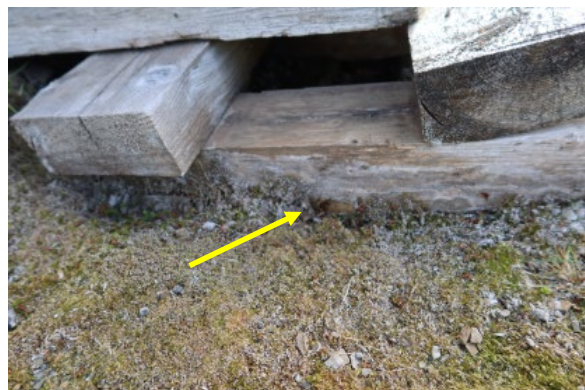
“Boligbrakke”, northwestern corner, north, after sampling. Location of sample indicated

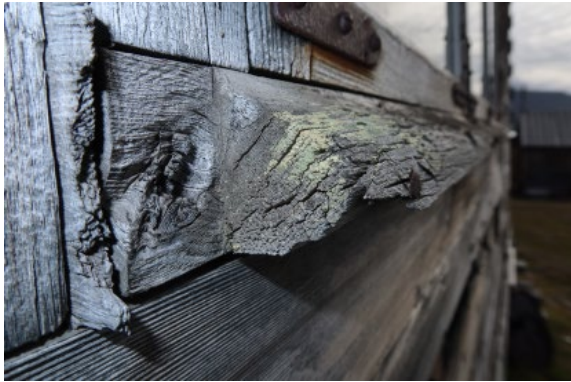
“Boligbrakke”, western facing side. Awl probing performed on end grain of weatherboard beneath southern window

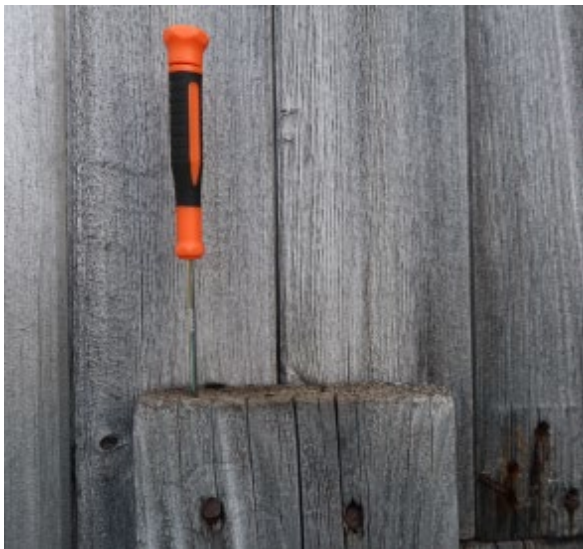
“Boligbrakke”, western facing side of covered porch. Awl probing performed on end grain of protruding board

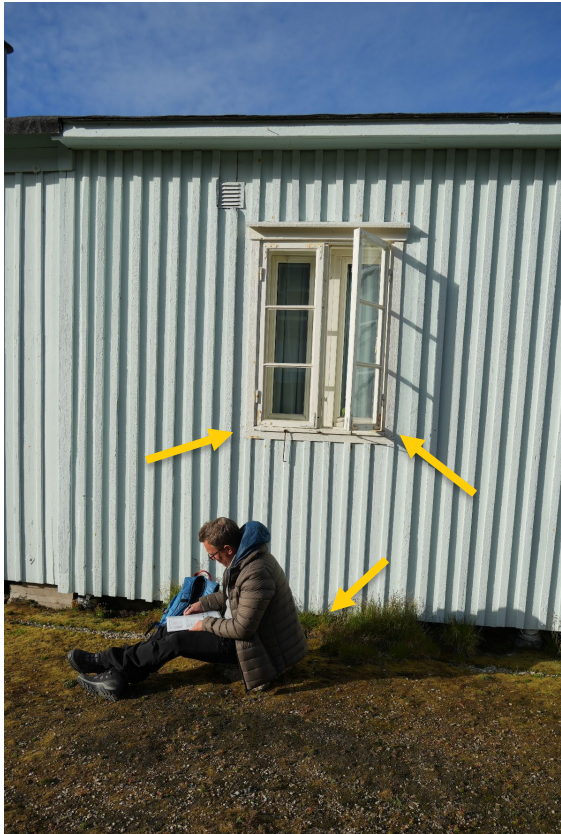
“Mexico”, façade facing south-west. Points of awl probing indicated

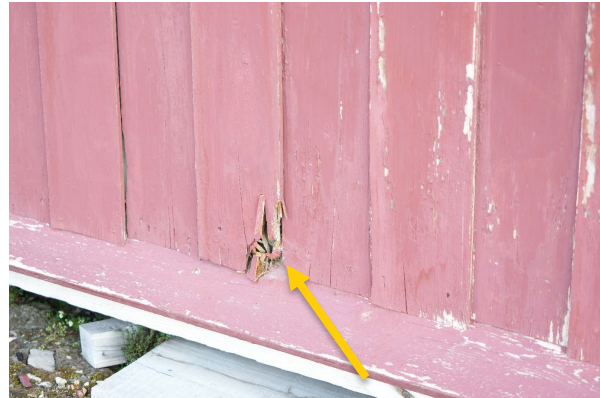
“Museum/Veteranhytta”, façade facing north-east. Only facade with window. Points of awl probing indicated

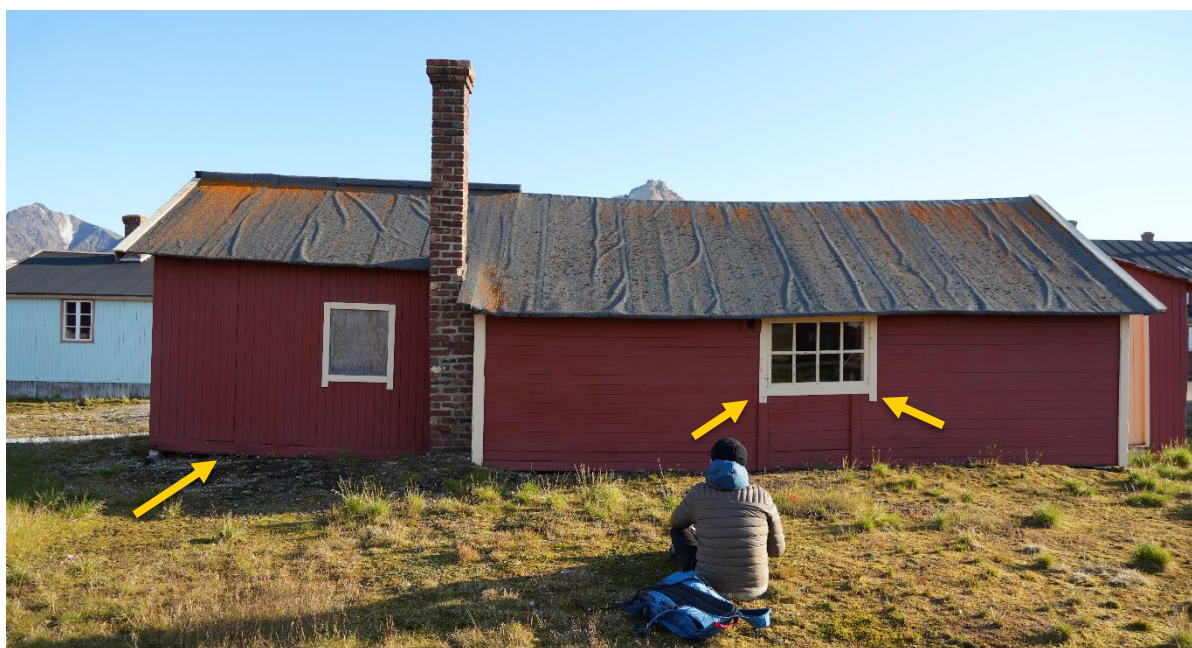
Green Harbour, façade facing north-east. Only façade with window. Points of awl probing indicated

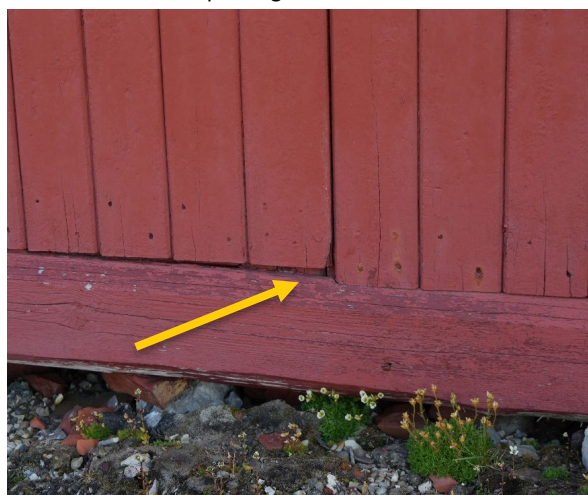
Green Harbour, façade facing north-east. Point of awl probing indicated. Awl probing performed on end grain of panel

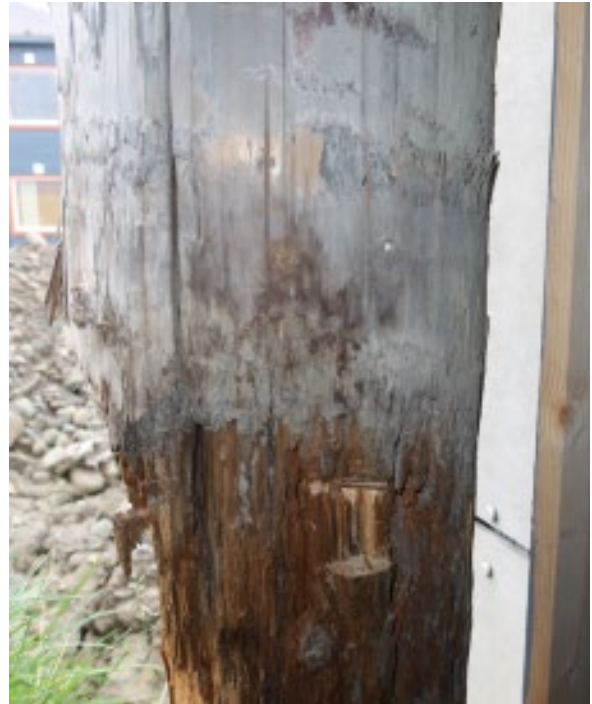
Hotel Radisson Blu, foundation pile SAS1. After cutting sample SAS1-1, 30 cm from beam
